Thrust-reverse system

Lufthansa Flight 2904 (September 14, 1993)

Red Wings Airlines Flight 9268 (December 29, 2012)

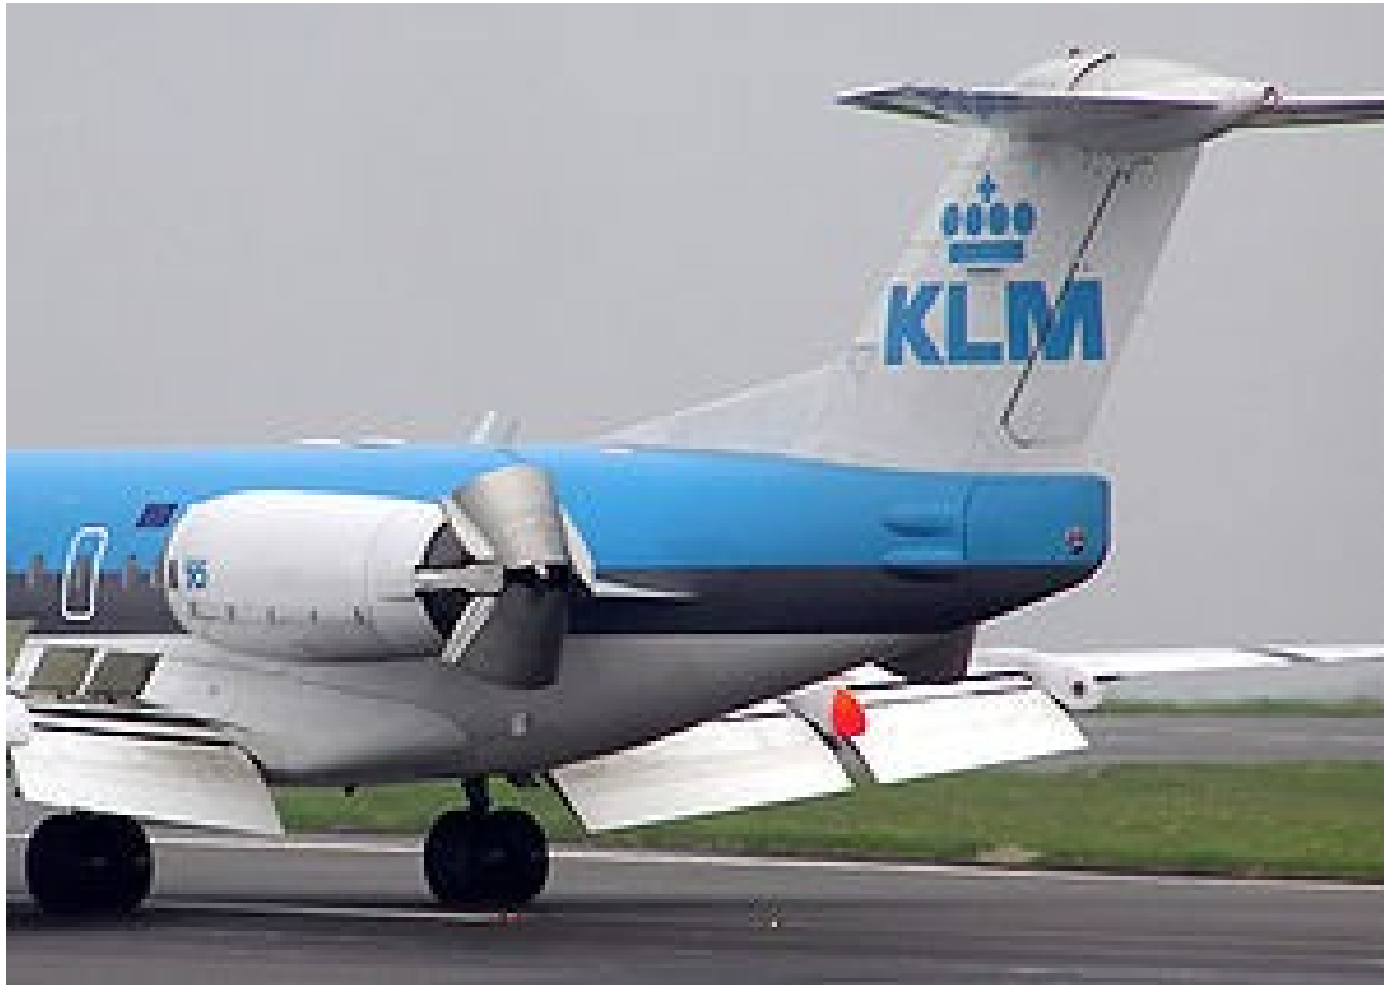
A KLM Fokker 70 rolling out with **flaps** fully extended, **spoilers** raised, and **reverse thrust** selected. The two reverse thrust buckets behind each engine can be seen in the deployed position, diverting the engine exhaust gases forward.

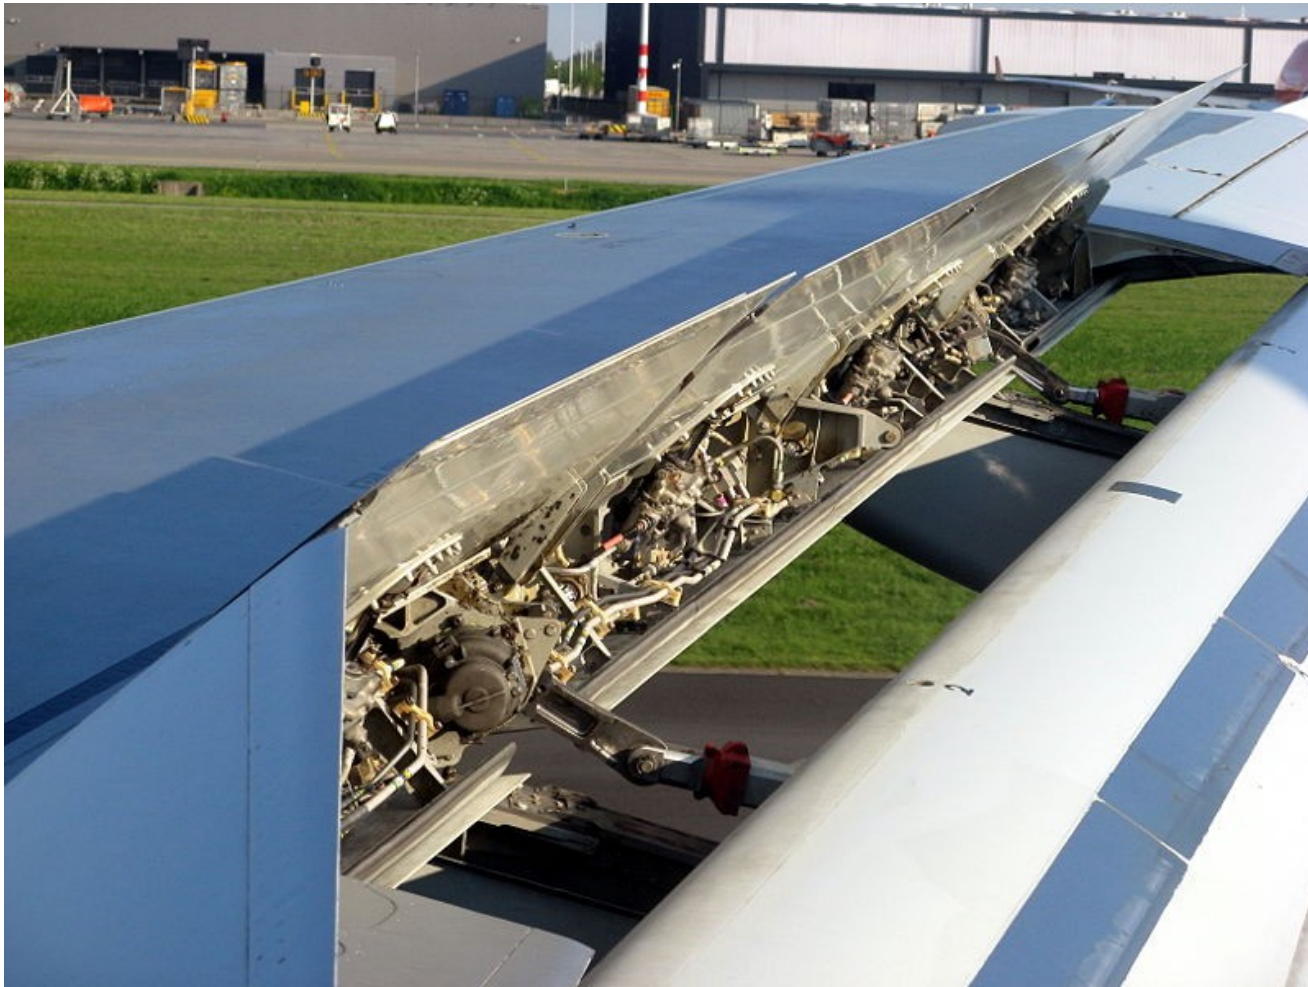
A close look at the inner workings of spoilers in lift dump deployment during the landing of an Airbus A320.

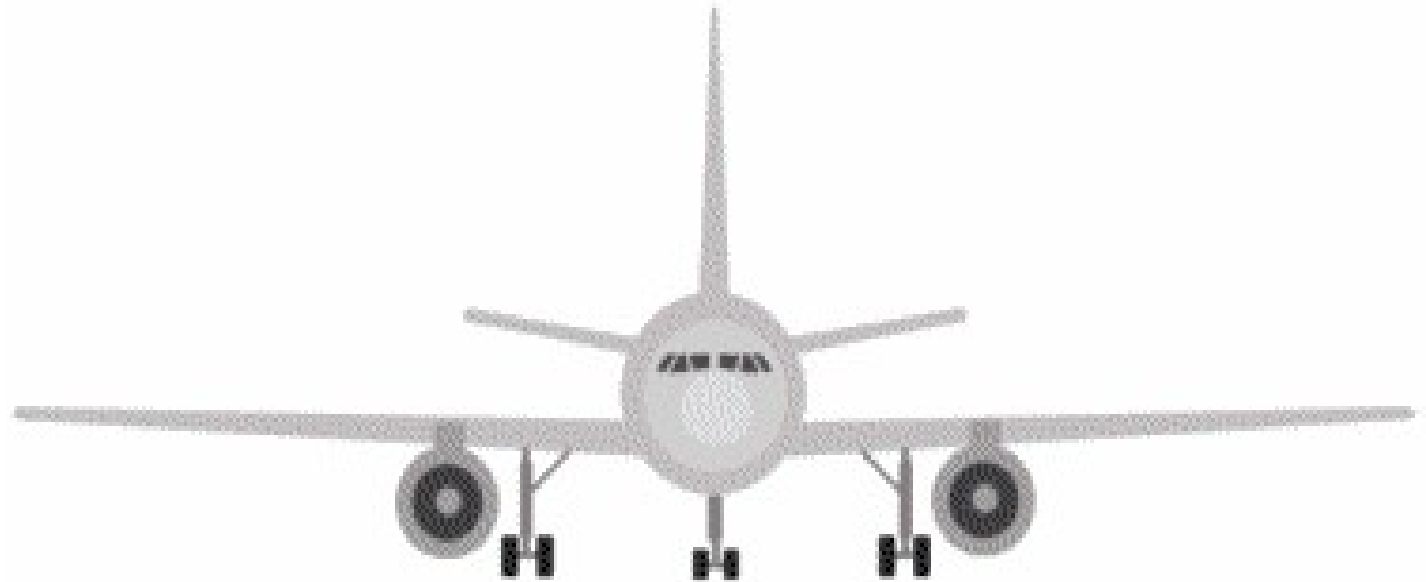
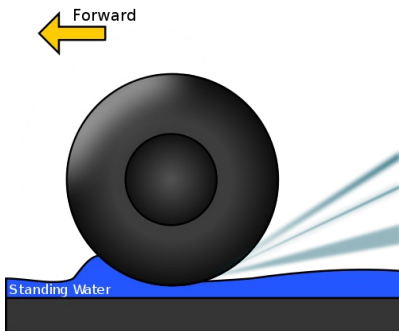
Illustration of distance relative to main strut touchdown. **The striped line** marks 1400 m, which divides the runway in half. **Red** indicates the landing gear have not touched down, **blue** indicates hydroplaning, and **green** indicates wheels on the ground.

In the case of the Warsaw accident neither of the first two conditions was fulfilled, so the most effective braking system was not activated. Point one was not fulfilled, because the plane landed inclined (to counteract the anticipated crosswind). Thus the pressure of 12 tons on both landing gears required to trigger the sensor was not reached. Point two was also not fulfilled because of a hydroplaning effect on the wet runway.

Only when the left landing gear touched the runway did the automatic aircraft systems allow the ground spoilers and engine thrust reversers to operate. Due to the braking distances in the heavy rain the aircraft could not stop before the end of the runway. The computer did not actually know the aircraft had landed until it was already 125 meters beyond the half way point of runway 11.
