Thrust-reverse system

From Frankfurt, Germany to Warsaw, Poland
Airbus A320-211

Red Wings Airlines Flight 9268 (December 29, 2012)

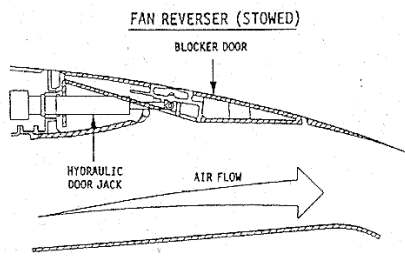
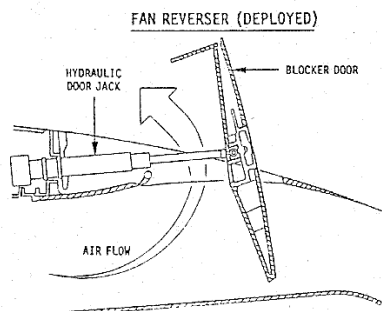
Reverse thrust is obtained by deflecting the fan airstream using four pivoting blocker doors on each engine.

Each door is actuated by a hydraulic door jack :

- ENG 1 : Green circuit
- ENG 2 : Yellow circuit

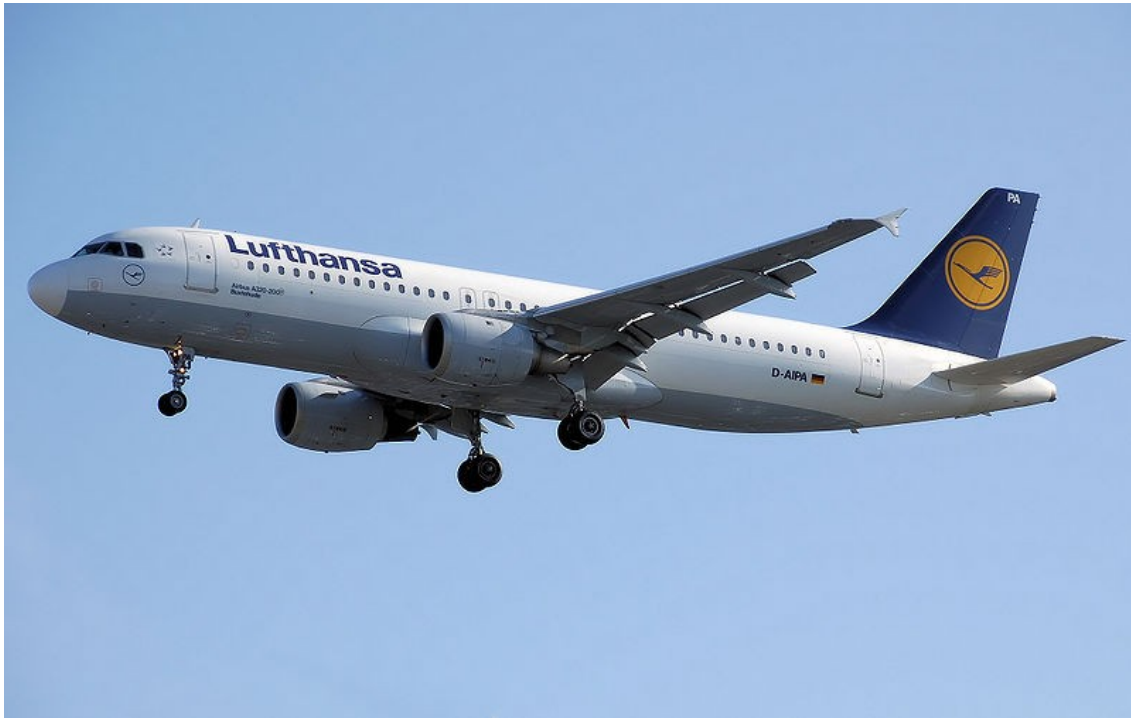
Lufthansa Flight 2904 was cleared to land at Okęcie International Airport Rwy 11 and was informed of the existence of wind shear on the approach. To compensate for the crosswind, the pilots attempted to touch down with the aircraft banked slightly to the right. Additionally they landed with a speed about 20 knots (37 km/h) faster than usual. According to the manual, this was the correct procedure for the reported weather conditions.

But the weather report was not up to date. At the moment of touch down, the assumed **crosswind** turned out to be a **tailwind**. Due to the tailwind of approximately 20 knots (37 km/h) and the increased speed the airplane hit the ground at approximately 170 knots (310 km/h) and far beyond the normal touch down point.

The aircraft's right gear touched down **770 m** from the runway 11 threshold.

The left gear touched down **9 seconds** later, **1525 m** from the threshold.

Only when the left gear touched the runway did the ground spoilers and engine thrust reversers deploy, these automatic systems depending on oleo strut (shock absorber) compression.

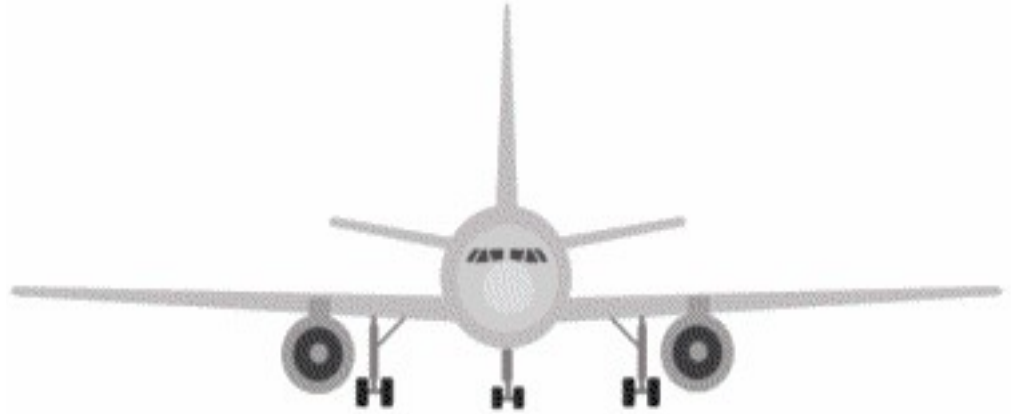
The wheel brakes, triggered by wheel rotation being equal to or greater than 72 knots (133 km/h) began to operate after about **4 seconds**.

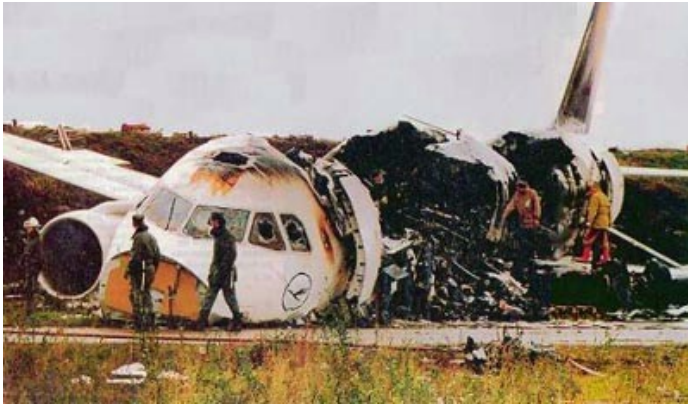
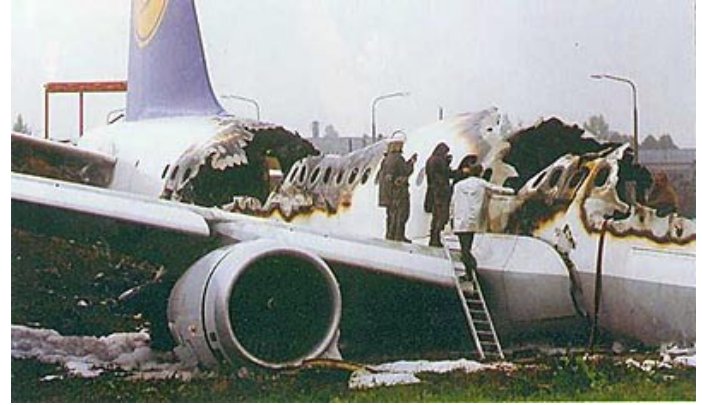
In the case of the Warsaw accident neither of the first two conditions was fulfilled, so the most effective braking system was not activated. Point one was not fulfilled, because the plane landed inclined (to counteract the anticipated crosswind). Thus the pressure of 12 tons on both landing gears required to trigger the sensor was not reached. Point two was also not fulfilled because of a hydroplaning effect on the wet runway.

Only when the left landing gear touched the runway did the automatic aircraft systems allow the ground spoilers and engine thrust reversers to operate. Due to the braking distances in the heavy rain the aircraft could not stop before the end of the runway. The computer did not actually know the aircraft had landed until it was already 125 meters beyond the half way point of runway 11.
