PRINT REPORT

LFM-0122-100-001

ReportNumber:	01	ProjectNumber:	LFM-0122-100-001
PartNumber:	LFM-0122-100-001	InquiryNumber:	LFM-0122-100-001.001
Requirements:	DO-01	DrawingNumber:	LFM-0122-100-001.idw
PartTitle:	Femoral head 32mm	Visual testing date:	04.04.2022

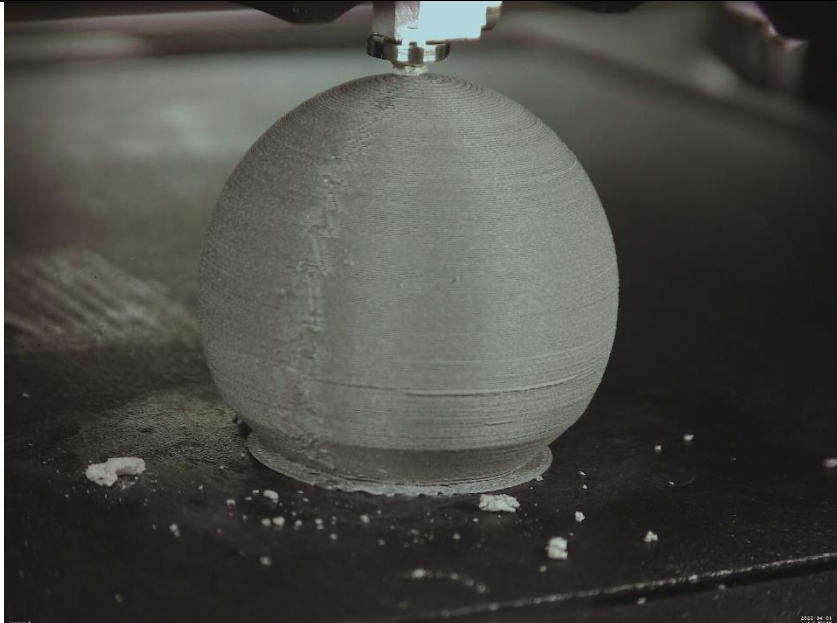
Test instruction	<ul style="list-style-type: none"> • The assessment and evaluation must be carried out by experienced and trained personnel. • Visual inspection after printing the part. • The surfaces must be free of any coating, dirt, dust, powder etc. • The testing/ inspection is carried out in daylight or under artificial light. The illuminance during the test must be at least 350lx, 500lx is recommended.
Acceptance rule	<ul style="list-style-type: none"> • There is currently no existing standard for 3D printing that defines the possible irregularities and limits for evaluation. • For this reason, only internal evaluation standards can be used. • The acceptance of the examinations here is based on the individual assessment of the examiner.
Part images after printing	
General view immediately after printing

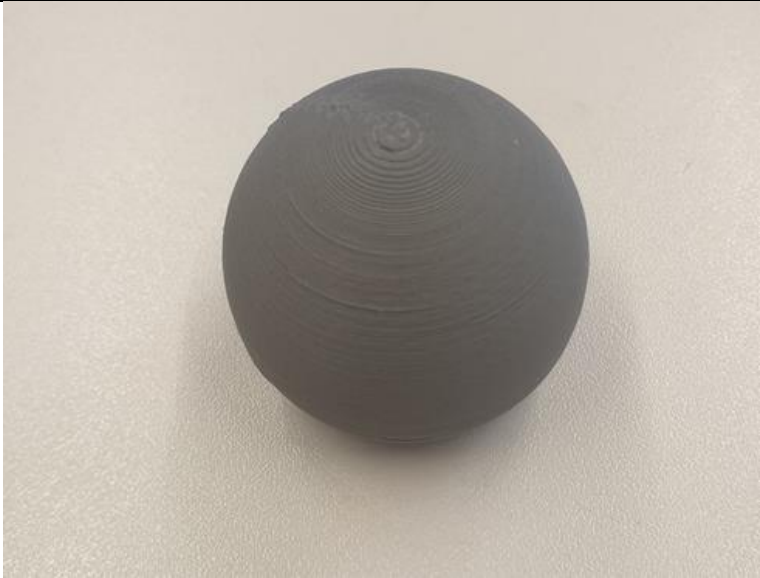
View under test conditions
