PRINT REPORT

LFM-0122-200-166

ReportNumber:	01	ProjectNumber:	LFM-0122-200-166
PartNumber:	LFM-0122-200-166	InquiryNumber:	LFM-0122-200-166.001
Requirements:	DO-01	DrawingNumber:	LFM-0122-200-166.idw
PartTitle:	Turbine blade	Visual testing date:	05.04.2022

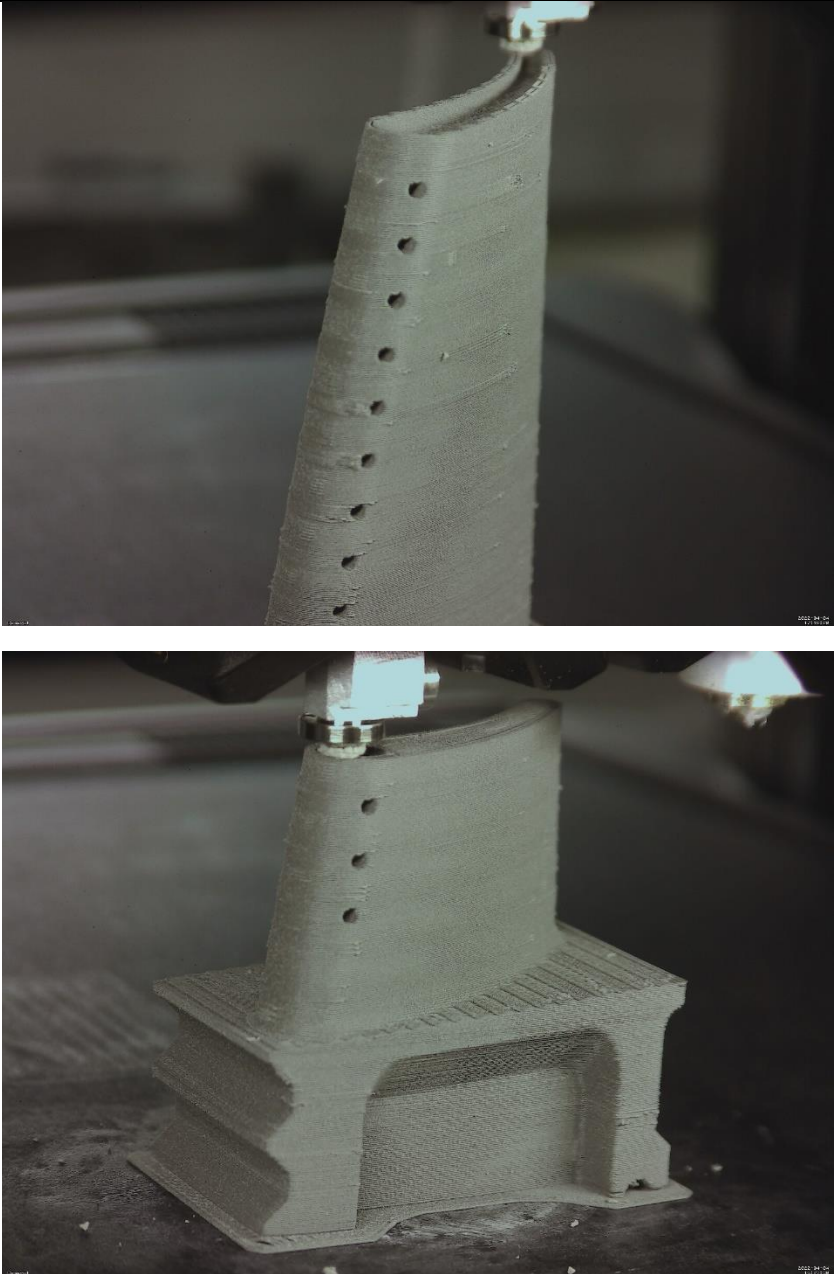
Test instruction	<ul style="list-style-type: none"> • The assessment and evaluation must be carried out by experienced and trained personnel. • Visual inspection after printing the part. • The surfaces must be free of any coating, dirt, dust, powder etc. • The testing/ inspection is carried out in daylight or under artificial light. The illuminance during the test must be at least 350lx, 500lx is recommended.
Acceptance rule	<ul style="list-style-type: none"> • There is currently no existing standard for 3D printing that defines the possible irregularities and limits for evaluation. • For this reason, only internal evaluation standards can be used. • The acceptance of the examinations here is based on the individual assessment of the examiner.
Part images after printing	
General view immediately after printing
