ENGINEERING REPORT

**Preliminary Report of Noticeable
4.84G in Vertical Acceleration of
PK-WGS, Registered MSN 1134, at
Sumbawa Besar (SWQ) Airport
on 20 April 2015**

No.	: ATR72-ER-05-034
Date	: May 4, 2015
Reference	: <i>See References</i>
A/C Type	: ATR72-212A
Effectivity	: PK-WGS
Attention	: QA, LM, SM, SSQ, OEM

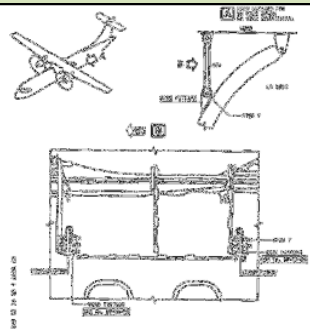
Main Structural Component	Damage Occurrence		Damage Description	Figure
	Yes	No		
Eddy Current Inspection on Wing-To-Fuselage Fitting on FR 25 and FR 27 STR 7 LH and RH		✓	No damage found NDT Report No. 140/IV/15/NDT
