Aviation Investigation Final Report

Location:	Hertford, North Carolina	Accident Number:	ERA17MA316
Date & Time:	September 8, 2017, 11:20 Local	Registration:	N146DU
Aircraft:	EUROCOPTER DEUTSCHLAND GMBH MBB BK 117	Aircraft Damage:	Destroyed
Defining Event:	Loss of engine power (partial)	Injuries:	4 Fatal
Flight Conducted Under:	Part 135: Air taxi & commuter - Non-scheduled - Air Medical (Discretionary)

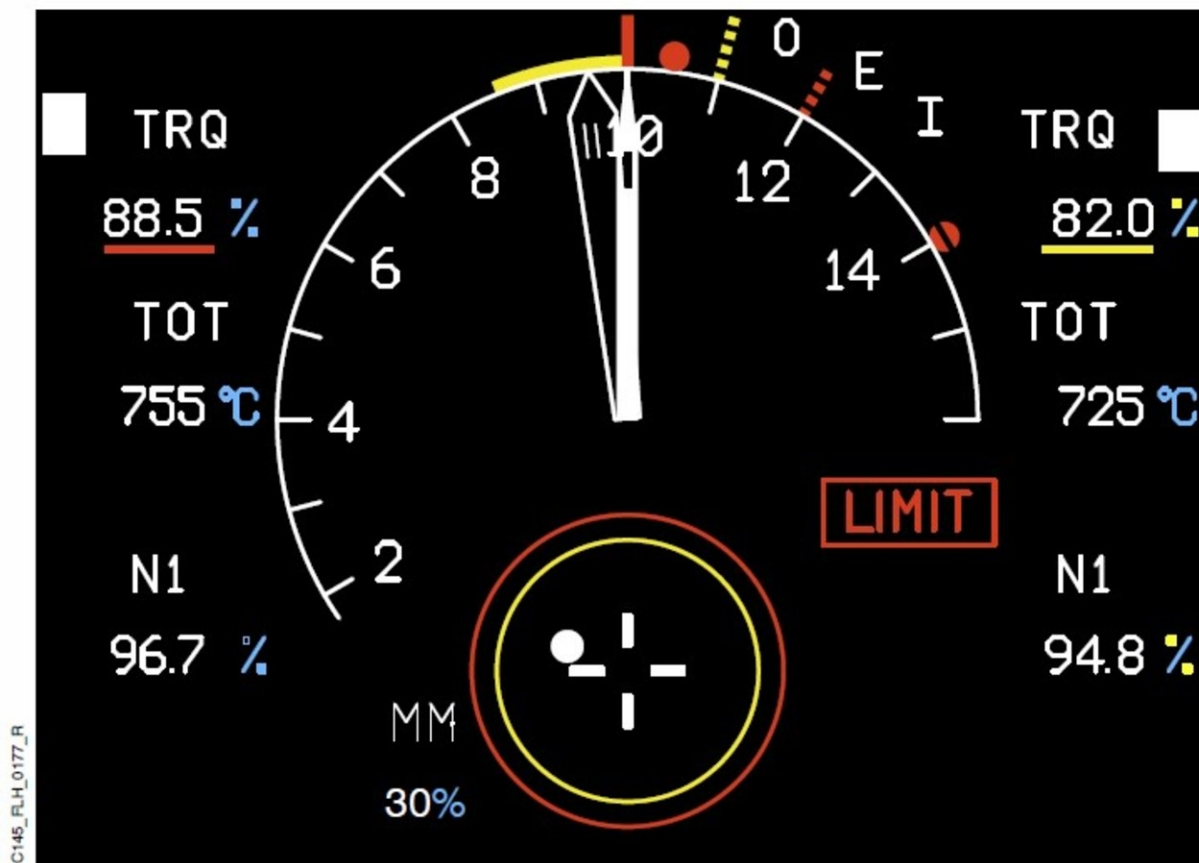
Figure 1 - First limit indicator. (Information from rotorcraft flight manual.)

The needles can represent TRQ, TOT, or N1, depending on which of these parameters is the closest to its operating limitation for each engine given the conditions at the time. For example, during cruise flight on the day of the accident, the needle for each engine (operating normally) would have corresponded to torque. In normal operation, both engines would have also remained torque matched by an automated variable rotor speed and torque matching system (VARTOMS). In this case, the “first limit” for both engines would be torque. The first limiting parameter is the parameter that is closest to its limit and does not mean that parameter has reached a limit. For example, as the pilot adds power, the engines would eventually reach one of the torque operating limits before reaching any of the turbine outlet temperature or gas generator speed limits. In different ambient conditions, such as operation at higher pressure altitudes, the first limiting parameter can instead be N1. Normally, both engines are limited by the same parameter.

The needles do not depict the value of the first-limited parameter (the scale inside the arc, numbered 2 through 14 in figure 1, is unitless, and standardized for comparison of the three limiting parameters) but rather the relationship of the parameter to several different limits that are shown on the outside of the arc as colored lines and symbols. These limits, including those for the OEI condition, are always displayed. The digital numeric values arranged vertically on the left side of the display show the values of TRQ, TOT, and N1 for the No. 1 engine; the numbers on the right side show the values for the No. 2 engine. These numbers, and the white boxes showing which parameter is currently closest to a limit for each engine, are also always displayed.

Should an engine be first limited by torque, its needles would depict engine torque with the various torque limits shown on the outside of the dial arc as red and yellow lines and circles. The white boxes that indicate the first-limit parameter for each engine (which in the example on Figure 1 is TRQ for both engines) also indicate that the respective needle is displaying that particular parameter. The needles in figure 1 show the No. 2 engine TRQ is in the yellow “AEO takeoff power range” and that the No. 1 engine TRQ is at the red “AEO max. takeoff power” limit. Additionally, the numeric value for the No. 1 engine TRQ is underlined with a red bar, indicating that it has reached the TRQ limit and is arriving to the transient range (meaning it can safely operate at that torque for a limited amount of time). If both engines are operating normally in cruise flight, both needles would indicate TRQ and would be positioned closely to one another with the same or about the same value, indicating that each engine is producing about the same amount of power. Small deviations in TRQ can be addressed manually by the pilot.
