Aviation Investigation Final Report

Location:	Pukoo, Hawaii	Accident Number:	WPR17FA021
Date & Time:	November 15, 2016, 18:41 Local	Registration:	N81GG
Aircraft:	Hughes 369	Aircraft Damage:	Destroyed
Defining Event:	VFR encounter with IMC	Injuries:	2 Fatal
Flight Conducted Under:	Part 91: General aviation - Personal

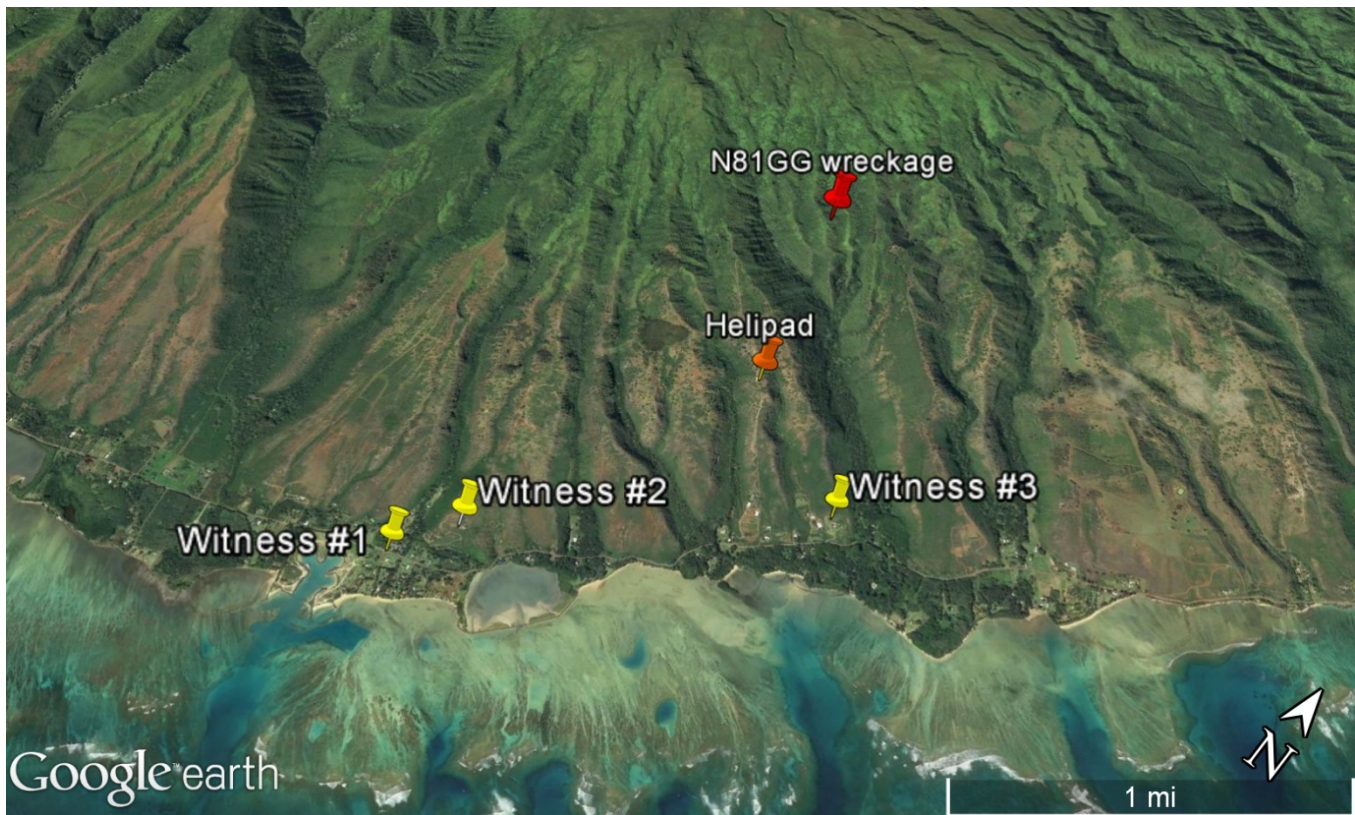
The Maui County Police Department interviewed six ground witnesses who observed the helicopter flying overhead in the Pukoo vicinity on the night of the accident. The witnesses stated that the weather conditions were dark with rain and wind and that the helicopter had its searchlight on. One of the witnesses (witness # 1 in figure 1), who lived 1.2 miles southwest of the helipad, stated that he saw the helicopter fly from the coastline to the mountain ridge and perform an approach toward the pilot's helipad, but this witness then lost sight of the helicopter when it entered a cloud.

Figure 1. Location of accident site, helipad and witnesses.

The National Transportation Safety Board (NTSB) interviewed four ground witnesses. One of the witnesses, (witness #2 in figure 1) who lived with another witness about 1 mile southwest of the helipad and 2 miles from the accident site, observed the helicopter flying "surprisingly low" and slow over their property with its searchlight on. The witness recognized the accident pilot's helicopter because she was accustomed to seeing that helicopter fly over her property. She stated that the pilot had flown in "horrific conditions" before and reported that, when she observed the helicopter, it was "very dark" and "very windy" with clouds and rain higher up on the mountain. The witness photographed the helicopter with her iPhone. The time stamp on the iPhone photograph was 1836, and it revealed that the helicopter was flying in dark night conditions.

A witness who lived 0.2 mile east of the pilot's property (witness #3 in figure 1) stated that the weather on the night of the accident was "very windy and rainy" and "as bad as I've ever seen." The witness
