Aviation Investigation Final Report

Location:	Reedsville, Wisconsin	Accident Number:	CEN16FA171
Date & Time:	May 4, 2016, 10:02 Local	Registration:	N629JK
Aircraft:	McDonnell Douglas Helicopter 369E	Aircraft Damage:	Substantial
Defining Event:	Loss of engine power (total)	Injuries:	1 Fatal
Flight Conducted Under:	Part 133: Rotorcraft ext. load

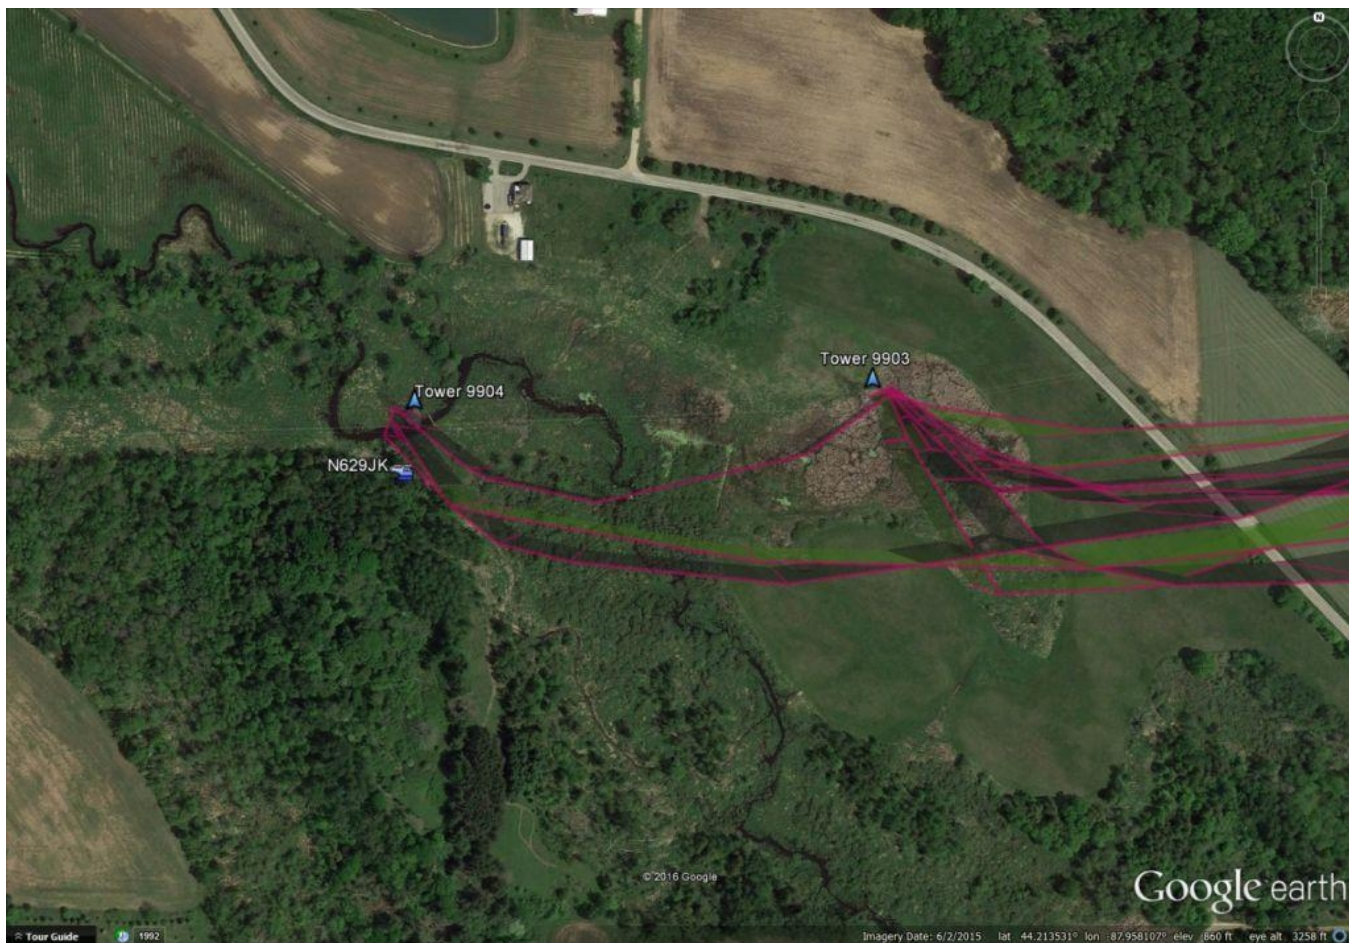
At 0949, the helicopter departed the LZ and transported two linemen from tower 9903 to the neighboring tower, 9904 (figure 1). When the linemen detached from the long line, the helicopter proceeded to the east and hovered for 2 to 3 minutes. The linemen requested that the helicopter come back to tower 9904 to pick up equipment and return to the LZ. The helicopter approached the tower from the southwest and faced northeast into the wind as the linemen presented hand signals to the pilot. The linemen stated that the end of the long line was about 20 ft laterally and 15 ft vertically from their reach when they noticed the helicopter's sound change and it descended suddenly. The helicopter veered to the right away from the tower, and the main rotor blades slowed noticeably. The helicopter continued into the trees and terrain south of the tower. The linemen climbed down from the tower and heard the helicopter's engine still producing noise. One lineman pulled the emergency fuel shutoff valve and turned off the battery.

Figure 1 – Google Earth overview of the accident area with GPS track downloaded from Garmin 496 onboard helicopter
