*Example property
London*

Part owner's damp report

12 April 2022

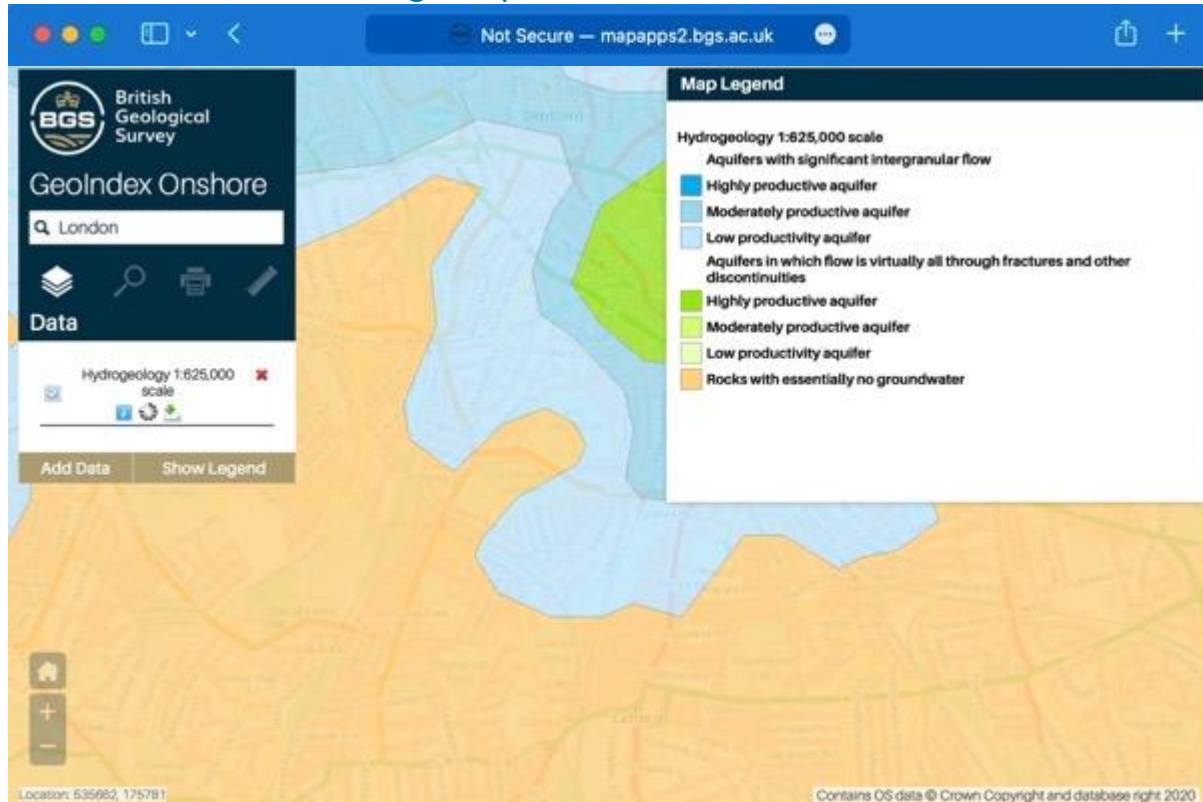
Groundwater – risk of rising damp

According to the British Geological Survey map, there is no risk of groundwater below the property.

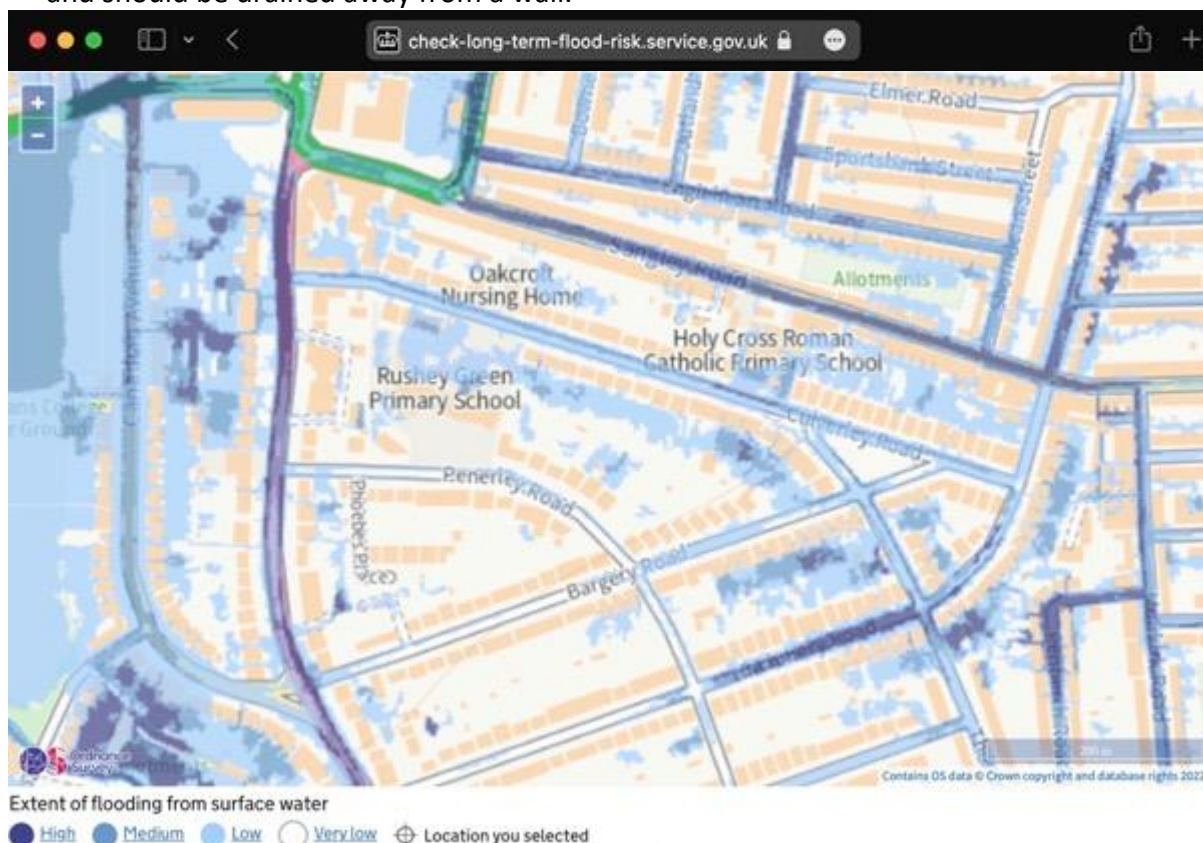
Surface water flood risk can be mistaken for groundwater. But even the risk of surface water is very low here.

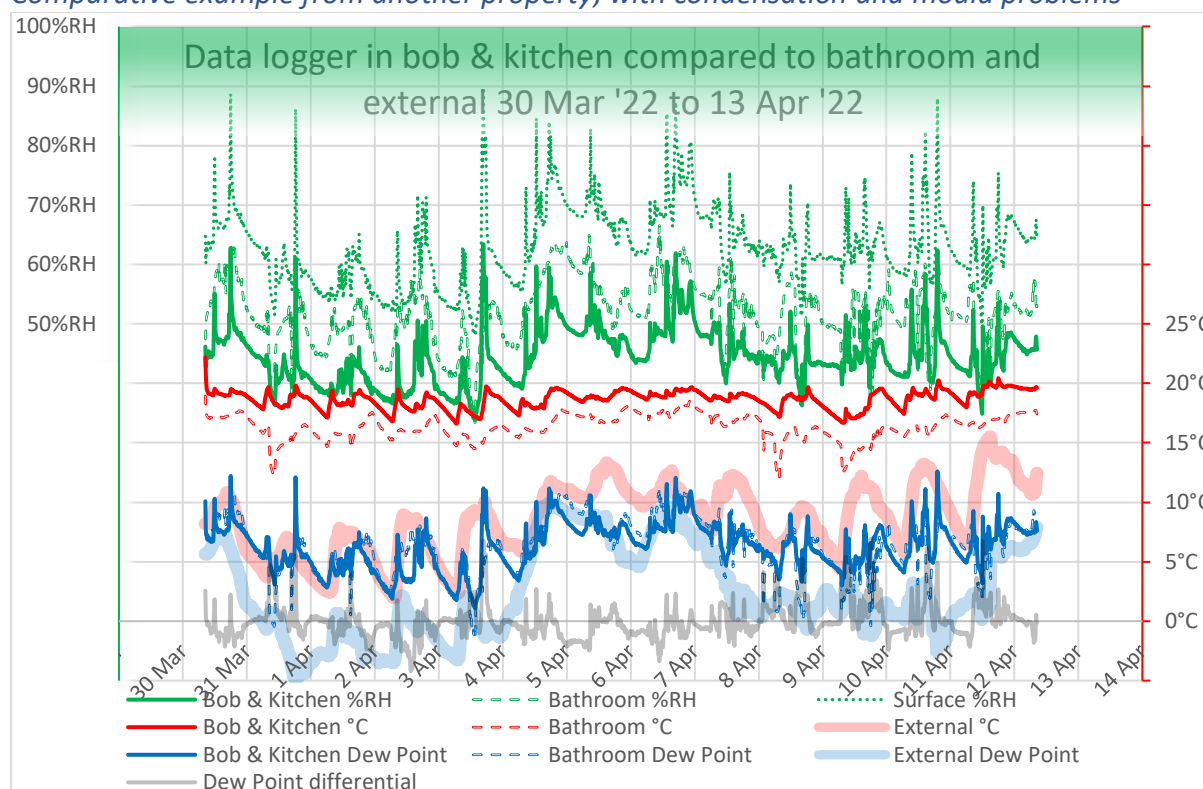
Comparative example from another property, with condensation and mould problems

This example property is well above 85%RH even in April.

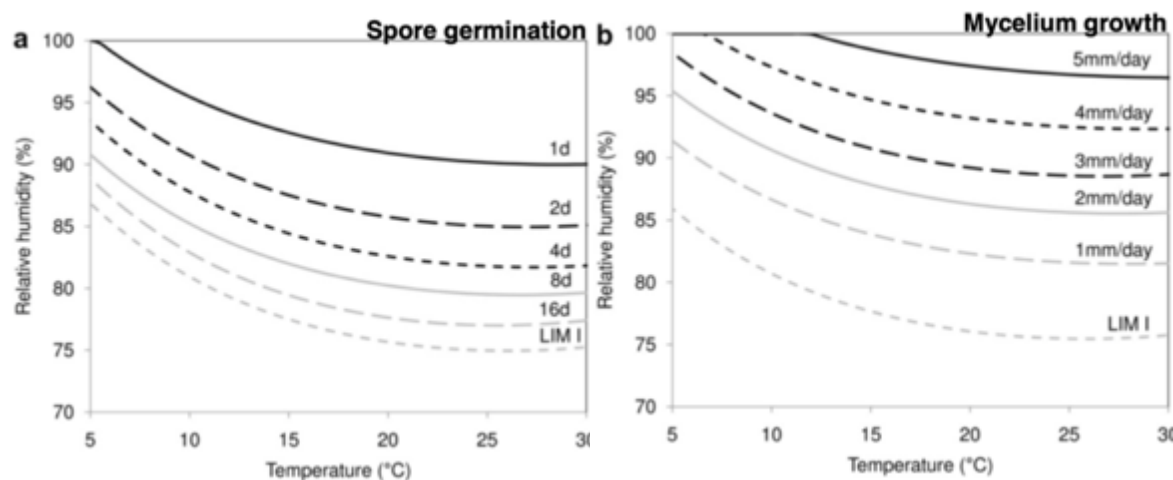
Graph from UK centre for moisture in buildings

Very consistent levels of humidity above 75%RH for over 16 days at 15°C can cause mould to germinate and grow, see above graph. It is in part the consistency of high humidity, not just the humidity per se. For example, a property at 90%RH for five hours a day, then 75%RH or less, would have a lower risk of mould growth than two weeks at 82%RH.
