(wafer2,2,0,-1,-1,0,1) Characteristics

- **Cell Size:** 15um
- **Times Accessed:** 6
- **Last Measurement:** 2022/March/23 at 04:09:35PM

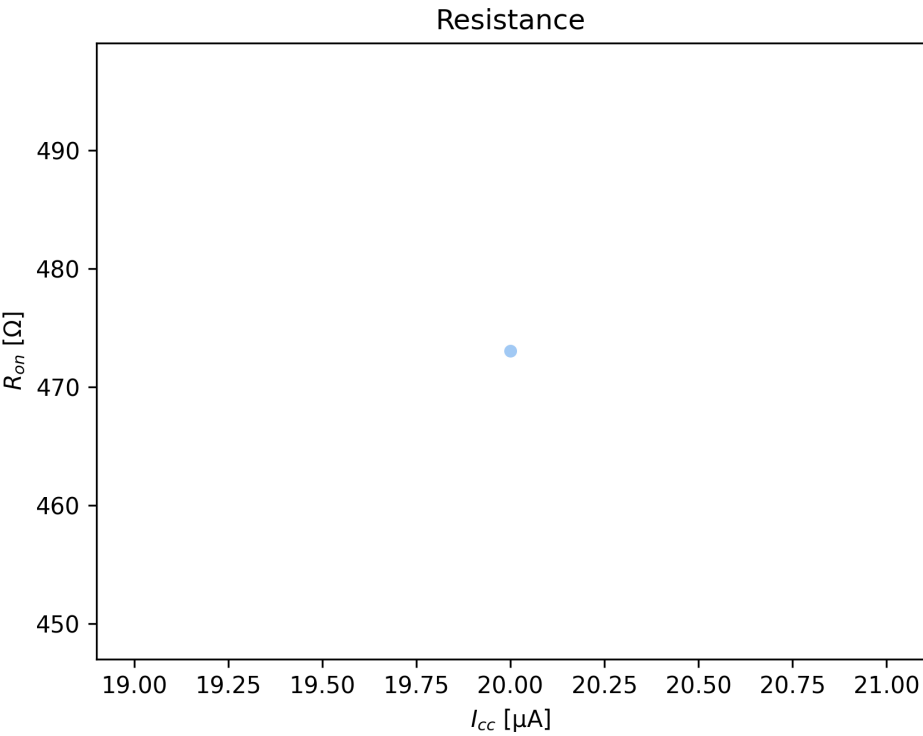
form

- **Time:** 04:01:03PM
- **Icc:** 20.0uA
- **Voltage Range:** 0V \rightarrow 5V
- **Target Ramp Rate:** 1V/s
- **True Ramp Rate:** 1.836 V/s*
- **Cycle:** 1
- **Error:** Set failed

Probe A on copper, B on platinum. Already set. Possibly due to minor layer short in wafer, around countour edge of bottom platinum layer.
