HARDWARE PATCH for Zemmix Neo, SX-1, SM-X and related machines (update 2020.04.06)

2020.08.19 Hardware Patch for OCM machines “aka BUSDIR_n patch”

2020.10.16 Hardware patch for Zemmix Neo BR machines (aka +5V line stability fix)

2022.04.19 Hardware Patch for SM-X, SX-2 and related machines (aka PS/2 keyboard compatibility fix)

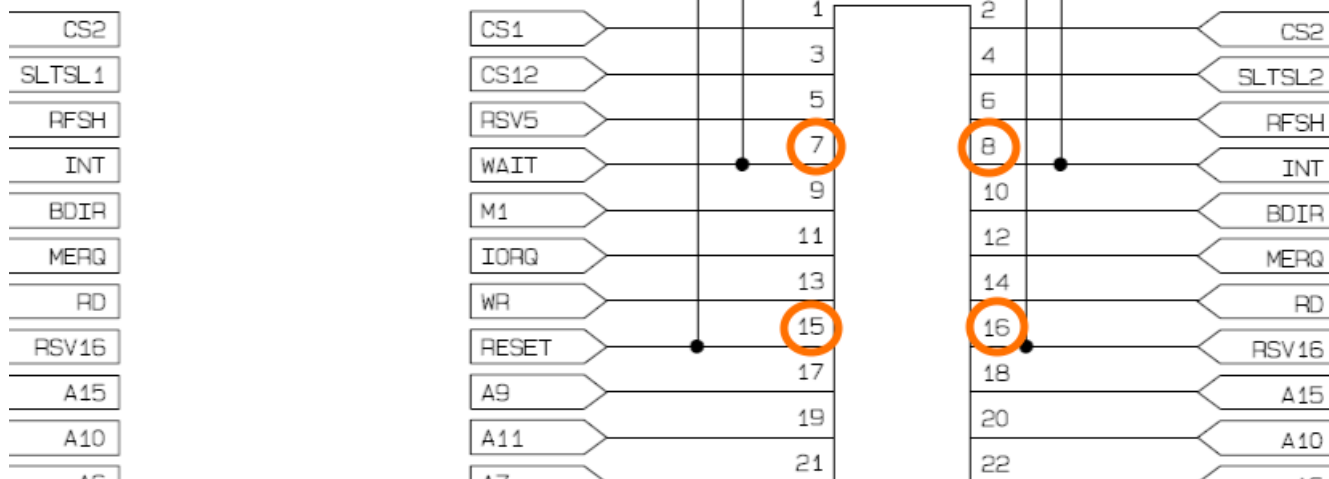
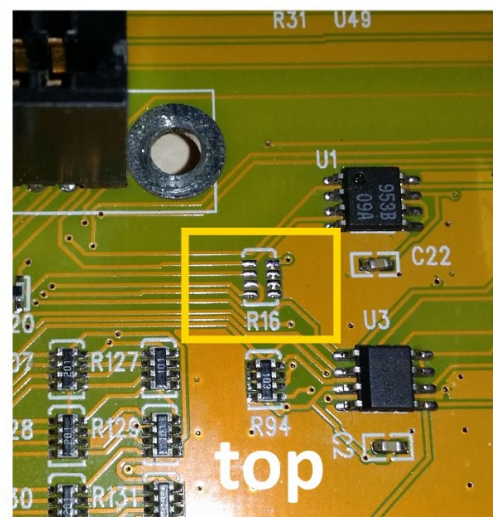
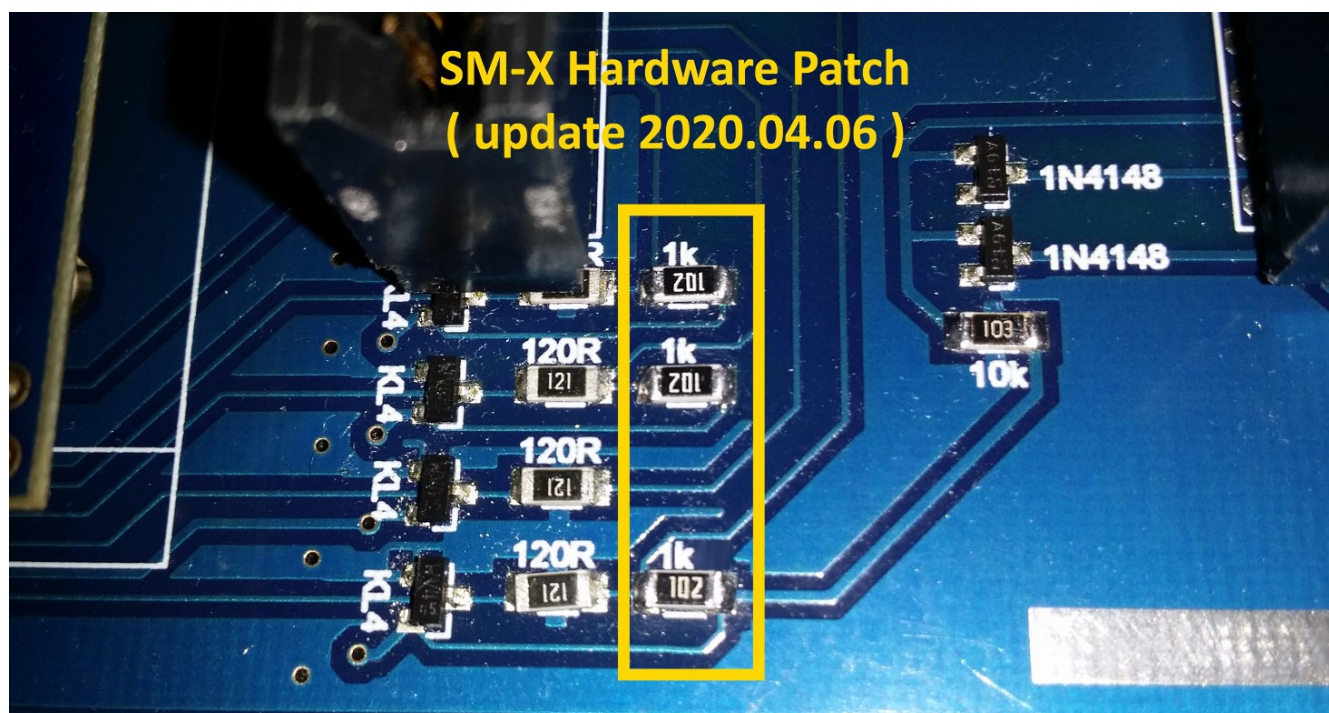
- In OCM machines we have a short circuit between pin-10 (BUSDIR_n) of the two external slots that continues towards the FPGA. This type of connection confuses some cartridges.
- While the Panasonic FS-A1ST and Canon V-20 service manuals confirmed that the BUSDIR signal is not used.

- Pin-10 (BUSDIR_n) of the external slots must be isolated.

- Method 1 - Cut the track that connects pin-10 of Slot-1 and Slot-2 leaving unchanged the connection to the FPGA already internally isolated by the firmware.
- Method 2 - Desolder pin-10 of slot-2 from the PCB and insulate it with the sheath of an electric wire and a drop of hot glue.
- Method 3 - Place non conducting tape over pin 10 of those cartridges that are not working properly, such as MoonSound and Darky.

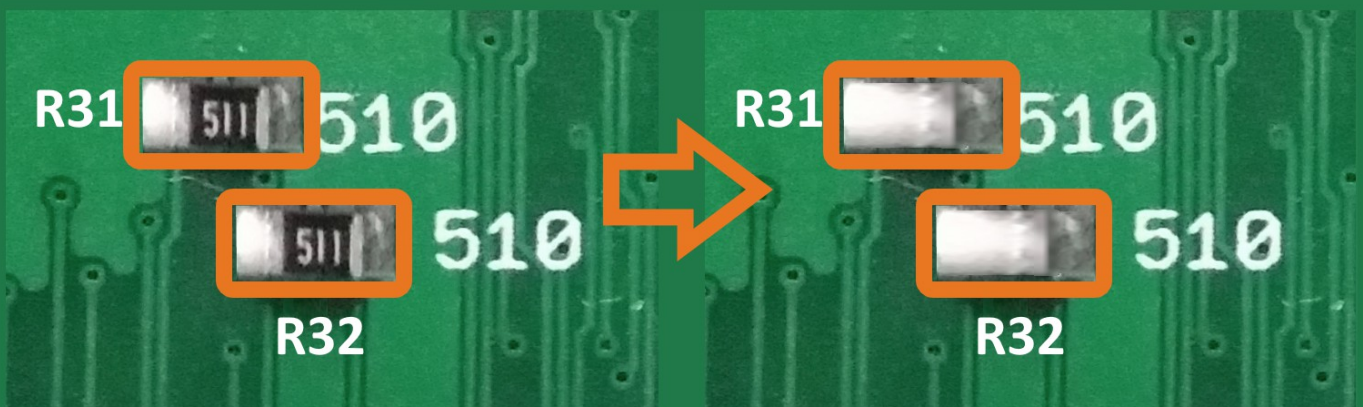
This is an optional fix. If your keyboard is NOT working properly you can apply this hardware patch or purchase another keyboard.

How to do it: short-circuit R31 and R32 like in this photo.
