# SunetC 200G blogg

## SunetC 200G

[Magnus Bergroth](#) posted on May 25, 2020

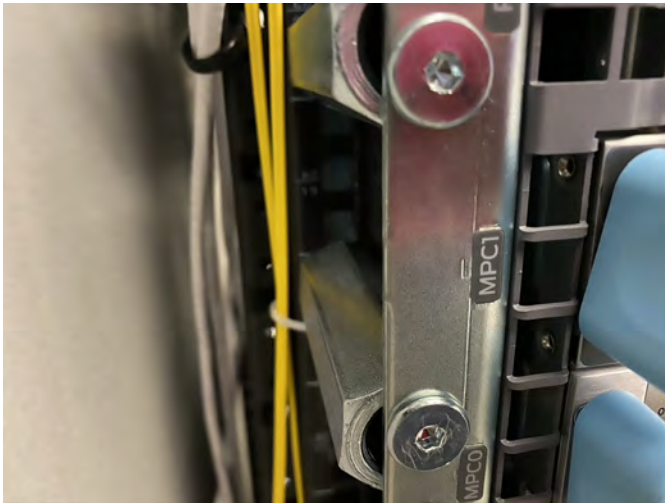
The small issue is that the Juniper MX960 and the MX10003 has different distance between the front and the back rack post. And the installed equipment made it impossible to move the posts.

A trip to the local company Biltema were some M16 long nuts and long m6 bolts over bridged the 75mm gap.

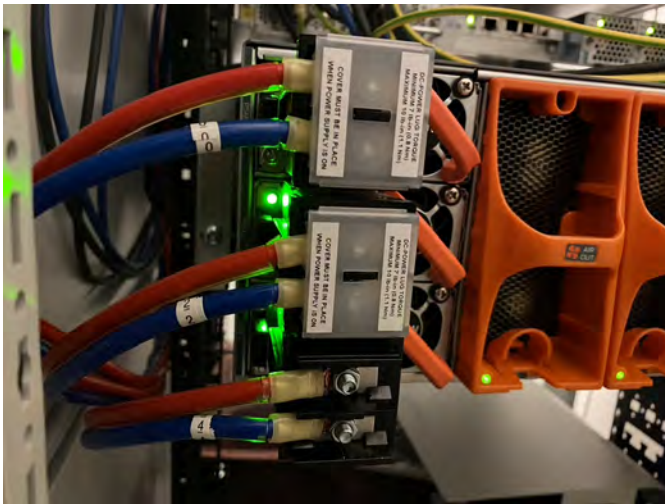
This is the A-side of the MX10003. Those safety plastic covers are a joke, they snap on but they do not sit very tight so if get close with a hammer or any other tool they get lost.

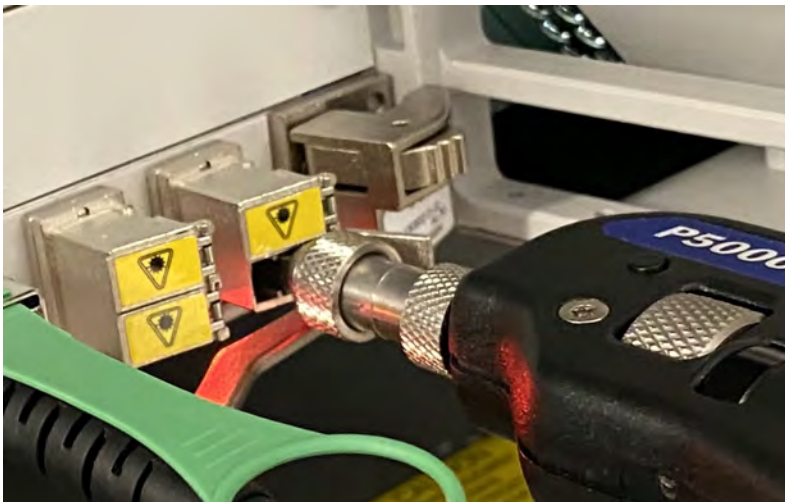
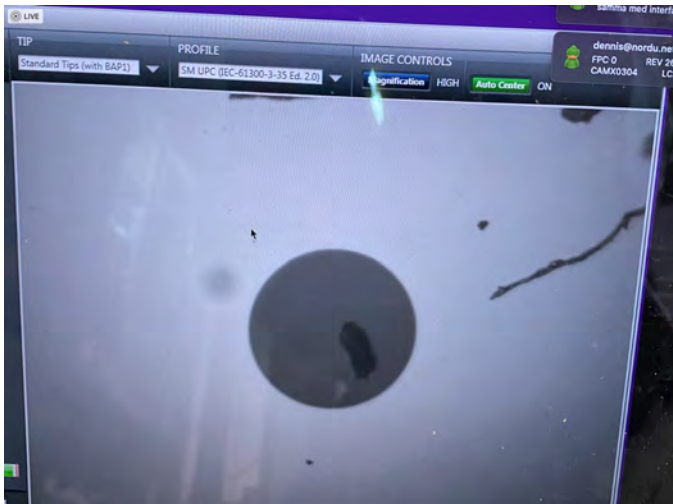
1. Move the fiber from the local mx960 router to the correct Adva network port and clean the fiber port. One could think that fiber ports with nice metallic flaps could all be clean from the factory. Most were but some looked like this.

Mantra to learn: Scope, clean, Scope

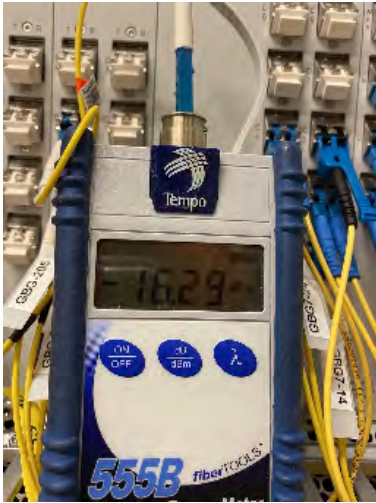
**But the new wave didn't want to equalize, tried to swap RX and TX still no luck. Tested with a light meter and it showed -16dBm into the 8PSM card, it should be atleast -1dBm.**

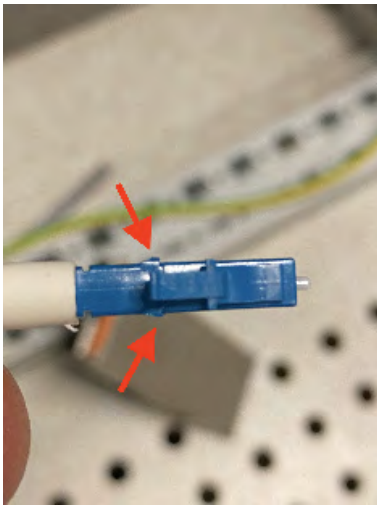
Turned out that the fiberpatch LC connector had a plastic burr from the manufacturing process that prevented the LC connector to be seated correctly in the CFP2 plug and the airgap created the extra attenuation.

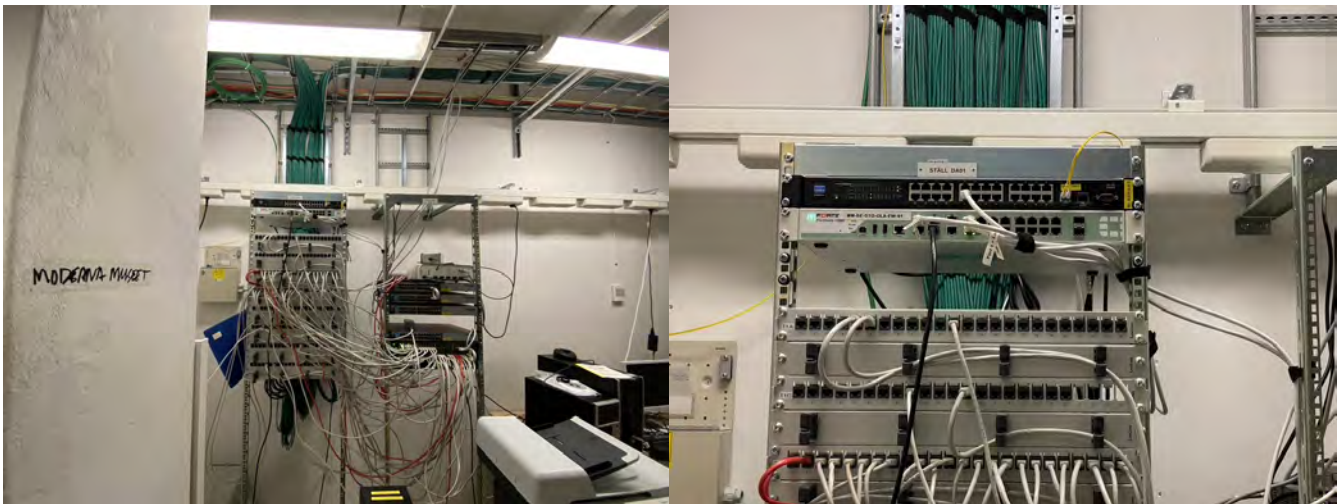
A 24 port linksys switch was used as a media converter. The fibre port flashed as one could expect. Connected my laptop to the switch and I could ping their FW but not our router.

Restarted the switch, swapped ports, no luck. Found a DB9 connector and logged into the switch.

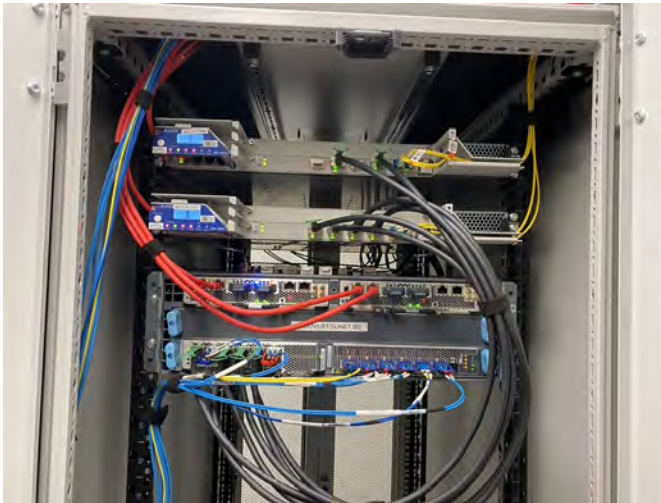
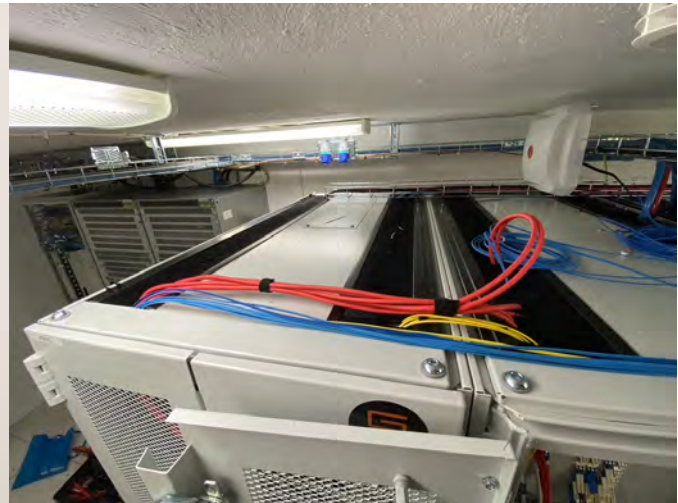
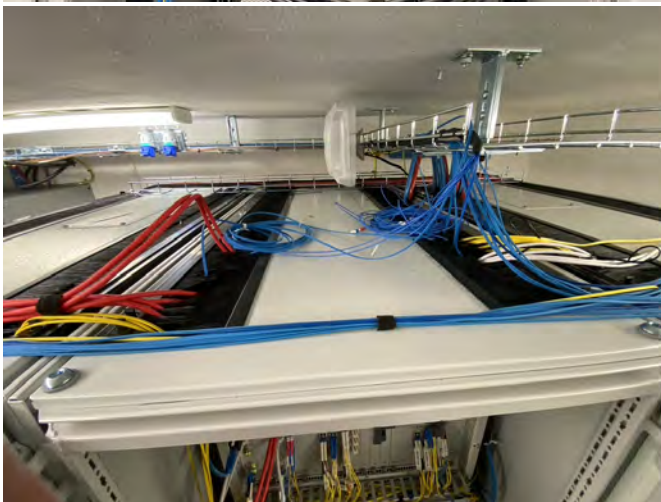
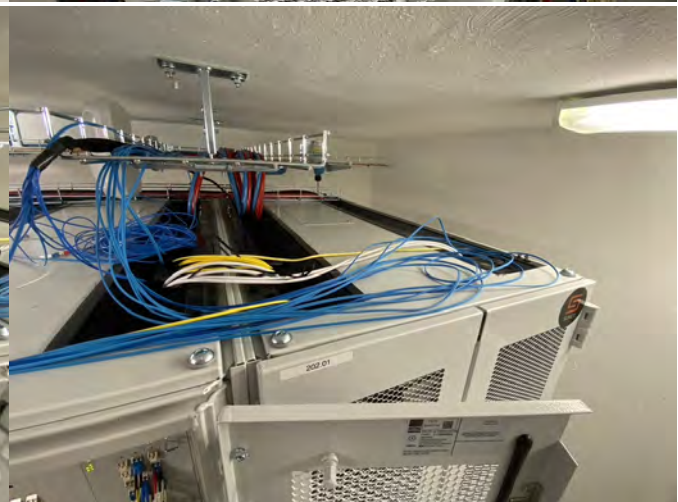
The delivery of the fibers could have been done better but, I guess it works.

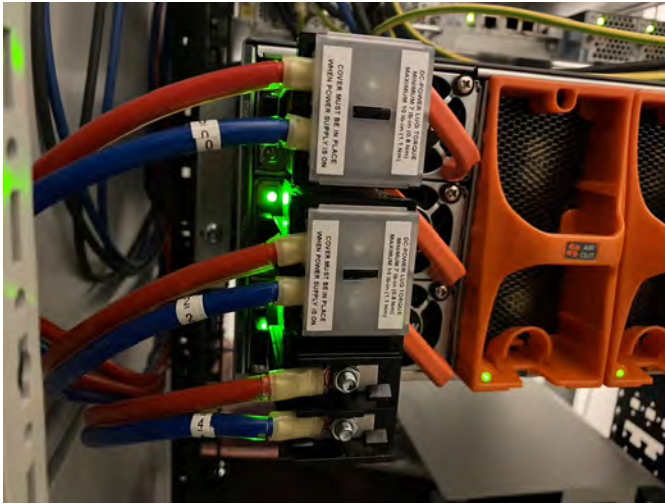
This is the A-side of the MX10003. Those safety plastic covers are a joke, they snap on but they do not sit very tight so if get close with a hammer or any other tool they get lost.

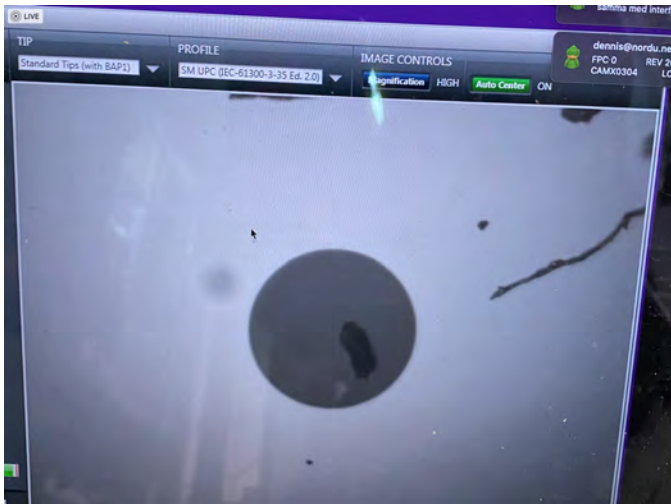
1. Move the fiber from the local mx960 router to the correct Adva network port and clean the fiber port. One could think that fiber ports with nice metallic flaps could all be clean from the factory. Most were but some looked like this.

Mantra to learn: Scope, clean, Scope

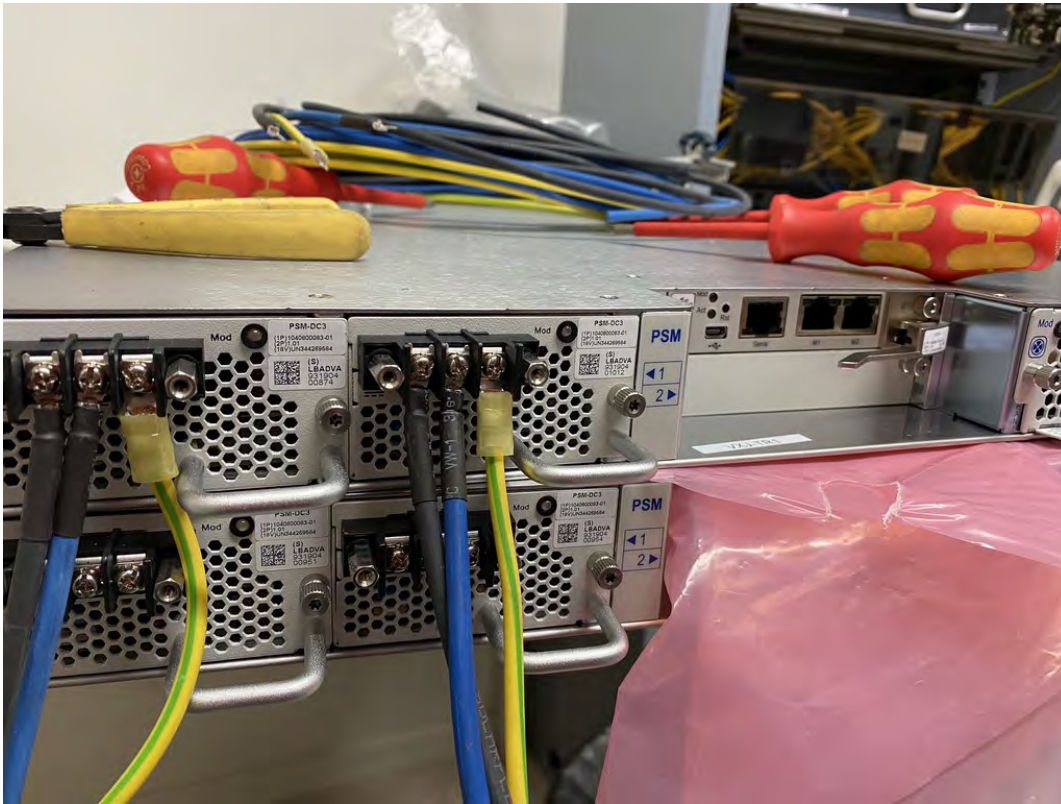
There are three cables into each power block + - and Ground. The colors for DC cables is a bit of a mess. This cable loom from Adva has black for positive +, blue negative - and Ground Yellow and Green (this is a standard in Europe at least).

After racking the boxes the first thing is to connect those ground wires to the ground bar in the rack. The ground bar is the bare copper strip in the left corner of the rack.
