# HISTORIC AMERICAN TIMBER-FRAMED STEEPLES

## *V. Engineering a Steeple Restoration*

ST. MICHAEL'S EPISCOPAL CHURCH in Charleston, South Carolina, was built by Samuel Cardy between 1752 and 1761. Its architect unknown (possibly Cardy), it follows English pattern book designs popular in the Colonies and somewhat resembles James Gibbs's design for St. Martin-in-the-Fields in London. St. Michael's survived wars, hurricanes, tornadoes, fires and the 1886 earthquake. During the Revolutionary War it was a center of American resistance and the tower was a target for British naval gunners. The 186-ft. steeple served as an observation post and navigational landmark in this and later military conflicts. As a result of the 1886 earthquake, the steeple settled 8 in. with the spire leaning 18 in. away from the nave toward Meeting Street, requiring reconstruction of the portico below. Repaired cracks in the brick masonry can be observed today from the inside of the tower (Fig. 1).

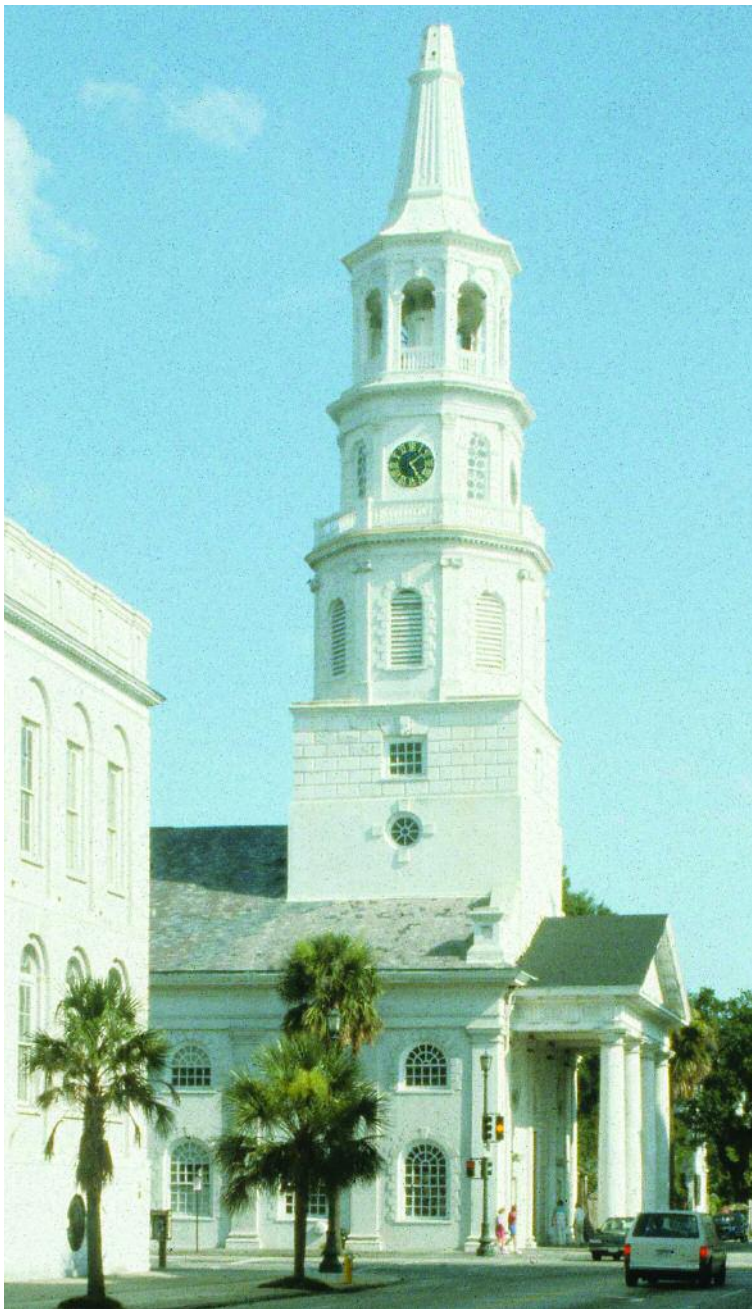
Fig. 1. St. Michael's after the 1886 earthquake. Portico leaning toward Meeting Street was rebuilt and large cracks in first bay repaired.

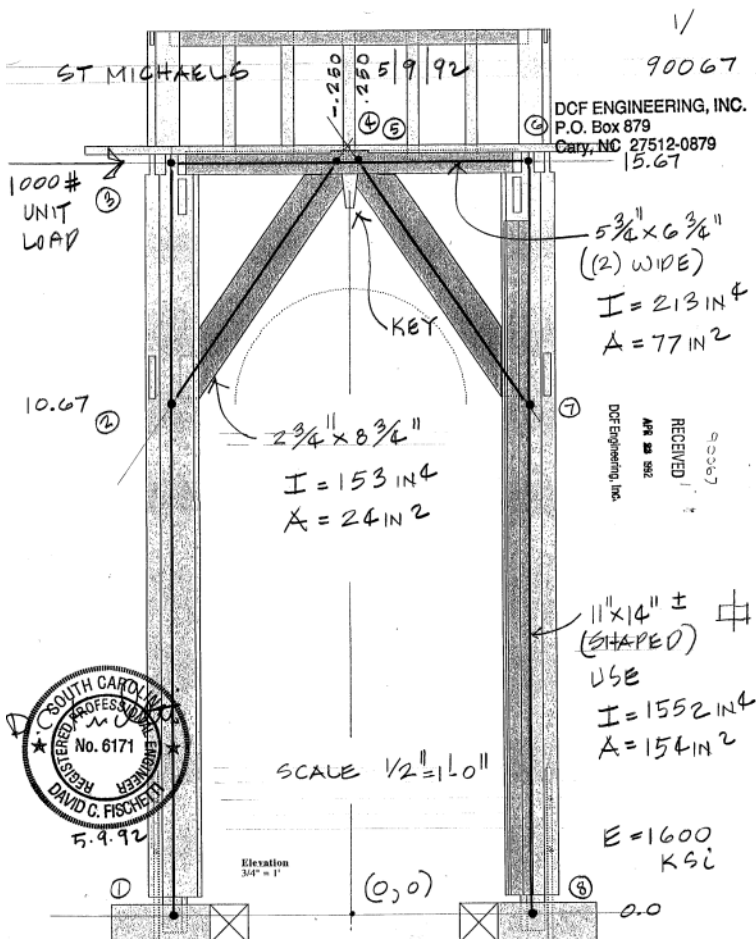
Fig. 5. Portal framing behind finish. Wedge descends through beam.

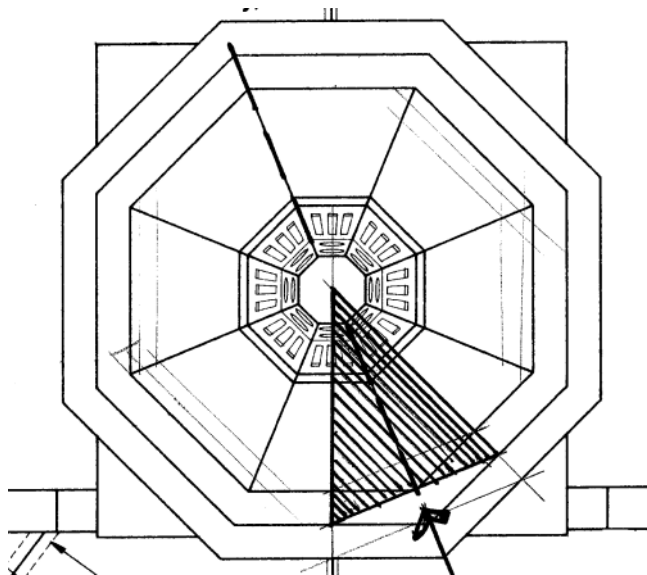
Fig. 7. Pie-shaped part of plan chosen to project upward for loading.

I then performed a plane frame (two-dimensional) analysis of one of the four identical intersecting frames of the spire, applying a 48- to 54-psf wind load to a pie-shaped portion of the plan, modeling the frame as originally built and also as deteriorated or altered by later modifications (Figs. 6–7).
