DURAFLEX™

Troubleshooting Guide

Rev #: 4.05

Date: 30 May 2022

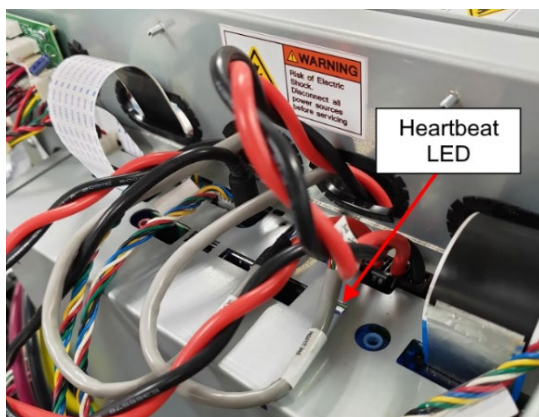
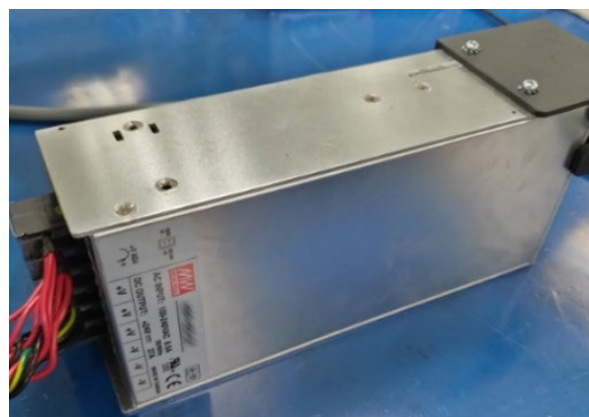
Figure 1 – Heartbeat LED and 24V Power Supply Unit

1. Verify that the heartbeat LED, as shown in [Figure 1](#) is flashing once per second.
2. If the heartbeat LED is not flashing:
 - a. Check connections to the 24V power supply unit (see [Figure 1](#)).
 - b. Check connections to the mechanical controller PCA.

1. Check the heartbeat LED ([Figure 1](#)) on the mechanical controller PCA (top right) to verify that the board is functioning properly. Heartbeat LED should be blinking once per second.
2. Open a PuTTY terminal, remotely log into DuraFlex, and use the following command to test the connection to mechanical controller PCA:

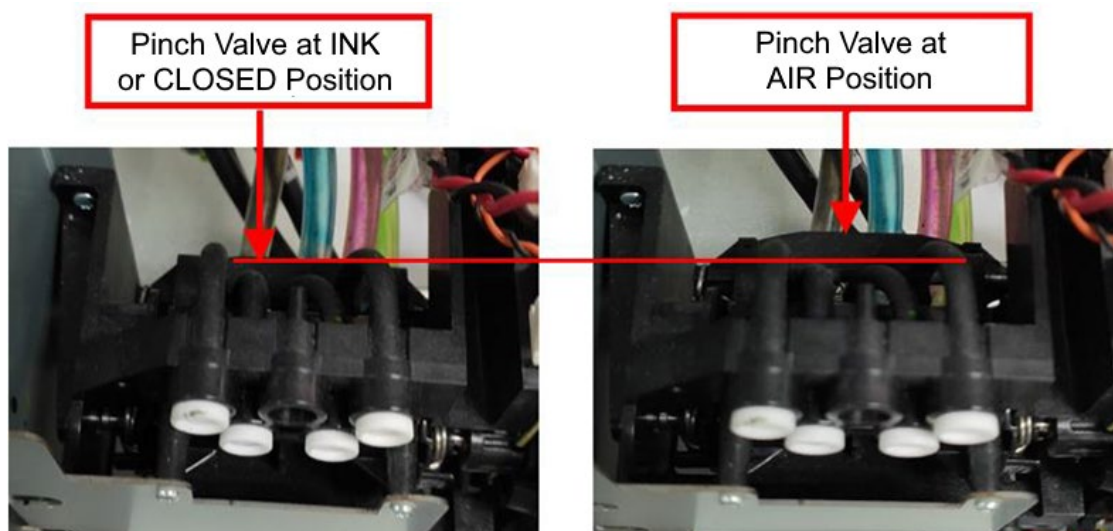
Figure 4 – Pinch Valve at the Air Position

1. Initialize the print engine.
2. Initiate **Deprime** to remove ink from printhead.
3. Visually inspect and confirm that the pinch valve is at the AIR position during deprime, see [Figure 4](#).

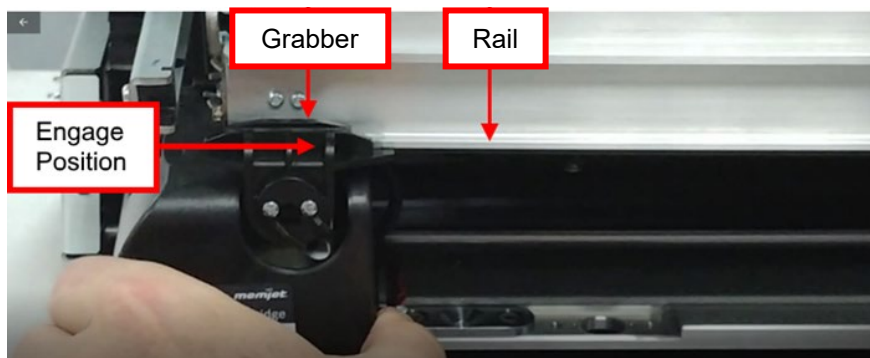
Figure 5 – Manual Wiper Movement to Check Engagement

A heavy service is performed at the end of the priming process. In some cases, the waste ink vacuum pump fails to build the pressure because the wiper is not at the correct position.

- Manually push the wiper to the engage position (see arrow in [Figure 5](#)) so that the waste ink pump can achieve the target pressure.
- Verify that the wiper grabber is hooked on the printhead cradle rail.

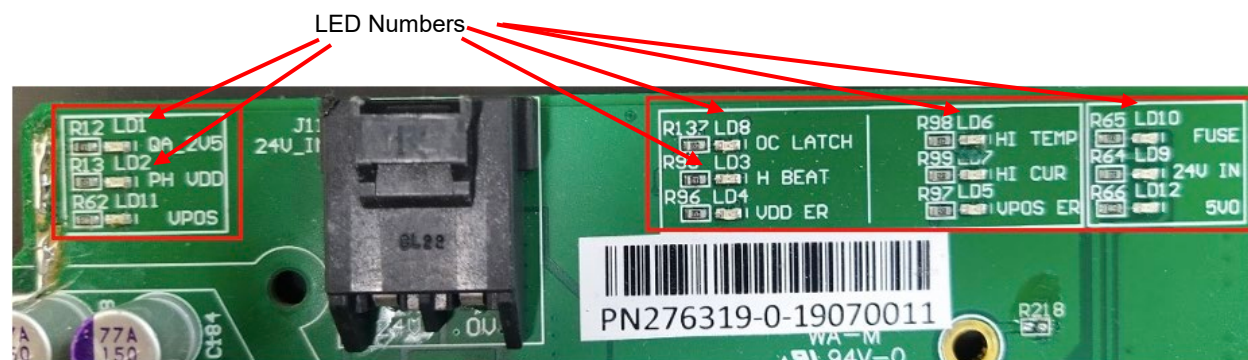
Figure 34 – DuraFlex Headboard LED Locations

The location of each LED is provided in [Figure 34](#), and [Table 13](#) explains the LED color and details of the LEDs signals.

#	Definition	Color	Appearance	Status / Description
LD1	QA 2V5	Green	Always on	LED will be lit when QA is being accessed
LD2	PH Vdd	Green	Always on	LED is lit if Vdd voltage on PH is correct
LD11	Vpos	Green	Always on	LED is lit if Vpos voltage to printhead is correct
LD8	OC Latch (Overcurrent)	Red	Steady	If LED is lit, overcurrent has been detected at some point.
LD3	Heartbeat	Yellow	1Hz flash	LED flashes at 1Hz during normal operational
			4Hz flash	If LED flashes 4 Hz, communication has been lost with PES
LD4	Vdd error	Red	Always on	If LED is lit, Vdd voltage error detected
LD6	High Temp	Red	Always on	If LED is lit, high temperature detected
LD7	High current	Red	Always on	If LED is lit, high current fault detected
LD5	Vpos error	Red	Always on	If LED is lit, Vpos error has occurred
LD10	Fuse	Red	Always on	If LED is lit fuse has blown
LD9	24V in	Green	Always on	24V power supply is connected and is active

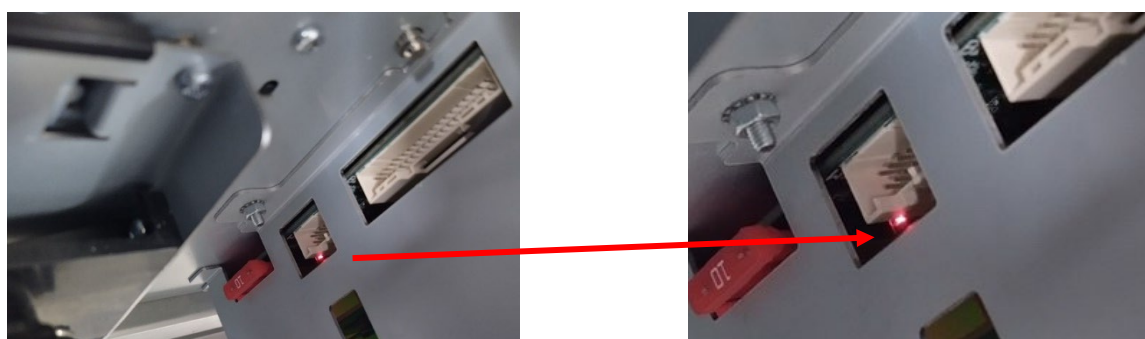
Figure 36 – DuraFlex Mechanical Controller PCA Fuse Indication LED

The Mechanical Controller PCA uses an LED to indicate the status of the fuse, shown in [Figure 36](#).

LED Color	Status	LED Color	Status
Green	Fuse working	Red	Fuse has blown
