- **WMO ID 6903269**
  - SBE41CP
  - 229 profiles
  - Deploy 2019/09/11
  - Levantine sub basin
  - Active

### OWC results

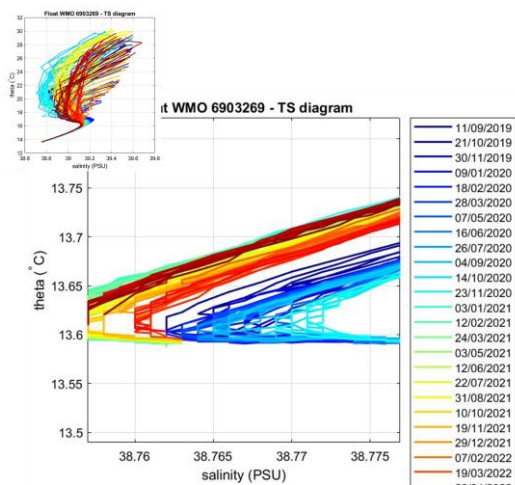
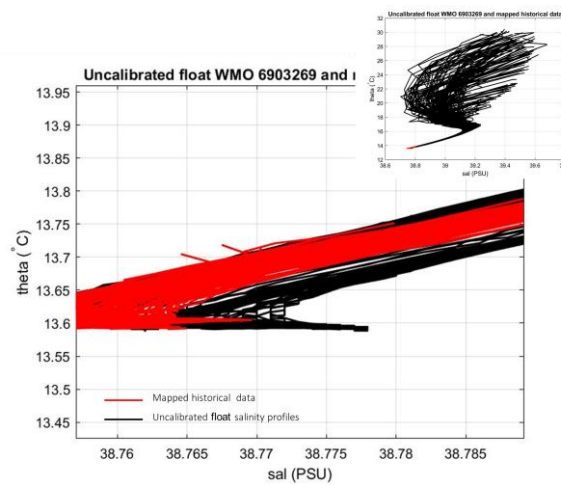
Comparison with WMO 6903802 float

What happened at cycle 90? The jump is not due to natural variability or different water masses. Sensor problem? After cycle 90, is the salinity correct?

Following the natural variability of the area, we apply an offset of about 0.01 with QC 1 on all profiles. But after the jump we are not sure if the sensor worked well. What do you suggest?
