SUBJECT : Notice for Suspension

Audit Findings: FAS Dock Audit - Interchanged Polycard

Final Assembly Process Inspection Record

INTERCHANGED POLYCARD		
Product No. 36064-64PE0, 36062-64PA0 Lot No. 59ZV51 & 59AJ73 Serial No. 60 Polycard Serial: 24 Defect Encountered: 7/25/2019

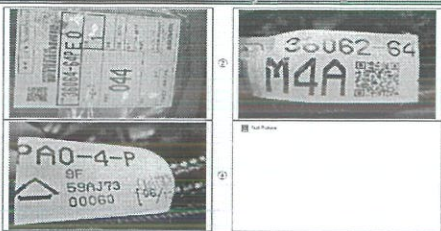
After packing, no checking conducted and did not use manual barcode scanner . Also no checking conducted before transferring to pallet.

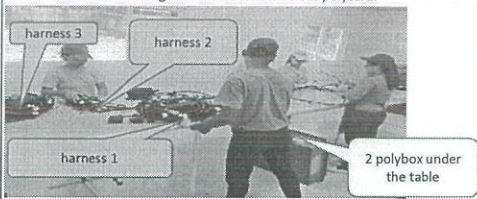
4M	ILLUSTRATION	ACTION TAKEN
MAN	<p>1. Not following SOP of one harness only at a time. 2. Inconsistent on checking the actual harness versus polycard.</p>

<p>Three harness were located in the table where in 2 polybox were also together under the table.</p>	<p>1. Re-educate inspectors for the risk of same defect occurrence if not following the SOP of one harness only at a time. 2. Implementation of one harness only at a time (no opening of another polybox until such running product is already packed) 3. One by one checking of lot number after packing and before transferring to FG pallet.</p>
