INSPECTION REPORT Nr LNP/BJ-12/048-CD01	
J-PECO Job nr: LNP/BJ-12/048

PROJECT: Ghana Early Phase Gas Infrastructure Project	Ref: JPP/HF-12/048
J-PECO Client: Sinopec International Petroleum Service Company (SIPSC)	P/o nr: / (client to J-PECO)
Manufacturer: SICHUAN KEYCON VALVE MANUFACTURING CO., LTD (KCON)	P/o nr: / (client to Manufacturer)
Inspection requested by: Sinopec International Petroleum Service Company (SIPSC)

No.	SUPPLY / SUBJECT OF INSPECTION	KCON Serial Nr	Project TAG Nr	QTY
1	12"-1500LB Top Entry Trunnion Ball Valves (PNEUMATIC ACTUATOR)	J-31362-1	ESDV-01-001-GP	1 set
2	12"-1500LB Top Entry Trunnion Ball Valves (GEAR OPERATOR)	J-31361-1, J-31361-2, J-31361-3, J-31361-4.	J-PECO-01-001-GP, J-PECO-01-002-GP, J-PECO-01-003-GP, J-PECO-01-004-GP.	4 sets

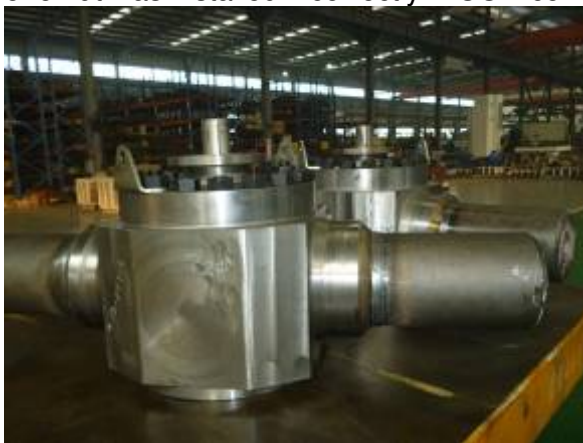
Overview

J-PECO inspector checked the Visual quality as per approved drawings and spec. The 2 plugs were welded after pressure testing, it met drawing's requirements. J-PECO inspector found one nut was installed incorrectly. KCON corrected them, acceptable.
