INSPECTION REPORT Nr LNP/BJ-12/048-CD01	
J-PECO Job nr: LNP/BJ-12/048

PROJECT: Ghana Early Phase Gas Infrastructure Project	Ref: JPP/HF-12/048
J-PECO Client: Sinopec International Petroleum Service Company (SIPSC)	P/o nr: / (client to J-PECO)
Manufacturer: SICHUAN KEYCON VALVE MANUFACTURING CO., LTD (KCON)	P/o nr: / (client to Manufacturer)
Inspection requested by: Sinopec International Petroleum Service Company (SIPSC)

No.	SUPPLY / SUBJECT OF INSPECTION	KCON Serial Nr	Project TAG Nr	QTY
1	12"-1500LB Top Entry Trunnion Ball Valves (PNEUMATIC ACTUATOR)	J-31362-1	ESDV-01-001-GP	1 set
2	12"-1500LB Top Entry Trunnion Ball Valves (GEAR OPERATOR)	J-31361-1, J-31361-2, J-31361-3, J-31361-4.	J-PECO-01-001-GP, J-PECO-01-002-GP, J-PECO-01-003-GP, J-PECO-01-004-GP.	4 sets

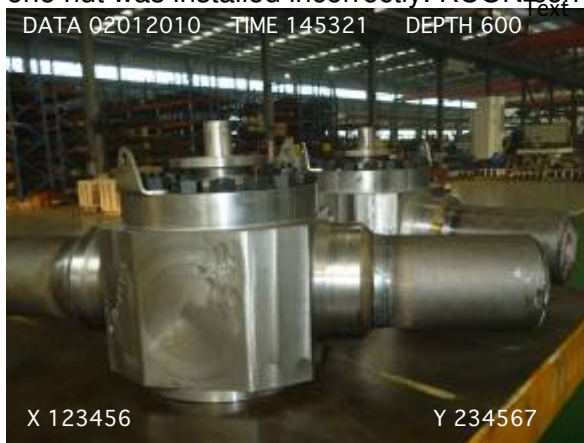
Overview

J-PECO inspector checked the Visual quality as per approved drawings and spec. The 2 plugs were welded after pressure testing, it met drawing's requirements. J-PECO inspector found one nut was installed incorrectly. KON corrected them, acceptable.

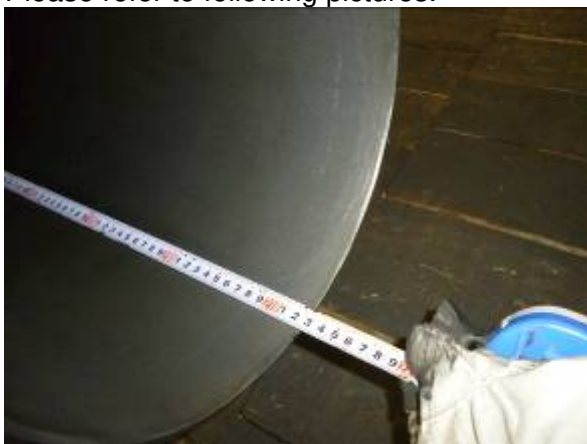
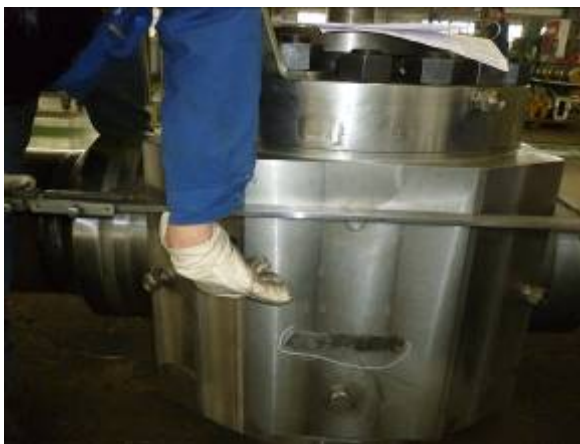
J-PECO inspector checked the main dimension as per approved drawings. It's acceptable. Please refer to following pictures.

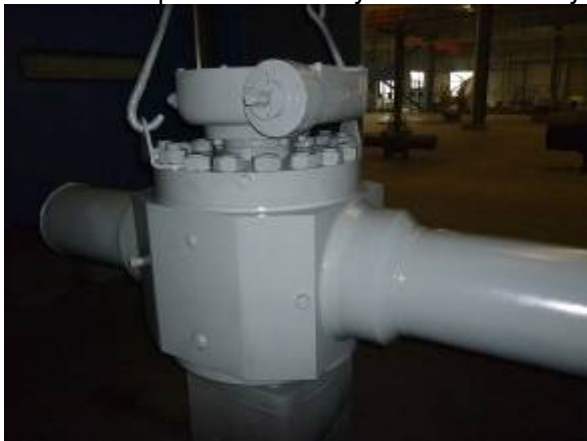
Overview

J-PECO inspector randomly checked the dry film thickness for primer.

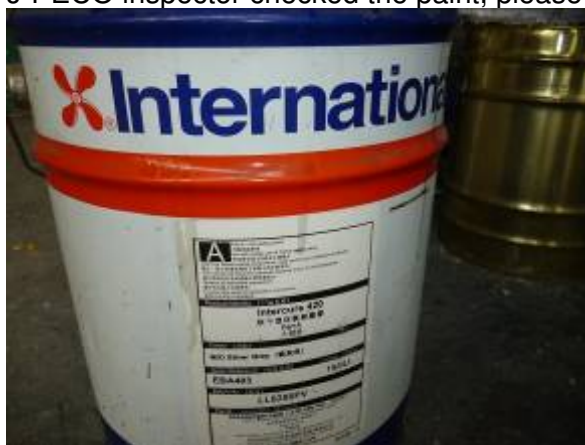
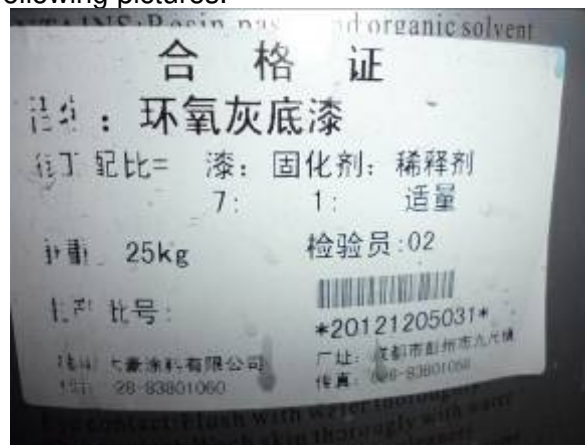
KCON do the painting as per KCON' specification. And DFT met KCON's procedure. KCON didn't complete top coat till J-PECO inspector leave.

J-PECO inspector checked the paint, please following pictures.
