STRUCTURAL AUDIT REPORT
FOR
“VISHAL SAHYADRI CO – OP HSG. SOC. LTD”,
“C12 – WING”
SITUATED AT
SAHYADRI NAGAR, CHARKOP,
KANDIVALI (W) MUMBAI – 400 067

978/B1/LSS/2021

JUNE 21, 2021

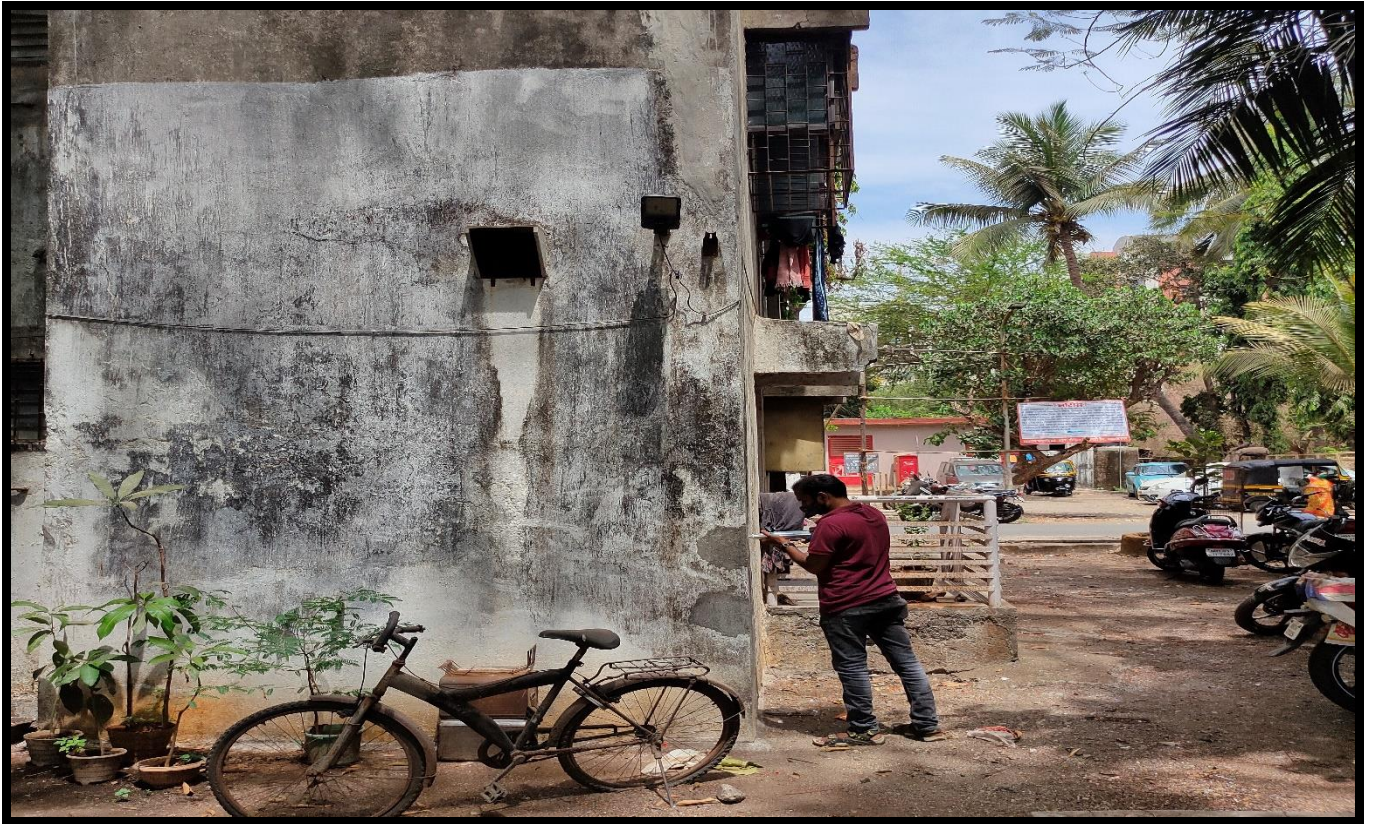
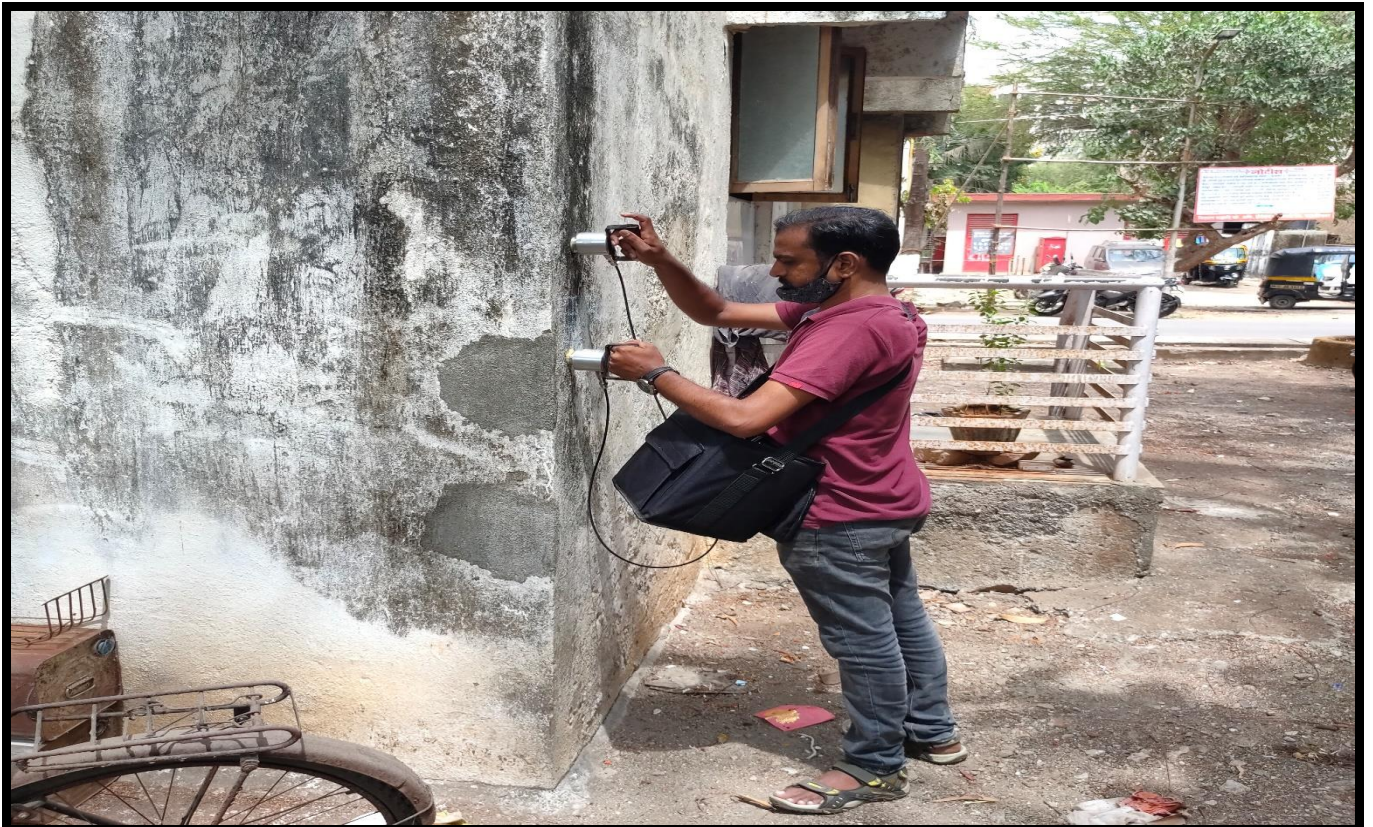
NON –DESTRUCTIVE TEST PHOTO

Half Cell Potential tested for corrosion activity by half – cell potential tests. Value is taken on Column. The result on tested column is – 321 mV.

This indicates the probability of corrosion is 50% on tested column steel reinforcement.

Carbonation test was conducted to assess carbonation depth. Readings are taken on Column. Result indicates the carbonation penetration depth is 35.00 mm. Carbonation depths have reached to the reinforcement level in all of the RCC elements. It is essential to give a suitable anti-corrosion treatment to all the RCC members to stop further carbonation and corrosion of concrete.
