## Field Biologist Site Inspection for Family Mart

FamilyMart Marang / 30 Jul 2025

Document No.	000129
Audit Title	Post-Opening Site Inspection
Site Name	FamilyMart Marang
Location	LOT 8994-B, Bangunan Komersial Marang, 21600 Marang, Terengganu, Malaysia (5.207336, 103.20646599999999)
Contractor Present	Yes
Name	Ho Kok Wai
Project PIC Present	Yes
Name	Yuziir
Inspected by	Arif Zulrushdi
Inspection Date	30.07.2025
Prepared by	Arif Zulrushdi

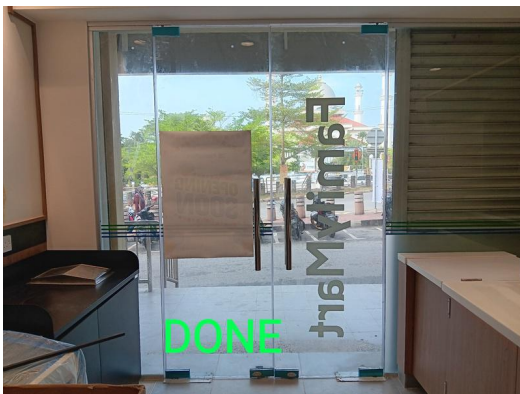
Photo 8

NA - no front door installation yet.

Updates during 30.7.2025

Door installation done with proper proofing.

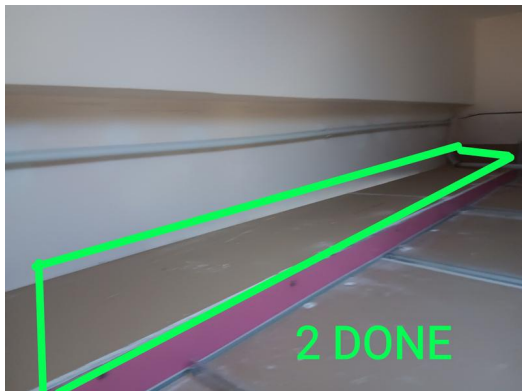
Photo 12

No plate on shutter roller casing installed. This may provide entry for rats.

Please close the upper shutter casing with suitable plate.

Updates during 30.7.2025

2: DONE

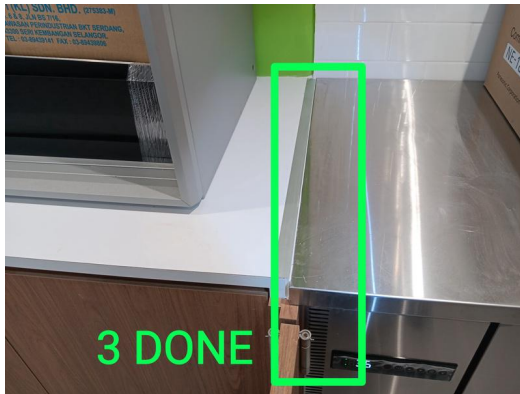
Photo 15

The plaster proofing is not complete and left some gaps.

Please seal the gaps completely.

Updates during 30.7.2025  
3: DONE

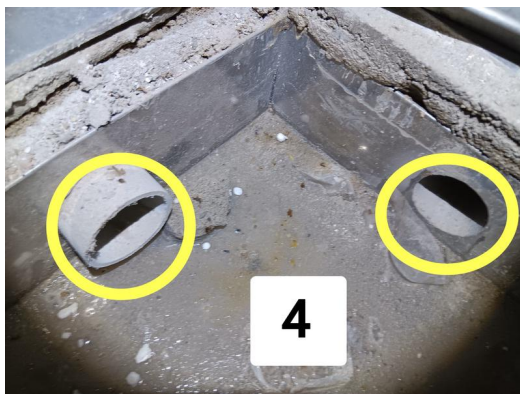
Photo 18

Floor trap pipes do not have metal mesh filter to prevent pest entry from outside.

Please install metal mesh filter at the pipes.

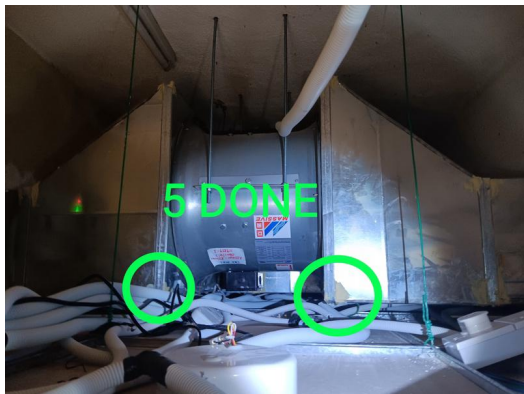
Photo 22

Gaps observed at the ventilator casing above manager area.

Please seal the gaps completely.

Updates during 30.7.2025  
5: DONE

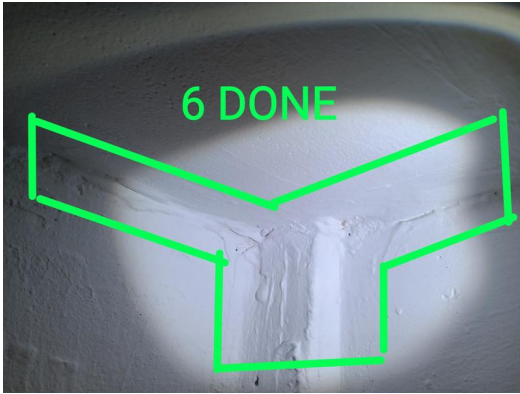
Photo 26

Crack and crevices at the wall edges can provide harbourage for pests.

Please seal the crack and crevices completely.

Updates during 30.7.2025  
6: DONE

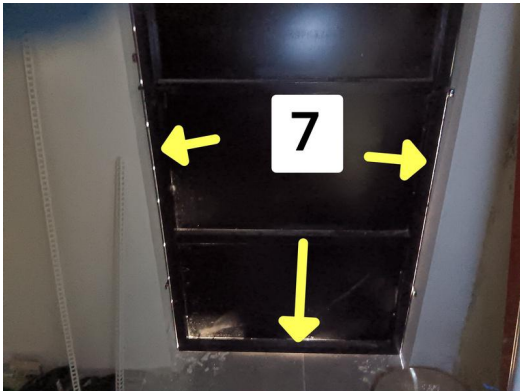
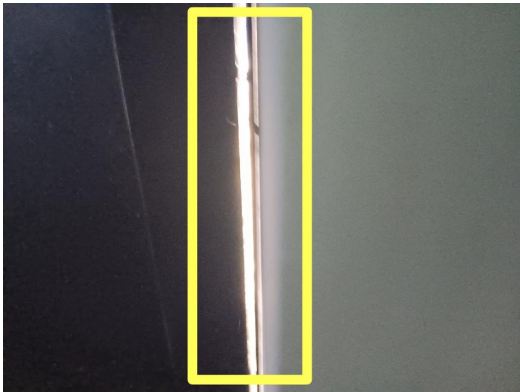
Gaps observed around the doorframe.

Please install additional door strips.

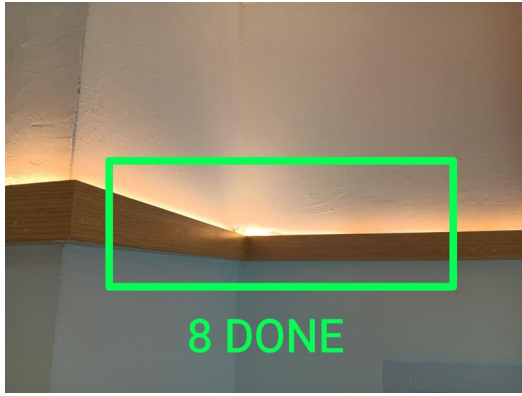
Photo 34

The wiring not yet complete and found with gaps at wall.

Please close the gap completely after complete wiring.

Updates during 30.7.2025  
8: DONE

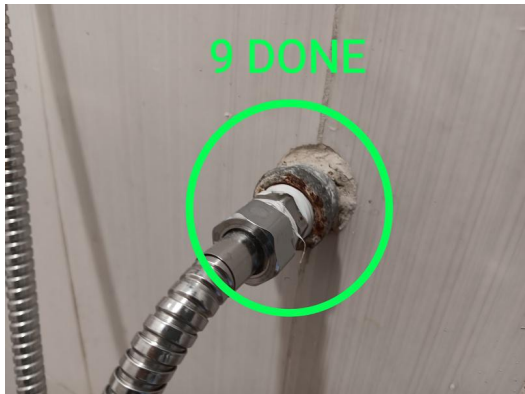
Photo 38

Gap found at unclosed pipe.

Please ensure no gap left after done installation.

Updates during 30.7.2025  
9: DONE
