# ***ROAD SAFETY AUDIT***

## **ROUTE 3 BEDFORD-BILLERICA- CHELMSFORD**

### **MAJOR HIGHWAY MEDIAN CROSS-OVER CRASHES**

**Final Report**

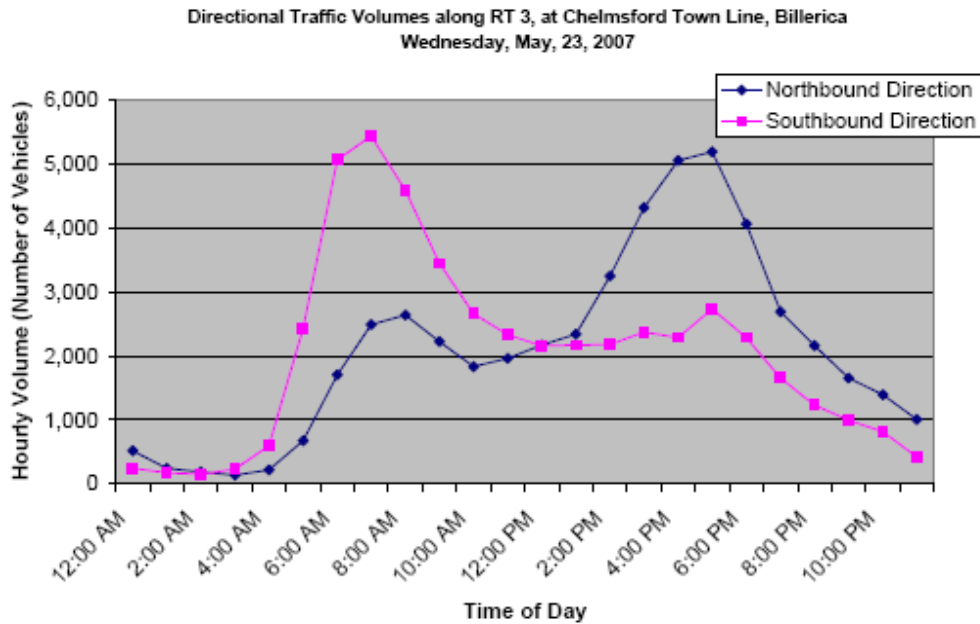
**Figure 6**  
**Route 3 Traffic Volume**

The traffic volumes observed on Route 3 in this section generally exceed 100,000 on an average weekday. Figure 6 depicts the volume measures in May 2007 near the Chelmsford-Billerica town line. One can see from the chart that directional volumes are significant in the peak direction during the peak hour with 5,000 vehicles being exceeded for several hours. Historical truck traffic counts were from MassHighway showing that a relatively high number of trucks traverse the study section. It amounted to 3% or approximately 180 trucks during the peak hour and 5% or approximately 5,000 trucks over the course of a day.
