ISEC2076 - ASSIGNMENT 1

CPTED Physical Security Assessment

Site Name	TD Canada Trust Branch	Location	5236 St. Margaret's Bay Rd Upper Tantallon, Nova Scotia B3Z 0P4
Site Manager	Jeremy Zwicker	Contact Details	902-826-3106 ext. 250 jeremy.zwicker@td.com
Security Manager	Joe Public	Contact Details	999-999-9999 ext. 999 joe.public@securityjoe.com

Description of site: Stand-alone single story brick building currently housing a branch of a Canadian bank in a rural community.

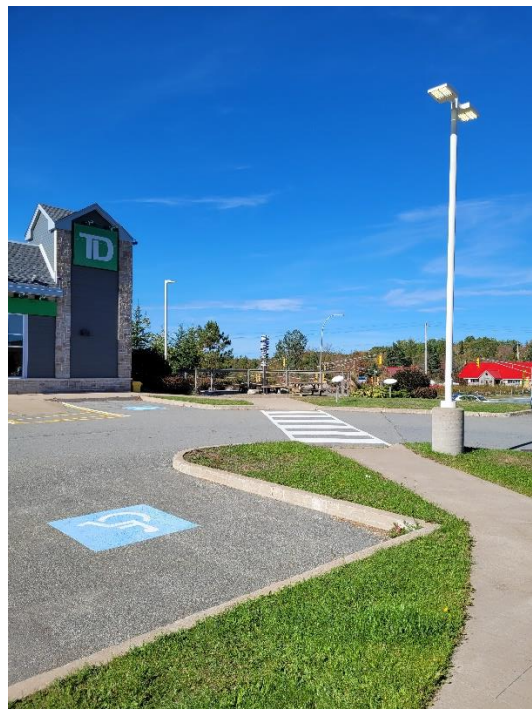
Image of landscaping from south side view

Vulnerability:	Dense and overgrown tree coverage along west side of site reducing visibility from busy main road along property boundary
Solution:	Thin the density of trees to increase observability as well as remove low tree branches to 8 feet from the ground
Vulnerability:	Several tall and overgrown bushes between site perimeter and back emergency door reducing visibility of security zone around building.
Solution:	Removal or trim bushes and maintain at 36 inches
Other:	No visible vandalism or garbage
Recommended:	Renew landscape/property maintenance contract with current providers

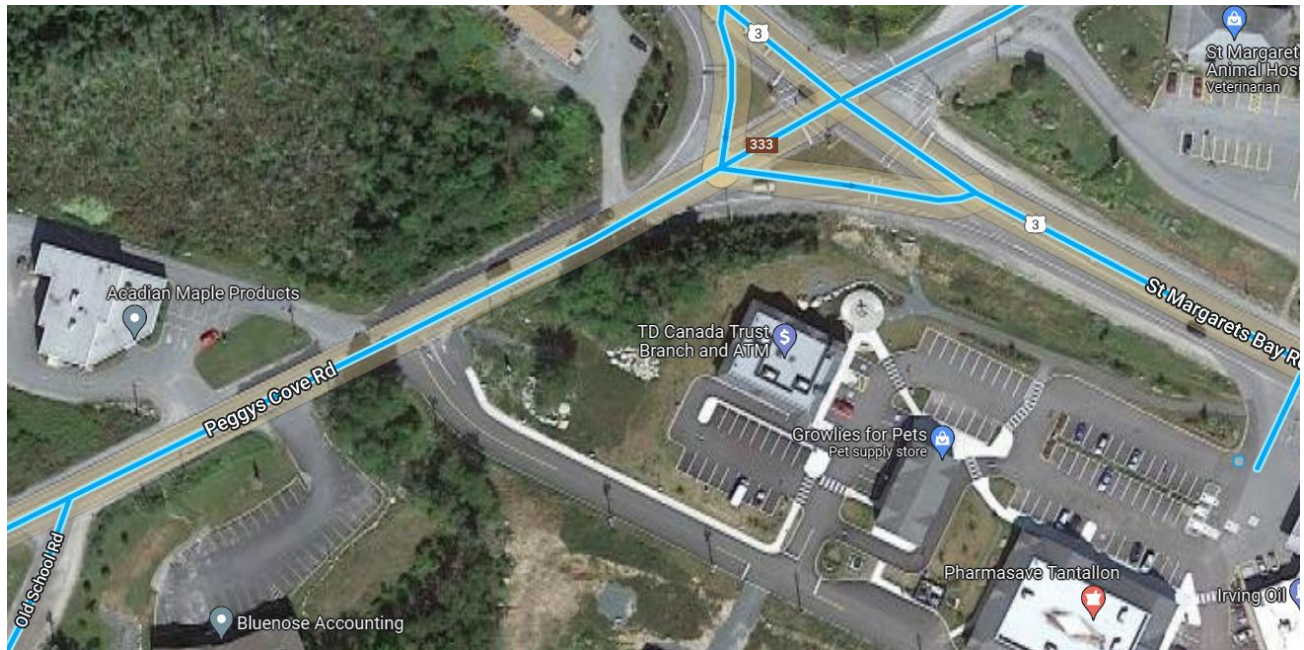
Image of traffic flow and major roadways/access lane

The south side of the property is along a well-lit, lightly travelled access lane with sidewalk, off the Peggys Cove Road accessing the group of business nearby, running behind the business locations and their excess parking areas, ending at a similar lane adjacent to the Real Atlantic Superstore parking lot. It was observed that the public uses this lane during both daylight and evening hours to access these businesses during their open hours.

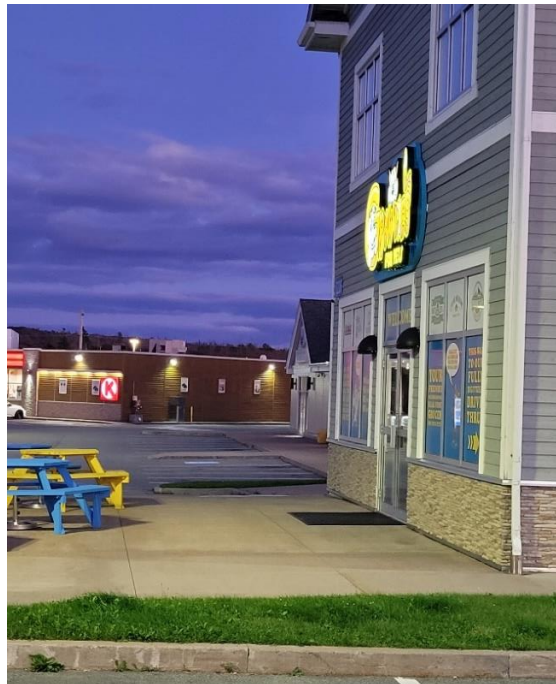
Image of neighbouring business with outdoor seating for public use

The building has multiple large windows on every side, providing clear views of most of the perimeter of the property during daylight hours from inside. Adequate lighting solutions and coverage will assist with visibility after dark. The surveillance provided by the public will also be improved by proper lighting and removal of excess foliage as recommended, as the site is located on an elevation from two main roadways and is accessible by vehicle to the public on all sides. Neighbouring business provides inviting outdoor seating for public use along with an unobstructed view of target site building, encouraging casual surveillance from community.
