Task Force SAFE

Inspection-Report_TFSAFE_F797V_12345_Team 101_19-12-25_1-3

Base Location	Erbil (Iraq)	Date:	2025-12-19
Base Code	F797V	Team #:	Team 101
Building #	12345	System Voltage	230/400
Building Type	Warehouse	Inspection Phase	Initial Inspection
Previous Report #:	N/A	Work Order:	TFS-F797V-2025-00001

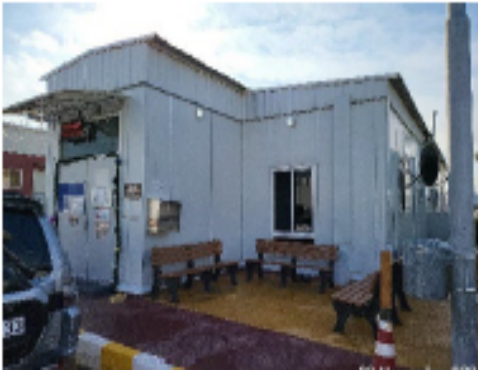
Building Picture:

Main warehouse building, north side of compound near gate 3

Overall Building Electrical System: **Poor**

Building is in a deplorable state of repair.
