Task Force SAFE

Inspection-Report_TFSAFE_CP2FL_ACCOM-1_128_24-12-25_1-1

Base Location	Tower 22 (Jordan)	Date:	2025-12-24
Base Code	CP2FL	Team #:	128
Building #	ACCOM-1	System Voltage	230/400
Building Type	Barracks	Inspection Phase	Initial Inspection
Previous Report #:	N/A	Work Order:	TFS-CP2FL-2025-00001

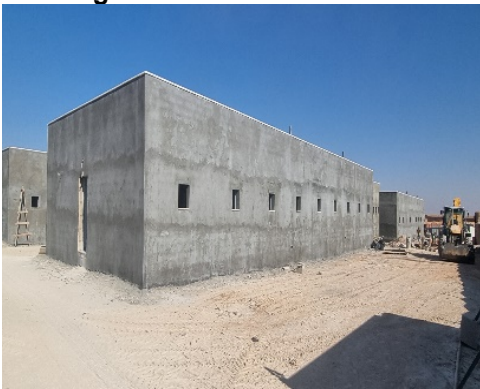
Building Picture:

Overall Building Electrical System: Fair

Accommodation 1 North Rooms were found to be at 40% completion upon inspection. All first fix wiring has been completed. No lighting has been installed yet as there is no ceiling present. Cables are still within copex. Partial 2nd fix on low level accessories within billeting rooms. Back boxes installed for sockets/AC has large gap between accessory and wall. Excess cable at connection of accessories. Compression when fixed into position.
