FLIGHT OPERATIONS TECHNICAL BULLETIN

NUMBER:	707-16-1	777-44
	B-717-16-01	787-17
	727-16-1	DC-8-16-01
	737-16-3	DC-9-16-01
	747-100/200/300/SP-21	DC-10-16-01
	747-400-69	MD-10-16-01
	747-8-9	MD-11-16-01
	757-89	MD-80-16-01
	767-92	MD-90-16-01

SUBJECT: Lithium Battery Fires on the Flight Deck

APPLIES TO: All 707, 717, 727, 737, 747, 757, 767, 777, 787, DC-8, DC-9, DC-10, MD-10, MD-11, MD-80, and MD-90 Airplanes

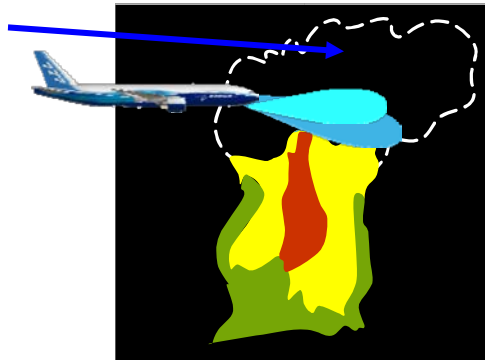
Potential for high concentrations of ice crystals

- From event weather radar analysis, events consistently occur when the aircraft is in Instrument Meteorological Conditions (**IMC**) and **over-flying an area which would be amber or red** on the pilot's weather radar. Ice that has been lifted to high altitude eventually falls through the freezing level and begins to melt. These wet particles are much more reflective and therefore visible (amber or red) to radar. These clouds can be identified by pilots if they **manually tilt the radar down** to scan below the freezing level.

Exit ice crystal icing conditions. Request a route change to minimize time above red and amber radar returns.
