PROPERTY INSPECTION REPORT

KLM ENTERPRISES, LLC
GOLDEN HOME INSPECTION SERVICES

Summary of Home Inspection Findings

RE: 17908 8th Ave NE
Shoreline, WA 98155

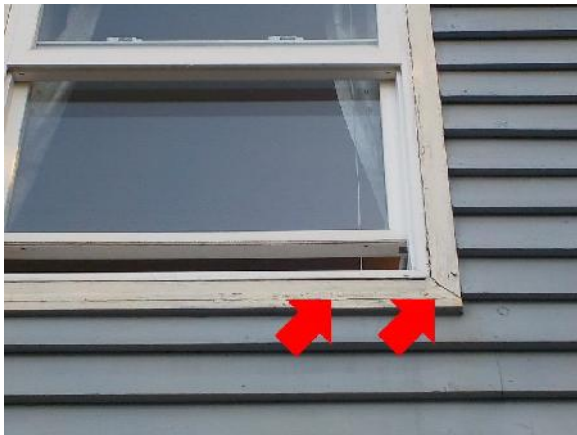
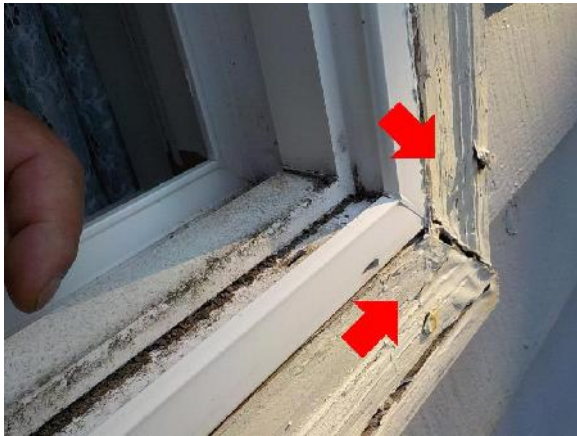
Window trim/framing: Seen on west side upper level window.

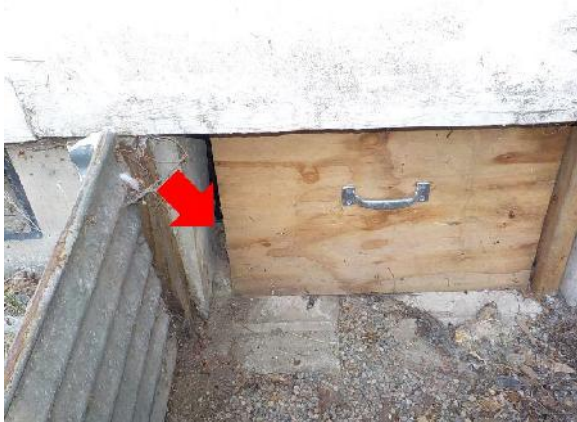
5.29 Crawl Space Access::

The crawl space access lid is inadequate or does not fit properly: The lid should be repaired or a proper lid should be constructed and installed suitable to keep animals, vermin and weather out of the crawl space. There is also missing framing and decay seen on some of the wood covering.

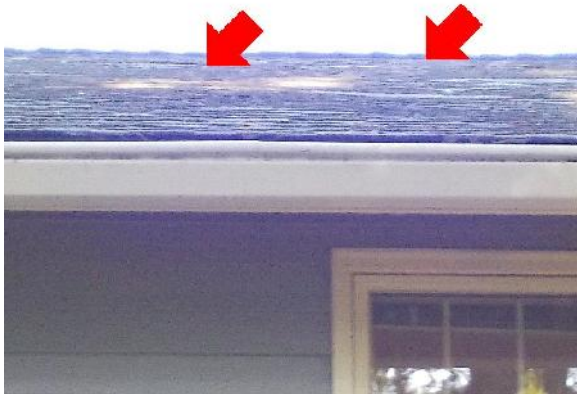
7.4 Moss/Debris:

There is moss or debris present on roof: As a normal maintenance issue, moss and debris should be cleaned off roof as it can lead to damage and leaking. Be aware that heavier moss coverage may conceal hidden damages and repairs may be needed once the roof is cleaned. At this time the amount of moss or debris buildup would best be described as: Minimal. Debris from trees seen on upper back section.

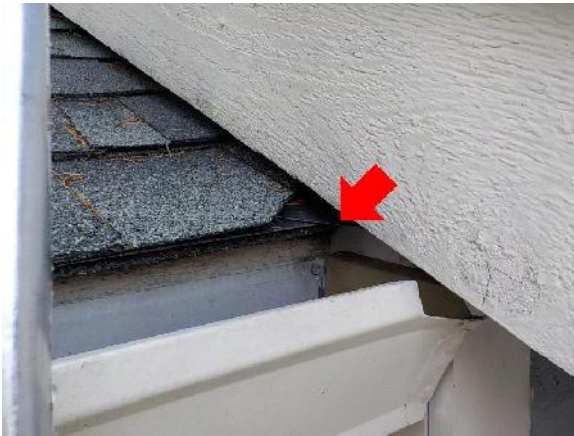
7.9 Kickouts:

Roof kick out flashing is missing or inadequate. Where the gutter edge of a roof meets a wall, the last sidewall flashing above the gutter end should be installed in a special manner so that water from the roof is directed into the gutter instead of over, or behind, the siding. This is called a kick out flashing. Be aware hidden conditions may exist. Caulking alone is not an acceptable substitute as it will fail over time. Correction is recommended. This was noted in the following area: Seen at front over entry.

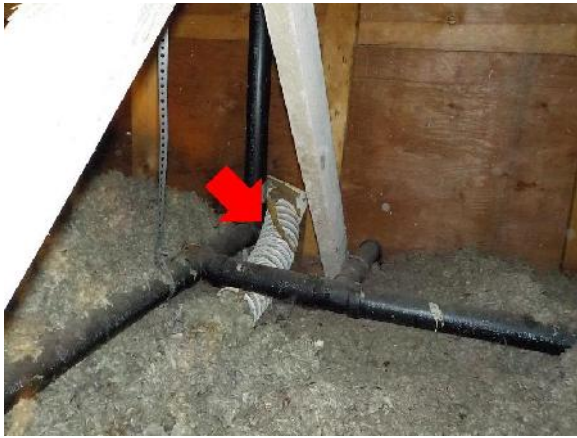
10.3 Duct Type:

The exhaust vent ducting is older flex type: The older, non-insulated exhaust fan ducting tends to trap considerable condensation reducing the efficiency of the vent. Suggest changing to insulated flex ducting as a future upgrade. Upper hall bathroom fan.

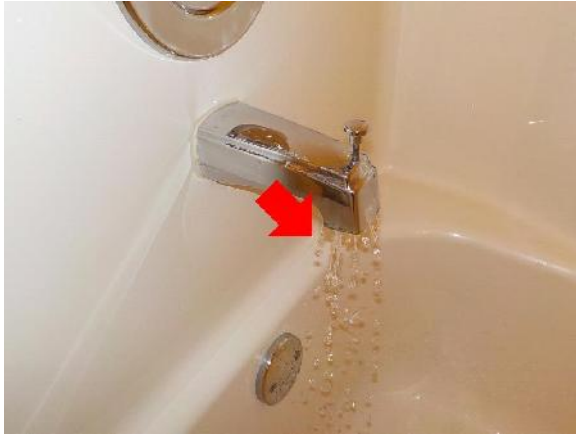
12.10 Fixture Leaks:

Tub/Shower diverter non-functional or leaking during use: Maintenance repair is indicated. Both upper level bathrooms.

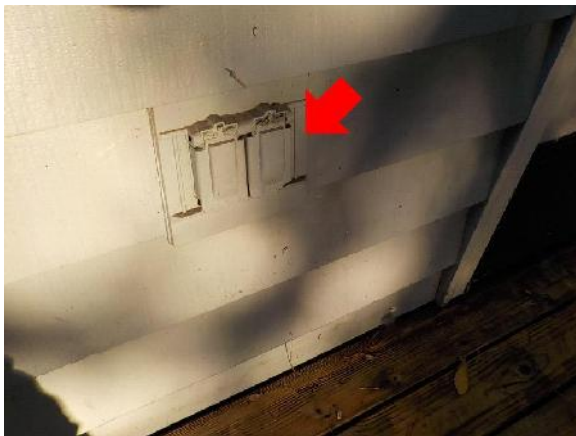
16.7 Installation:

Ground fault circuit interrupter protection is incomplete or absent: Ground Fault Circuit Interrupter (GFCI) protection is currently required for the following areas: Exterior, Garage, Garage door opener circuit, Bathrooms, Kitchen, Spas and Hydro massage tubs, Pools and Fountains, Crawl Spaces, Unfinished Basements. They should be considered as a safety upgrade for homes which pre-date the current requirement. The presence of complete GFCI outlet protection could not be confirmed in the following area(s): Garage. Exterior.

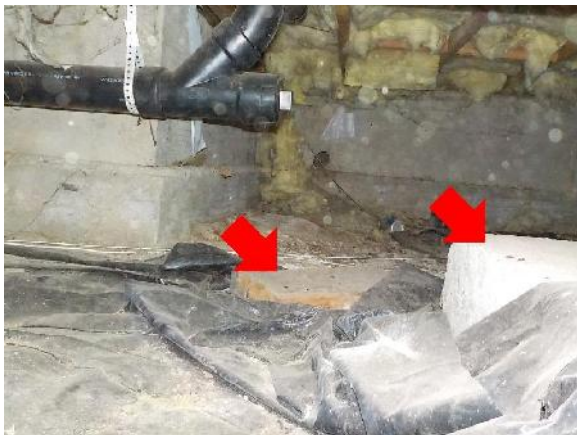
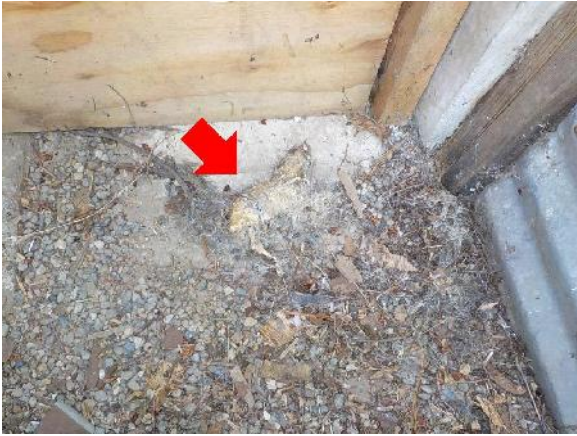
19.2 Rodents:

Evidence of rodent activity is seen: This evidence was seen in the following area(s): The crawl space, Rodent evidence includes: Droppings, Carcasses.

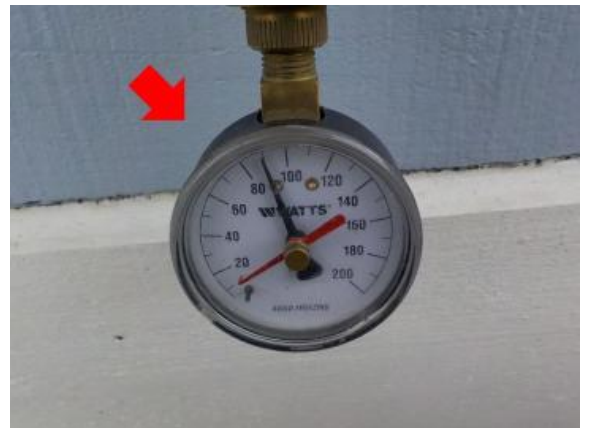
4.60 Water Pressure:

Water pressure is excessive: Water pressure in excess of 80 PSI can have long term adverse effects on the plumbing system itself as well as dishwashers and icemakers and building standards generally require that a pressure reduction valve be installed in such cases. Recommend follow up with a licensed plumber. The water pressure, in PSI, was measured to be: 88.

Water pressure in PSI is: 88.

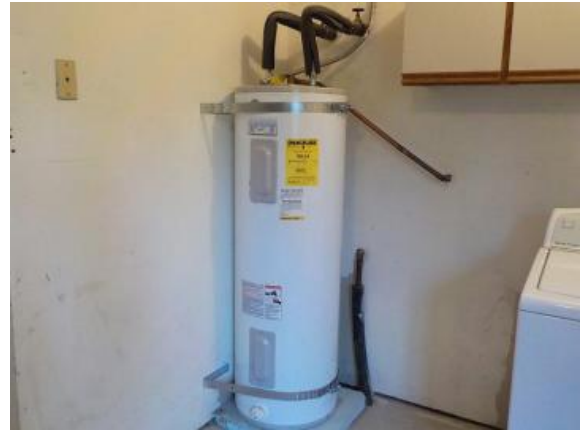
4.63

Water heater appears older, (>10 years old): Be aware the appliance may be nearing end of useful life, may not be reliable and could need replacement soon. Determining the life expectancy of plumbing related equipment is outside the scope of inspection.

- 4.64 Location:** Garage.
- 4.65 Description:** The water heater is electric.
- 4.66 Equipment Brand:** GE Dated 6-2010.
- 4.67 Size:** 40 Gallons.
- 4.68 TPR:** A temperature and pressure relief (TPR) valve and associated piping is seen.

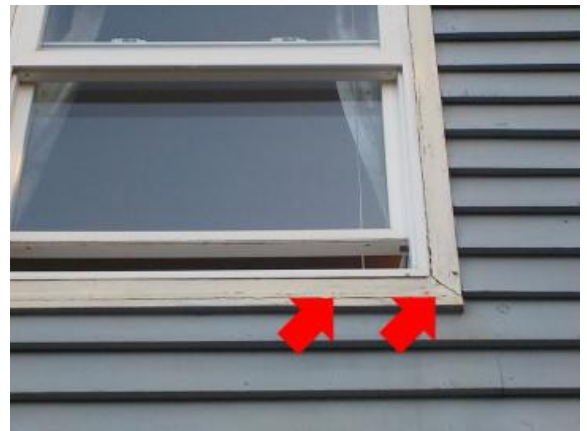
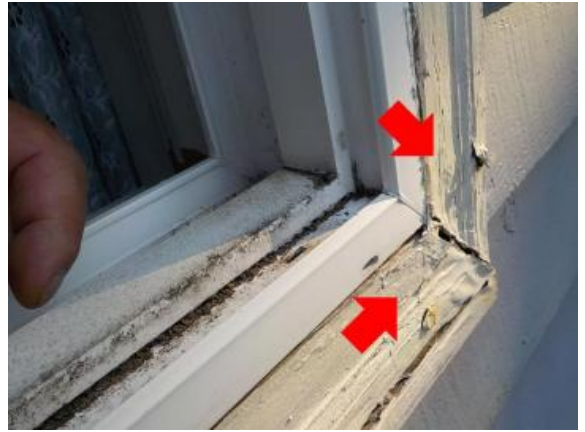
Window trim/framing: Seen on west side upper level window.

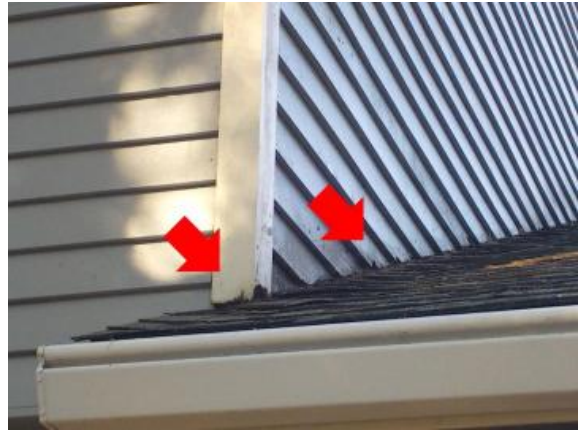
Exterior trim and lower roof to wall siding: Seen on the back side.

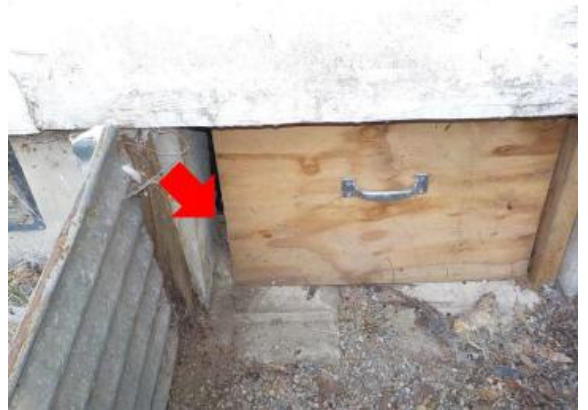
5.29 Crawl Space Access::

The crawl space access lid is inadequate or does not fit properly: The lid should be repaired or a proper lid should be constructed and installed suitable to keep animals, vermin and weather out of the crawl space. There is also missing framing and decay seen on some of the wood covering.

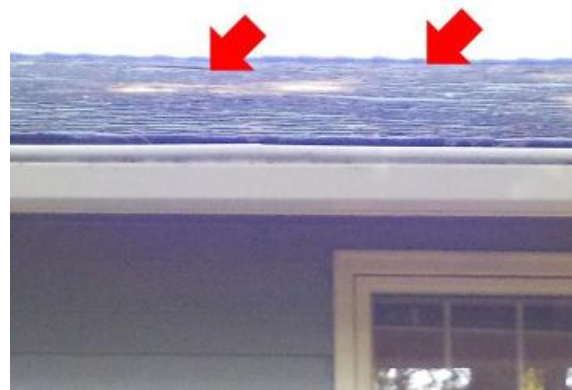
7.4 Moss/Debris:

There is moss or debris present on roof: As a normal maintenance issue, moss and debris should be cleaned off roof as it can lead to damage and leaking. Be aware that heavier moss coverage may conceal hidden damages and repairs may be needed once the roof is cleaned. At this time the amount of moss or debris buildup would best be described as: Minimal. Debris from trees seen on upper back section.

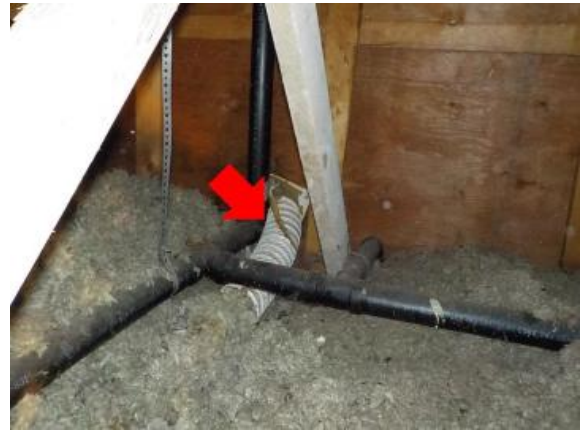
10.3 Duct Type:

The exhaust vent ducting is older flex type: The older, non-insulated exhaust fan ducting tends to trap considerable condensation reducing the efficiency of the vent. Suggest changing to insulated flex ducting as a future upgrade. Upper hall bathroom fan.

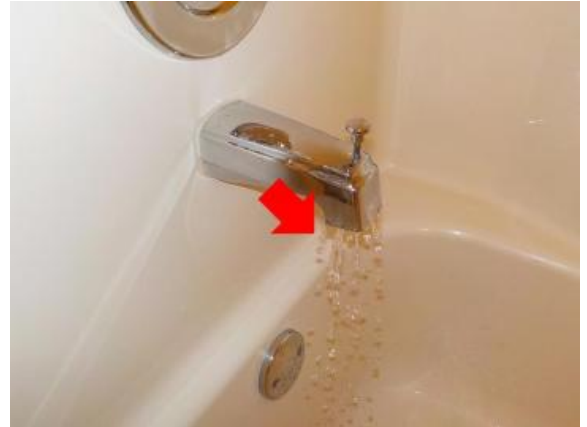
12.10 Fixture Leaks:

Tub/Shower diverter non-functional or leaking during use: Maintenance repair is indicated. Both upper level bathrooms.

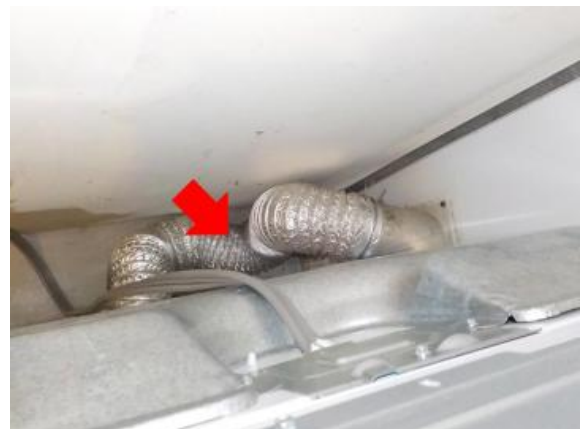
12.13 Ducting:

The clothes dryer duct is older flexible type: Newer standards require clothes dryer ducts to be smooth wall pipe as the flexible type tends to trap lint and debris which can cause blockage. Suggest changing to smooth wall pipe as a future safety upgrade. Regular duct cleaning is also advised as trapped lint may constitute a fire hazard.

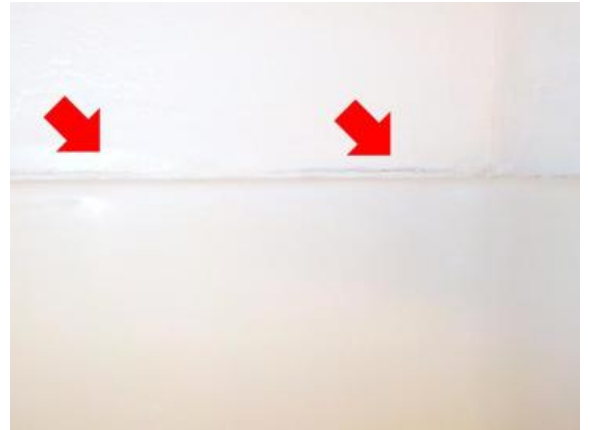
12.15 Tub/Shower Surround:

The caulking or grout on the tub or shower surround is failing. Maintenance repair indicated. Upper portion of the shower surround. Master bathroom.

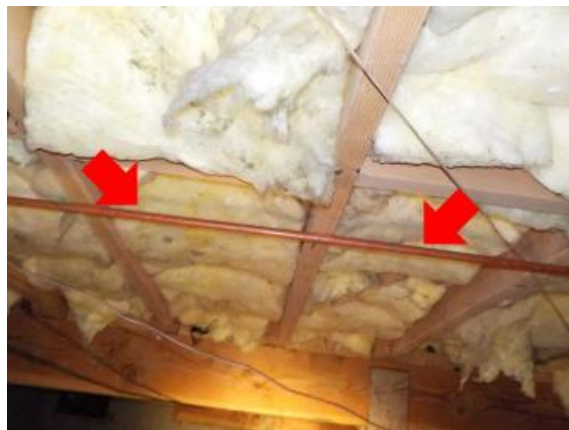
The main plumbing line and/or supply lines are not insulated:

Recommend wrapping all pipes for efficiency and to prevent possible freeze damage. Seen in crawl and garage.

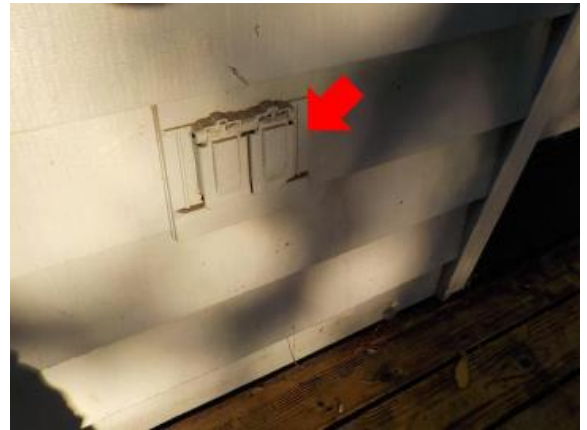
16.7 Installation:

Ground fault circuit interrupter protection is incomplete or absent: Ground Fault Circuit Interrupter (GFCI) protection is currently required for the following areas: Exterior, Garage, Garage door opener circuit, Bathrooms, Kitchen, Spas and Hydro massage tubs, Pools and Fountains, Crawl Spaces, Unfinished Basements. They should be considered as a safety upgrade for homes which pre-date the current requirement. The presence of complete GFCI outlet protection could not be confirmed in the following area(s): Garage. Exterior.

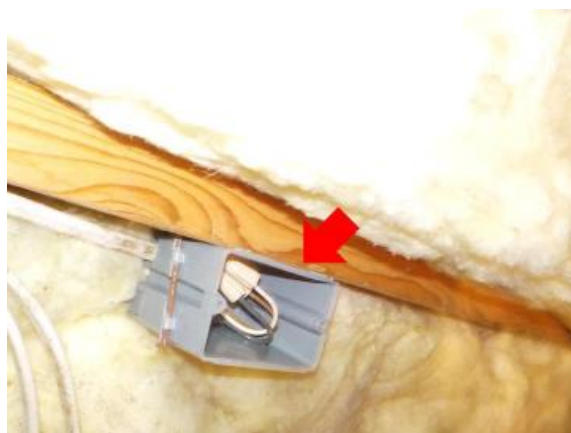
16.11 Installation:

Missing electric junction box covers are noted: Junction boxes should always have covers in place. Correction indicated. This was noted in the following area: Seen in crawl space.

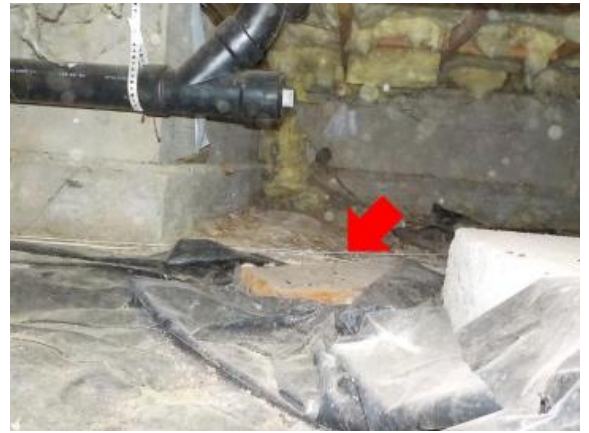
17.11 Debris:

Conductive debris is present in the crawl space: All rake-able sized conductive debris should be removed from the crawl space. Fallen/damaged insulation should be re-installed or replaced. If present, cardboard footing forms should be removed as best as able. Debris present included: Wood scraps.

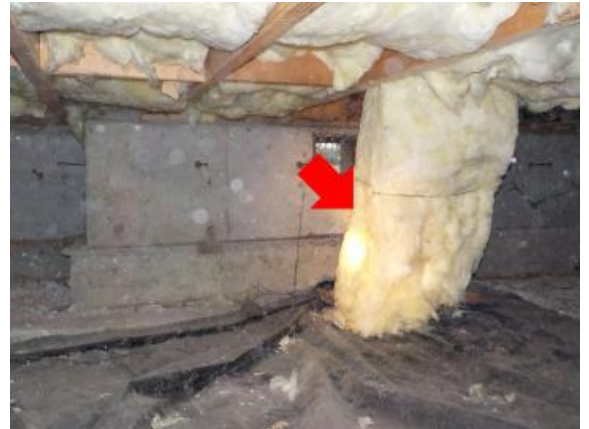
17.12 Insulation:

There is fallen or damaged insulation in the crawl space. This is also considered to be debris which is conducive to the infestation of wood destroying insects. Damaged or fallen insulation should be removed or restored as needed. Minimal.

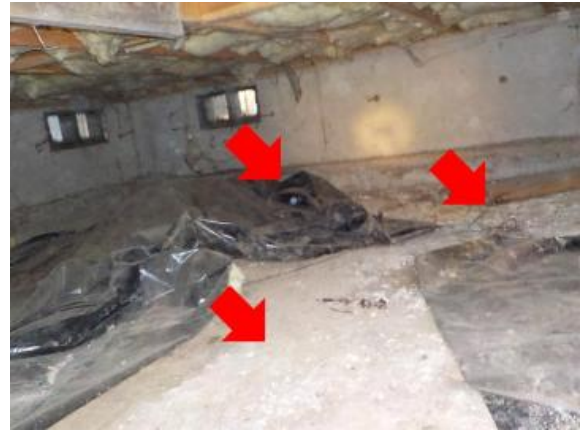
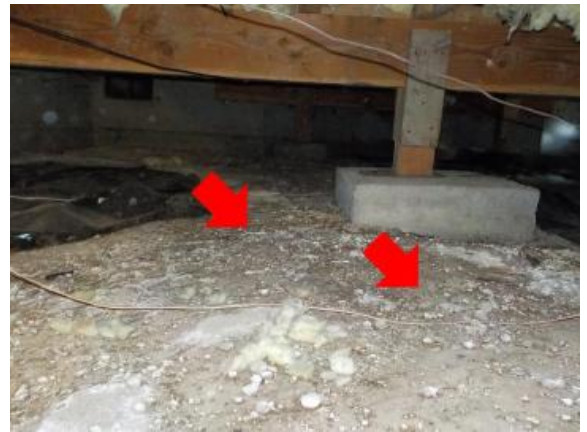
17.13 Vapor Barrier:

Crawl space has inadequate and/or damaged vapor barrier.

Re-spread existing crawl space vapor barrier as able and install additional 6 mil black plastic vapor barrier as needed to meet current building requirements with provision for appropriate overlap at seams, (12 inches). Seen scattered in the crawl, may have been cause by people in crawl running cables. Re-spreading where required is indicated.

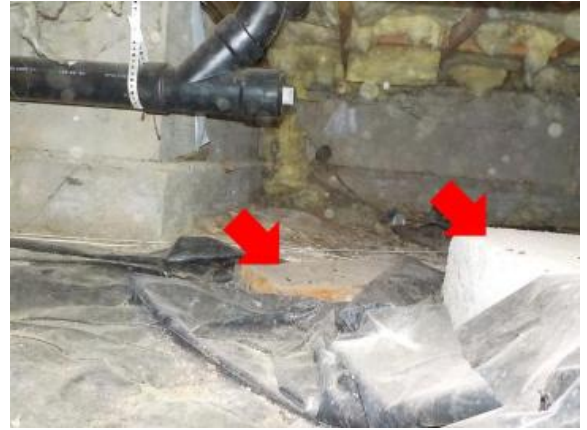
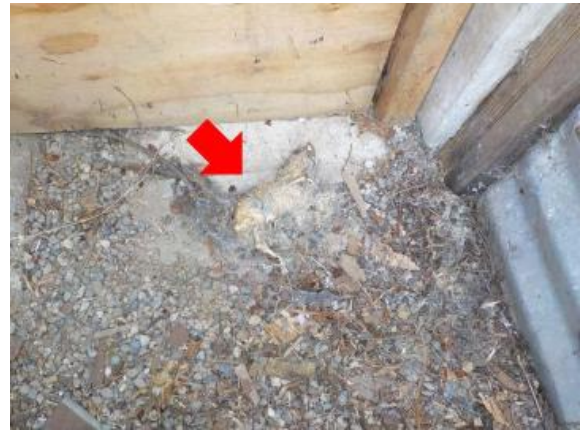
19.2 Rodents:

Evidence of rodent activity is seen: This evidence was seen in the following area(s): The crawl space, Rodent evidence includes: Droppings, Carcasses.
