Job Site

CRAWLEY RTW,
PRIESTLEY WAY,
CRAWLEY,
RH10 9NT

Job Number	16944	Reference	475.100.
Logged	25/09/2024	Job Type	Contract - PUWER
Contact	Michael William	Tel.	01293 721800

PUWER Inspections

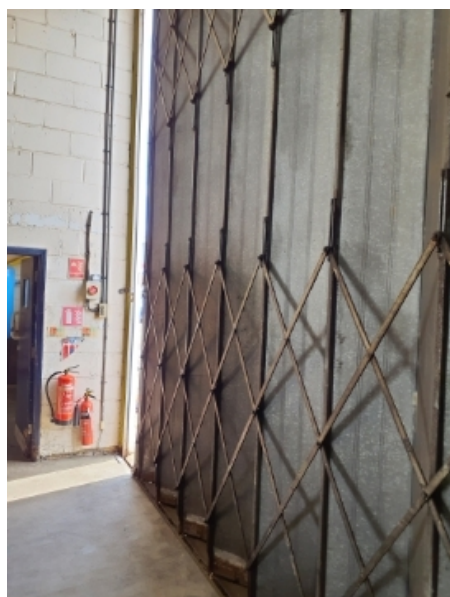
Intolerable - Defects requiring immediate action	None
Substantial - Defects requiring attention within a time period	None
Moderate - Other defects requiring attention	None
Tolerable - Observations	None

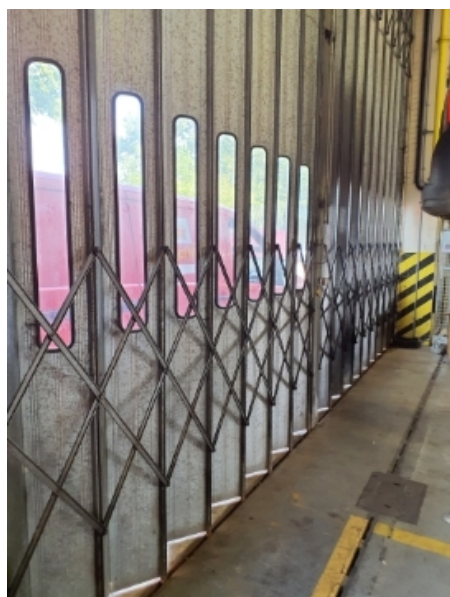
ISI Equipment No	Make / Model	Serial No	Client ID
0000152316	Door Powered Vertical		0000152316

Intolerable - Defects requiring immediate action	None
Substantial - Defects requiring attention within a time period	None
Moderate - Other defects requiring attention	None
Tolerable - Observations	None

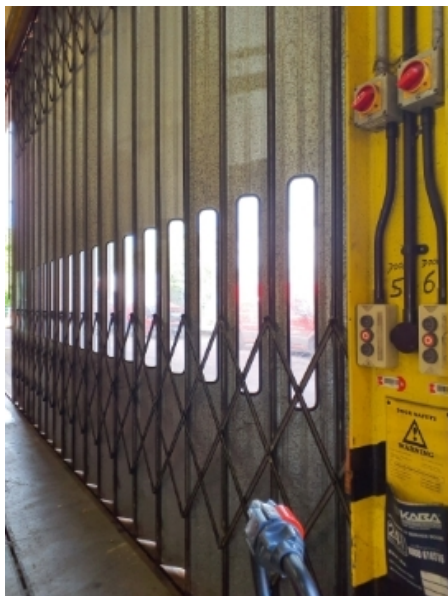
ISI Equipment No	Make / Model	Serial No	Client ID
0000152296	Door Powered Vertical		0000152296

Intolerable - Defects requiring immediate action	None
Substantial - Defects requiring attention within a time period	None
Moderate - Other defects requiring attention	None
Tolerable - Observations	None

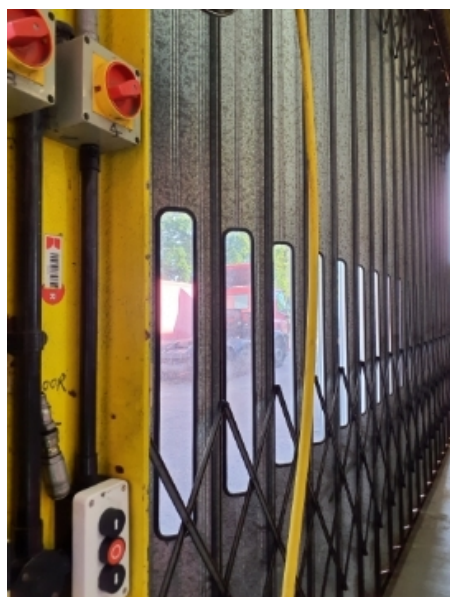
ISI Equipment No	Make / Model	Serial No	Client ID
0000152276	Door Powered Vertical		0000152276

Intolerable - Defects requiring immediate action	None
Substantial - Defects requiring attention within a time period	None
Moderate - Other defects requiring attention	None
Tolerable - Observations	None
