**RE: Incorrect Thermal broken Aluminum Joinery: 2 Rapare St. Job No.27363 - JSR Construction.**

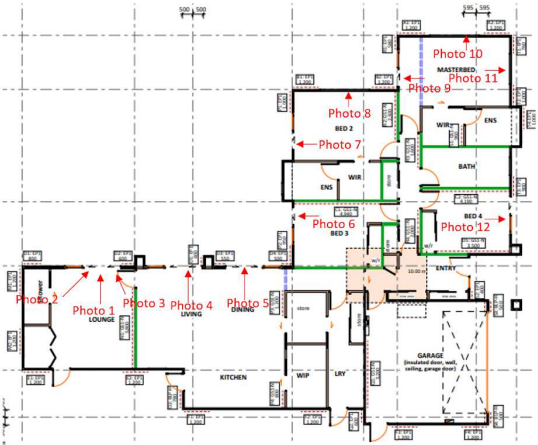
Photo 11 – Indicating uncertain thermally broken window “Master Bedroom W3” (Door number referred to the attached quote no. 27363) (Trim Size: 1000 x 1500; Area: 1.5 m sq.)

You shall provide us with all the satisfied up-to-standard thermally broken aluminium joinery. You are requested to replace and re-install all the incorrect entire windows and doors. Partly replacement of aluminium materials on the site is not acceptable. You are also liable for all our losses of cost including but not limited to the related matters of any material reinstatements, any material variations, any time delay and any opportunity costs incurred by the correction of the aluminium windows and doors. The incorrect and uncertain products are stated below with the corresponding photos and the photo location plan (Figure 1 below). The product quote no. 27363 from your subcontractor is attached for your reference.
