Re: Incorrect Thermal broken Aluminum Joinery: 2 Rapare St. Job No.27363 - JSR Construction.

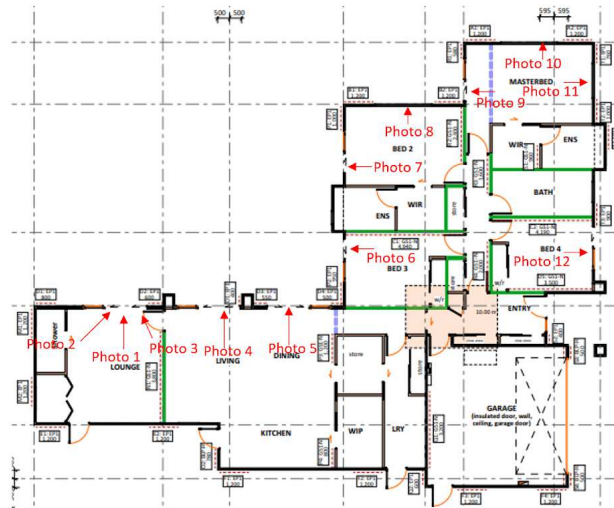
Figure 1 - Photo location plan

and uncertain products are stated below with the corresponding photos and the photo location plan (Figure 1 below). The product quote no. 27363 from your subcontractor attached for your reference.
