The failure of Carsington Dam

A. W. SKEMPTON* and P. R. VAUGHAN*

The upstream slope of Carsington Dam failed just before its completion in 1984. The slip started on the right abutment and spread across the valley to a length of nearly 500 m. Extensive investigations were conducted, and further information was obtained when the dam was reconstructed. The initial slip sheared through the core, which contained shear surfaces due to rutting, and along a layer of Yellow Clay which contained solifluction shears. Both materials were brittle, with low residual strengths. The factor of safety based on measured peak strengths was about 1.4; with reductions to allow for shears it was 1.2. It had been reduced to 1.0 by progressive failure. Finite element (FE) analyses in which strain-softening was reproduced confirmed this. It was concluded that the slide spread by lateral load transfer, through sections of the dam with a safety factor greater than 1. In the valley centre, the slide passed through the base of the mudstone fill. A combination of FE and limit equilibrium analysis indicated that the factor of safety just before collapse was about 1.1. The factor of safety was 1.6 with intact st

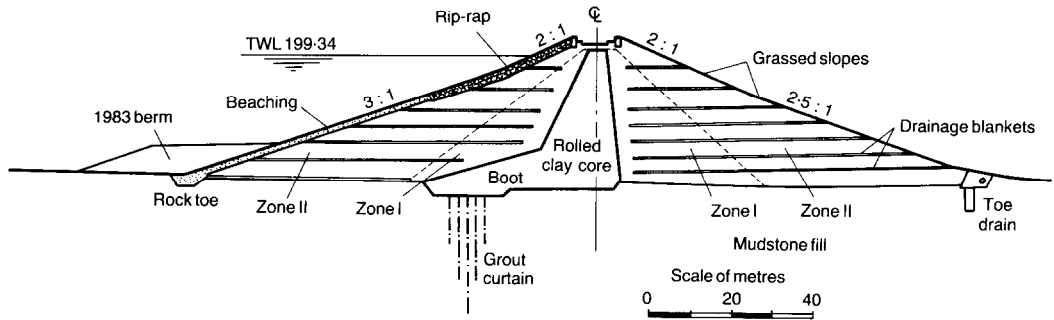
A typical section of the Carsington dam as designed and a plan of the works are shown in Figs 1 and 2. Intended crest level was el. 202, 37 m above the stream bed. The dam had a clay core with an upstream extension (the 'boot'), and shoulders of compacted mudstone with drainage layers of crushed limestone about 4 m apart. Fill placing began in May 1982 and took three summers, with winter shutdowns from October to April at bank level el. 182 in 1982–83 and at el. 197–198 in 1983–84. A small berm was placed at the upstream toe as compensation for an increased rate of construction in August 1983.

Fig. 1. Typical section of dam

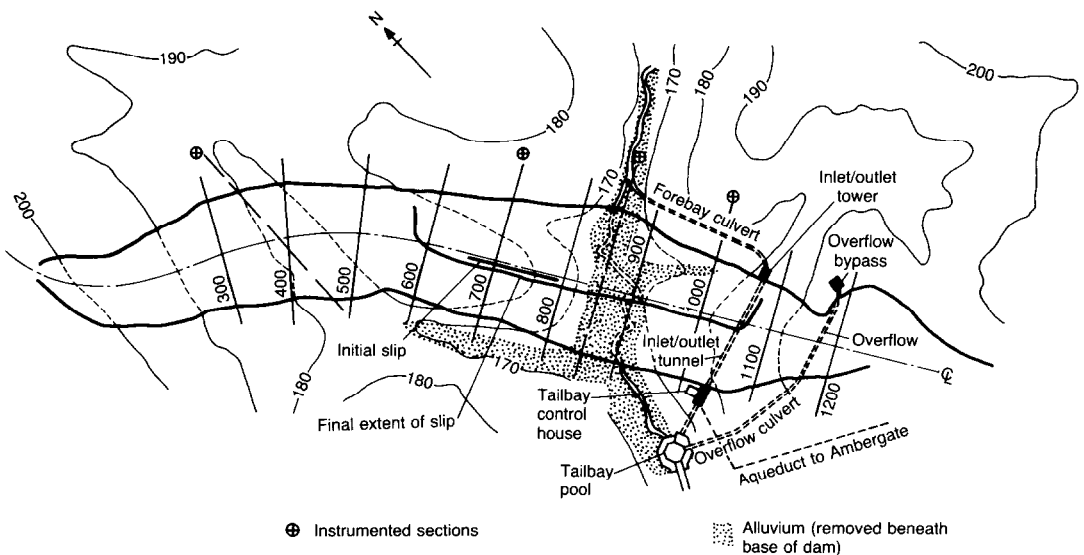
Fig. 2. Plans of works and location of slip

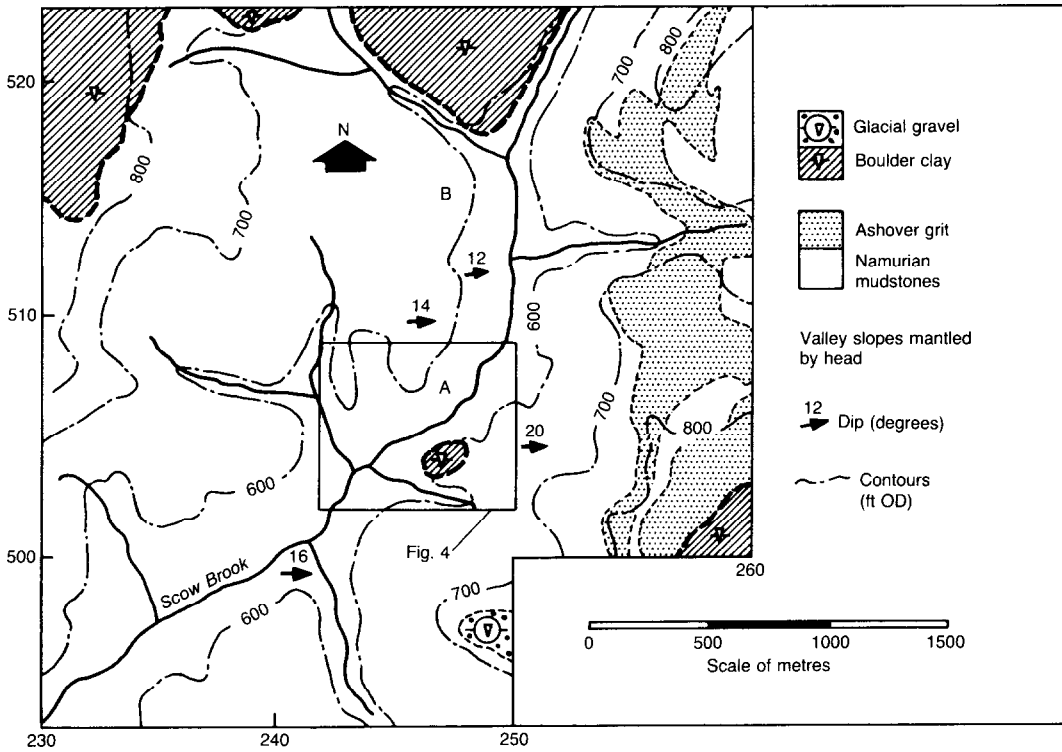
Fig. 3. Geology

and patches of glacial gravel exist on the neighbouring higher ground, and in places boulder clay survives on the valley sides (Fig. 3). The site lies well outside the limits of the last (Devensian) glaciation, so the glacial deposits belong to the Older Drift, and are probably of Wolstonian age.

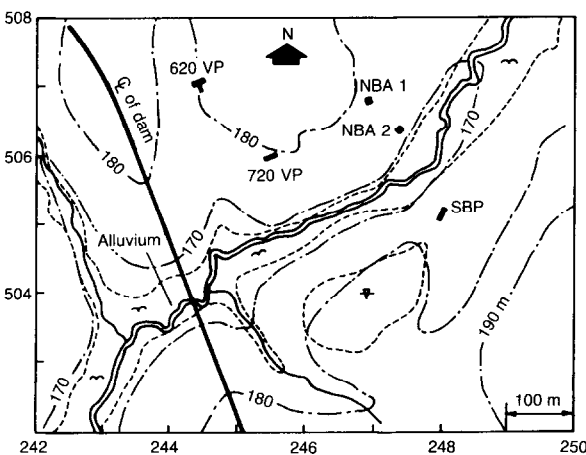
Fig. 4. Location of trial pits

Four trial pits were excavated as part of the investigation of the site in the north flank of the valley in area A (Fig. 4). Together with borings in area B (Fig. 3), they show that the lower parts of the slopes, inclined at 4° – 6° , are mantled by a layer of head averaging 1.2 m in thickness. On the steeper slopes (8° – 9°) on the opposite (south) side of the valley the head is slightly less thick. A typical section (Fig. 5) shows head consisting of silty clay subsoil a_1 and plastic yellow-brown clay a_2 , both containing scattered sandstone fragments and rare quartz pebbles derived from the glacial deposits, overlying a layer of completely weathered mudstone b_1 almost identical to soil a_2 except that it has no foreign inclusions. For geotechnical purposes a_2 and b_1 can be grouped

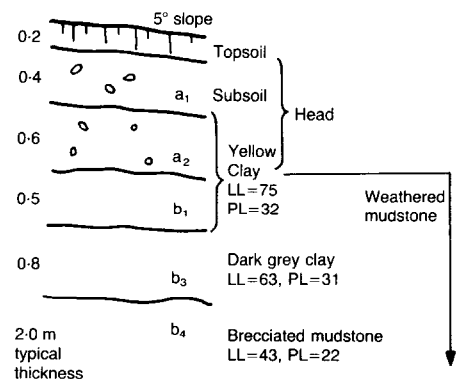
Fig. 5. Geological profile in natural ground: shear surfaces found near junction of a₂ and b₁

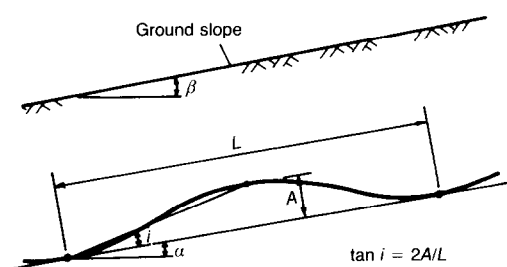
Fig. 7. Idealized undulation in shear surface

Solifluction shears occurred over 40% of the total length (56 m) examined in pits on the north side of the valley where the slope is around 5° . Two examples are shown in Fig. 6. The undulations in the shear surfaces in this area can be quantified approximately by an angle $i = 3^\circ$ as sketched (to an exaggerated vertical scale) in Fig. 7. On the south side of the valley, with a ground slope of 8° , the shears were flatter and more extensive. Details of the exploratory pits, and an illustration of the soil fabric in thin section, which shows substantial alignment of particles along a shear surface, are given by Skempton *et al.* (1988).

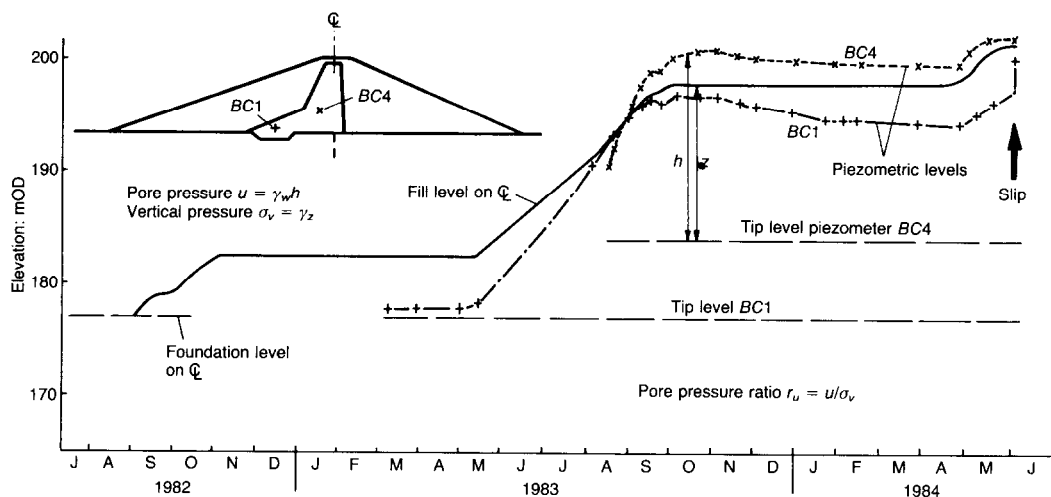
Fig. 8. Typical piezometer records from core and boot at ch. 705

Typical pore pressures measured in the core and boot are plotted in Fig. 8, and the last complete set of readings before the failure, taken on 21 May, are plotted against height of fill in Fig. 9. The upper bound shown represents an increase in pore pressure equal to the increase in nominal overburden pressure. The original (negative) pore pressures become zero under 7 or 8 m of fill.

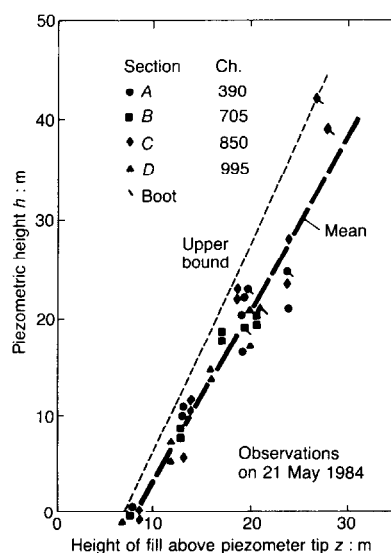
Fig. 9. Relationship of pore pressure in core and boot and depth of fill immediately before collapse

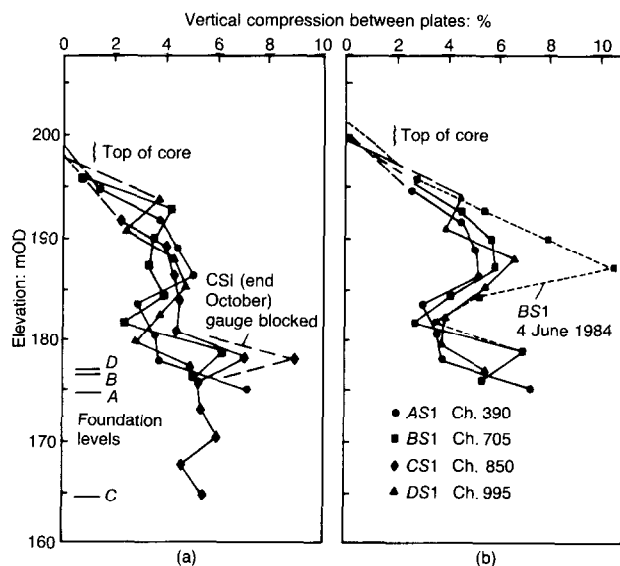
Compressions between the plates of vertical settlement gauges in the core 4 m upstream of the centreline are plotted against elevation in Fig. 10(a) for the end of the 1983 placing season. They are large but unremarkable, except for the compression at a depth of about 20 m at ch. 850 m, which increased from 7% to 9% by the end of October, when the access tube to the gauge

became blocked. This depth corresponds to the eventual failure surface, and to the point of maximum deviatoric strain (15%) predicted by the FE analysis for this section with the fill at el. 197.5 m, although at this stage there were still quite small strains along the base of the mudstone fill, where failure subsequently occurred.

Fig. 10. Vertical strain measured by USBR settlement gauges in core 4 m upstream of centreline: (a) October 1983; (b) 24 May 1984

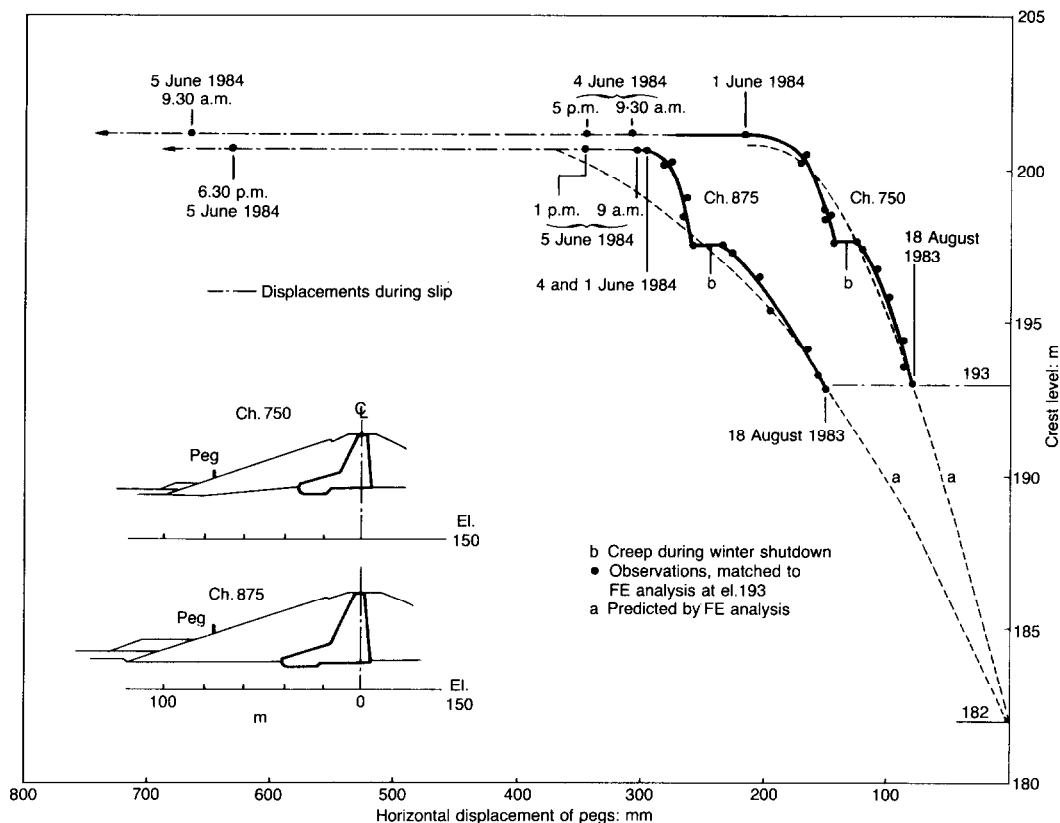
Observations of the lower line of pegs began on 18 August 1983 with the bank level at el. 193. Displacements at ch. 750 and ch. 875, representative of displacements at what became the initial slip and at the valley centre, are plotted against time in Fig. 11, with starting points matched to displacements predicted by FE analyses at nearby sections (ch. 725 and ch. 850). At ch. 750 observed movements are similar in magnitude to those predicted by analysis up to 1 June 1984, and the fill elevation at failure predicted by the analysis almost coincides with that observed. At ch. 875 movements predicted by a matching FE analysis are larger than those measured, probably due to shortcomings in the modelling of the stiffness of

Fig. 11. Measured horizontal movements at toe pegs, and predictions of these movements from the FE analyses

A feature of the peg movements is the creep observed during the 1983/4 winter shutdown, particularly at ch. 875, and the subsequent increased 'stiffness' when construction restarted. Note also the disproportionate increase in displacement at ch. 750 (nearly 50 mm) between 25 May and 1 June, as only 0.8 m of fill was placed. Up to that point the larger movements at ch. 875 than at ch. 750 reflect the difference in height of fill above foundation level (35 m and 28 m respectively at final level). The maximum difference in displacement at the two sections before the initial failure was 110 mm and, as the sections are 125 m apart, the average longitudinal strain along the embankment never exceeded 0.1%. Displacements and strains within the embankment might be twice as much, but an analysis of lateral load transfer (Vaughan, 1991) has shown that such strains do not allow significant transfer of load along the embankment.

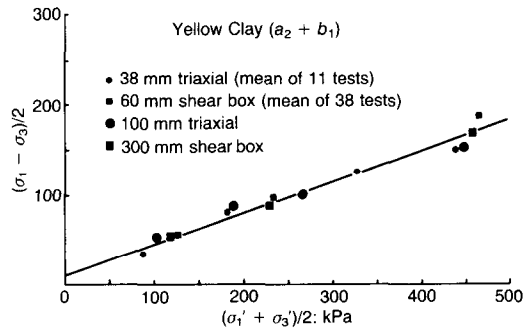
Yellow Clay. Drained triaxial tests, direct shear tests and simple shear tests were carried out on intact samples. The peak strength parameters obtained (Fig. 18) were $c_p' = 10$ kPa, $\Phi_p' = 20^\circ$. Stress-displacement curves from $300 \times 300 \times 150$ mm and $60 \times 60 \times 20$ mm direct shear box samples showed no significant scale effect. Direct shear box and triaxial tests were also conducted to measure the drained strength on samples containing the shear surface from the slip and on samples containing solifluction shears (Fig. 19). Both showed a drained residual strength of $c_R' = 0$, $\Phi_R' = 12^\circ$. The reduced peak strength and the small displacement to residual (Fig. 19(b)) on the solifluction shears are typical. The shears concentrate strain so that particle orientation, polishing and the development of residual strength occurs in a few millimetres displacement, at an equivalent strain much less than is required to develop peak strength in intact samples (Fig. 20). Thus if soil which contains a discontinuous shear surface is sheared along the plane of the surface, the surface will have reached residual strength before

Fig. 18. Yellow Clay: peak intact drained shear strength ($w = 38$, $c' = 10$ kPa, $\phi' = 20^\circ$)

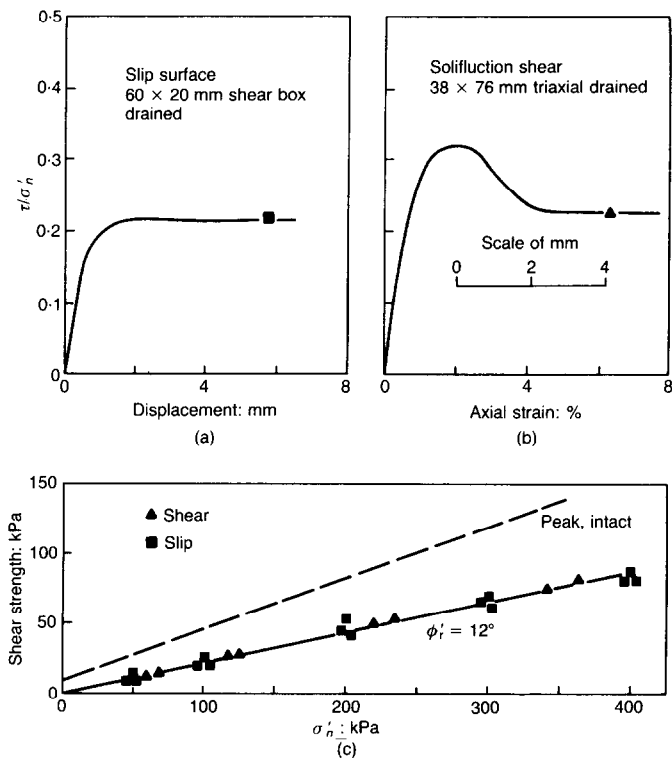
Fig. 19. Yellow Clay: drained shear strength on solifluction shears and slip surfaces

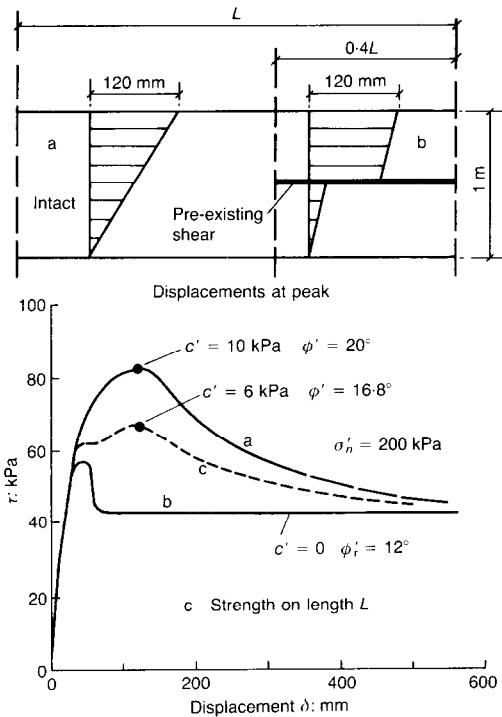
Fig. 20. Yellow Clay: composite stress/displacement curves for a layer containing a planar shear occupying 40% of its area

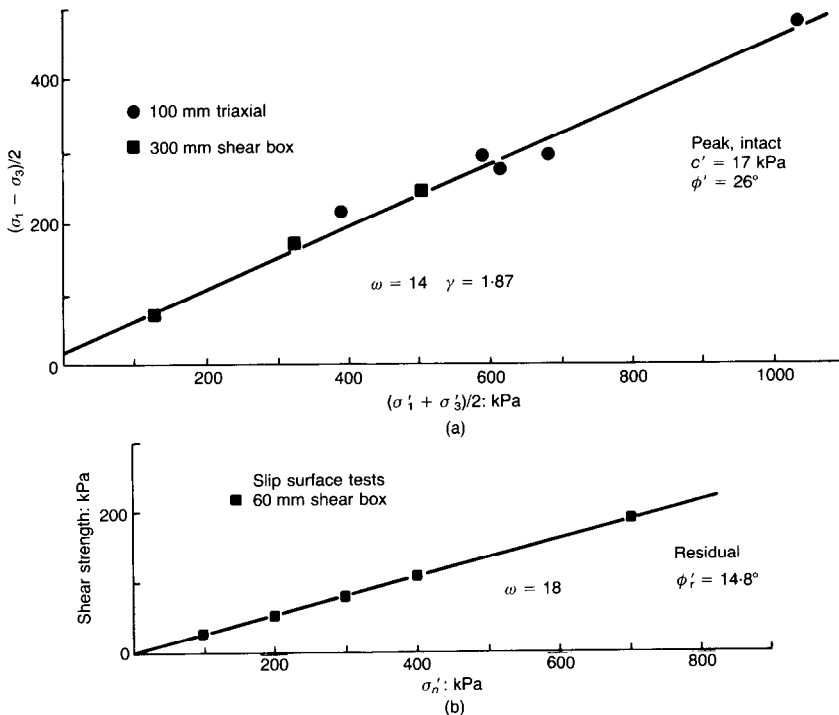
Zone II fill. Drained tests on large samples of the fill taken in June–July 1984 gave a peak strength envelope (Fig. 21(a)) described by $c'_p = 17$ kPa, $\Phi'_p = 26^\circ$. The water contents and dry densities of the test samples are plotted in Fig. 22. Drained direct shear box tests on the main slip

surface at ch. 825 and on the slip surface at ch. 620 (Figs 15 and 16) both gave $c_R' = 0$, $\Phi_R' = 15^\circ$ (Fig. 21(b)).

Fig. 21. Zone II fill drained shear strength: (a) main fill; (b) shear zone

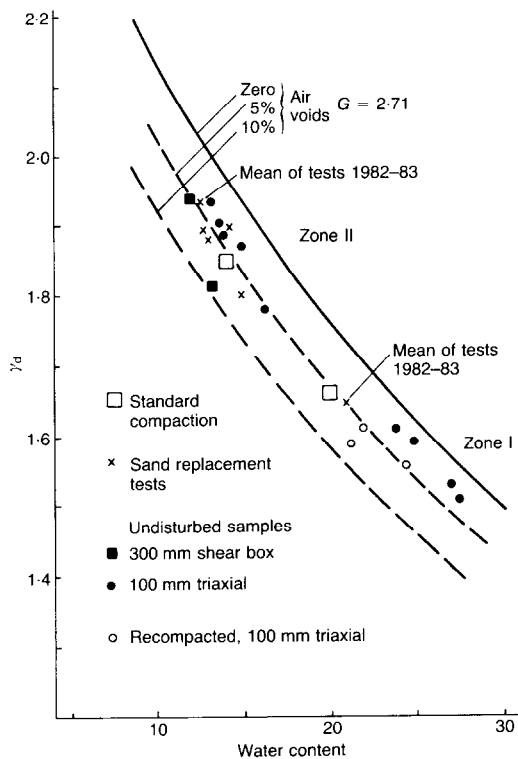
Fig. 22. Mudstone fill: compaction test results and in situ densities

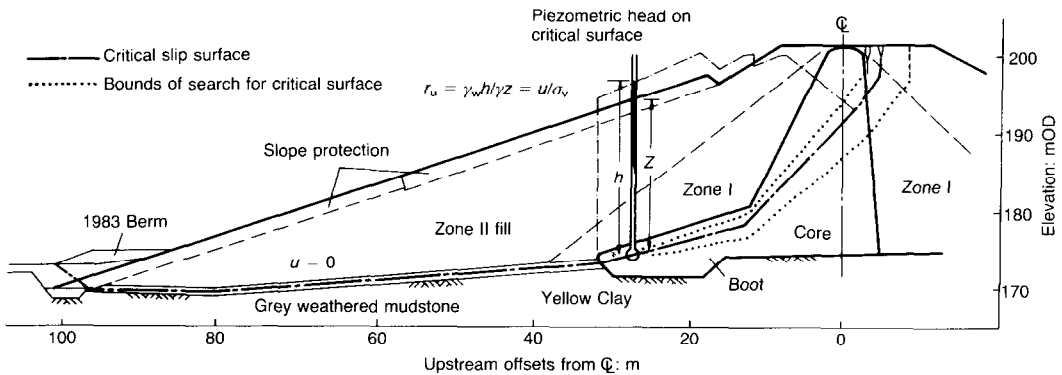
A representative section at ch. 725 was analysed (Fig. 23). Crest level at failure was el. 201. Vaughan (1991) has shown that a deep-seated slide in brittle soil fails without three-dimensional effects if longer than a critical length. The length of the initial failure was greater than the critical length, and the section could be analysed in two dimensions without error.

Limit equilibrium analysis. Stability was investigated using a multiple wedge analysis incorporating six vertical slices, with, typically, interslice forces acting at an angle $\delta = 10^\circ$. This gave closely similar results to analyses using the simplified assumptions of Morgenstern & Price (1965). Pore pressures in the core and boot were taken from the mean line of Fig. 9. The Yellow Clay must have been fully consolidated, with ground water level at the base of the layer just before failure, and zero pore pressure was assumed. A strength of $c' = 0$, $\Phi' = 30^\circ$ was adopted for the short length of the slip through the slope protection and berm fill. This assumption has little influence on the results of the analysis. Various slip surfaces were tried through the core, within the bounds shown in Fig. 23. The

Fig. 23. Initial failure ch. 725: limit equilibrium stability analysis (unit weights (kN/m^3): core and boot 18.5, zone I 20.5, zone II 22.0 slope protection 18.5; average values of τ_u 0.42 in core, 0.53 in boot)

surface that gives the lowest factor of safety is almost coincident with the actual one.

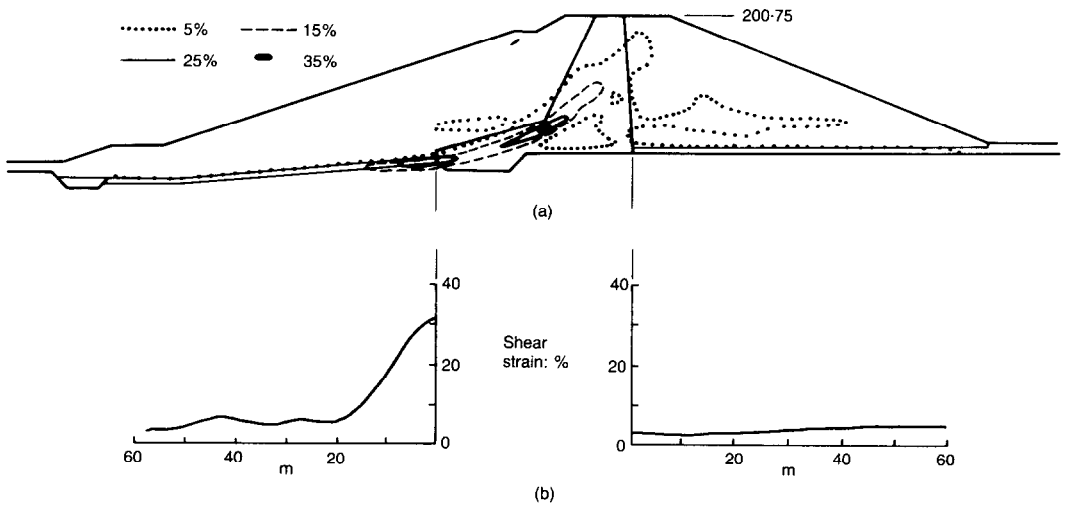
Figure 24, derived from this analysis, shows

how progressive failure reduced the average strength available. The highly non-uniform strains along the Yellow Clay vary from 30% near the boot to 5% near the toe, and they also vary in the core and boot. Just before failure part of the Yellow Clay had been strained well past peak strength, and part had not reached peak. Thus the average shearing resistance available was much less than peak. The degree of progressive failure is determined directly in these analyses, and can be expressed in terms of the residual factor R for each material, with $R = (\tau_p - \tau_m)/(\tau_p - \tau_R)$, where τ_m , τ_p and τ_R are the average mobilized, peak and residual strengths respectively. In the Yellow Clay, $R = 0.52$ was predicted. In the core and boot nearly all the fill had exceeded peak, and $R = 0.42$. These strength losses are closely equivalent to those that must be assumed in the limit equilibrium analysis to account for failure.

Fig. 24. Initial failure ch. 725—strains predicted by FE analysis just before collapse: (a) contours of deviatoric strain; (b) shear strain distribution along Yellow Clay

Yellow Clay below the downstream slope are also shown in Fig. 24. They are small and all the clay is some way from failure: this is consistent with the stability of this slope, although it was steeper than the one that failed. The strains at this point are also relatively uniform. Dounias *et al.* (1989) have considered what would have happened had the thrust from the core become sufficient to load the downstream side more severely.
