## TABLE OF CONTENTS

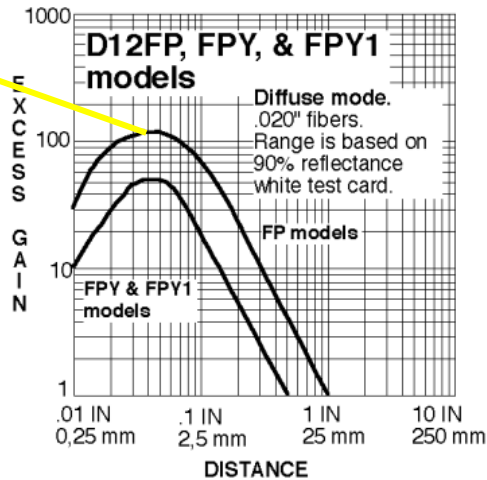
Diffuse Mode—0.020 Inch Fibers

After thorough testing, it was concluded that all three fiber optics sensors are working. They were reinstalled in the fixture and were tested again. It was noticed that after prolonged use of the fixture, signal strength received by the sensor decreases. This is seen as the violation of safety conditions by the safety controller and hence it locks the fixture. I investigated sensor's data sheet, sensor's performance changes with respect to the distance and is affected by dust. It was noticed that with the change in distance the excess gain of the sensor must be changed, shown in the figure below. For example, at 0.1 inches, the gain should 20 times the original signal for correct performance. Fiber optics cable attached to the emitter and receiver of the sensor were cleaned and sensors were re-installed. They were tested again but still they are failing. Will investigate other problems tomorrow.

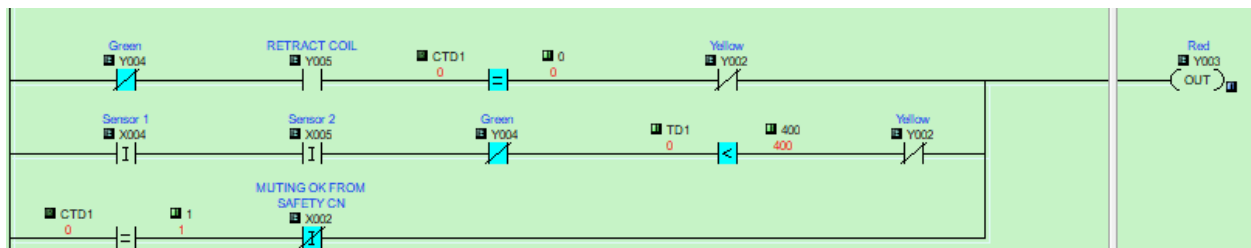
Red Light:

Red light would turn on if the system is locked, or if rear sensor fails or if the systems is in lockdown zone. Locked down zone is programmed to be 390 ms, which is more than debounce and response time i.e. 134 ms.

To pull the fixture up user must touch the sensor and hold it till red light goes OFF. As soon as the sensors are touched the red light would turn on and would remain turned on till 390 ms, if the user lets go of his/her finger before the red light turns off then the systems would lock. To unlock the system either the user can hold the sensor for 5 seconds or turn the power off and back on.

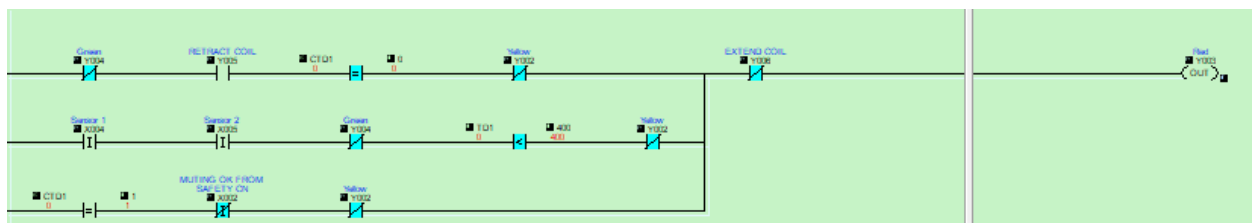
Red:

This morning the fixture got stuck again, upon inspection it was noticed that the safety controller needs a system reset after every 24 hours. The safety controller can be resetted by recycling the power. Safety controller was reprogrammed to monitor the side sensor faults, rear sensor fault and systems reset separately, shown in figure. The output of the safety controller is fed to the PLC and previous

connections were removed. Now, the safety controller will inform the PLC about the status of side sensor, top rear sensor and system reset separately. And if any fault occurs the PLC would turn on the respective light.

Furthermore, the PLC was reprogrammed to have an instant drop for the fixture. Before, user would have to wait for the red light to turn green before they can remove their finger i.e. for 390 ms. However, this is not desired, since if someone's hand is stuck then they shouldn't have to hold the sensor for 390 ms. Hence, PLC was reprogrammed so the fixture can have an instant drop-down, this was done by making the operation event dependent rather than time dependent. Also red and green light were reprogrammed to not turn on anymore in pulling down operation.

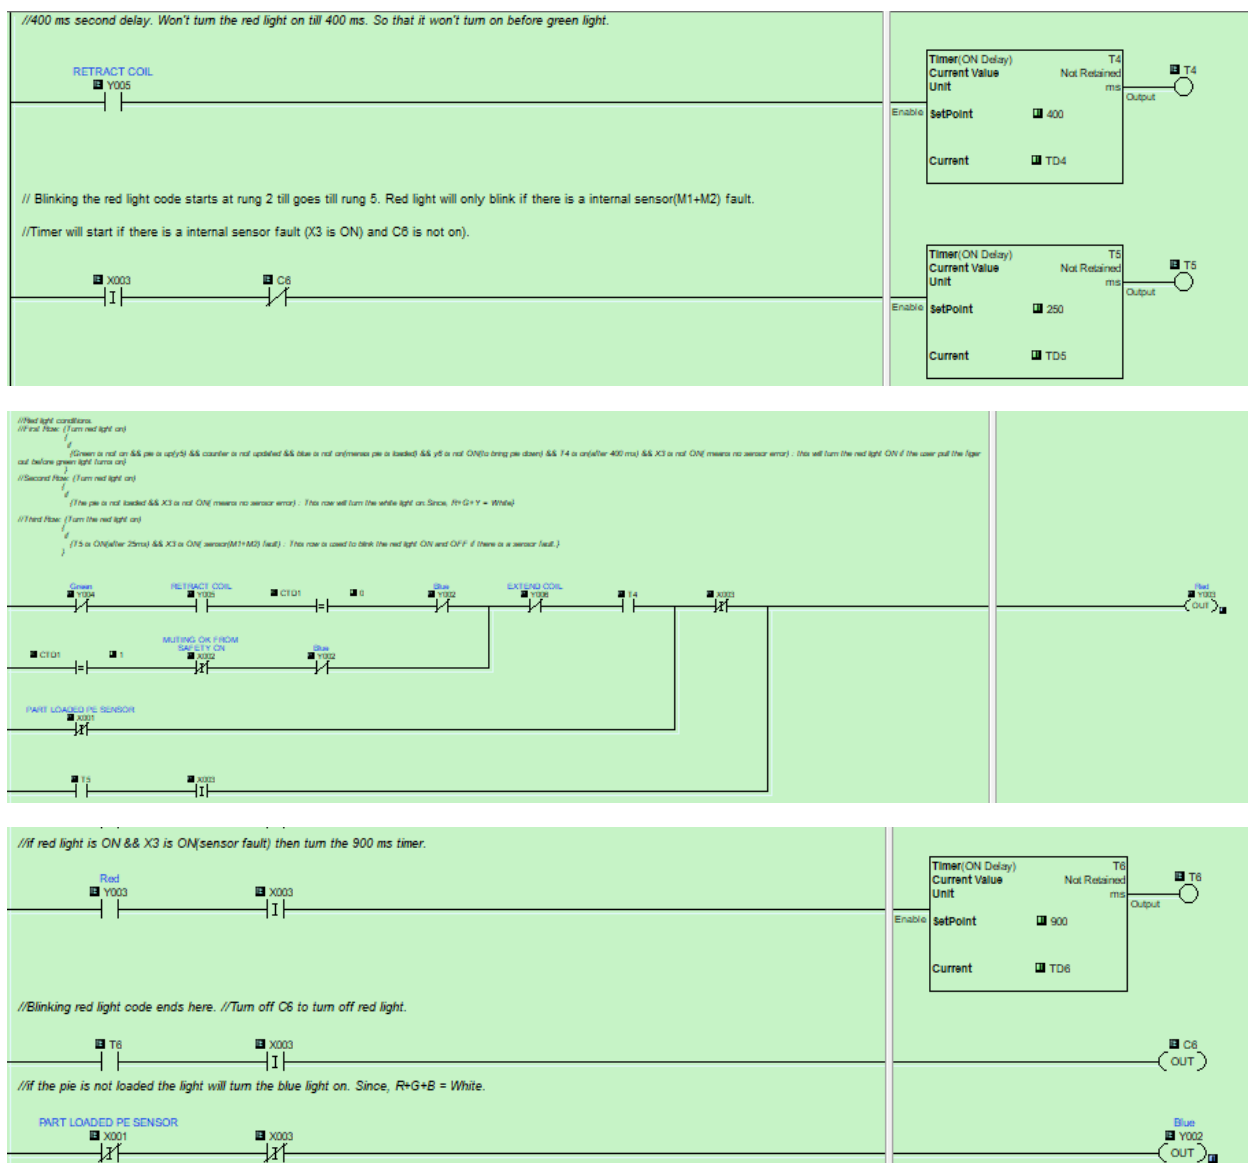
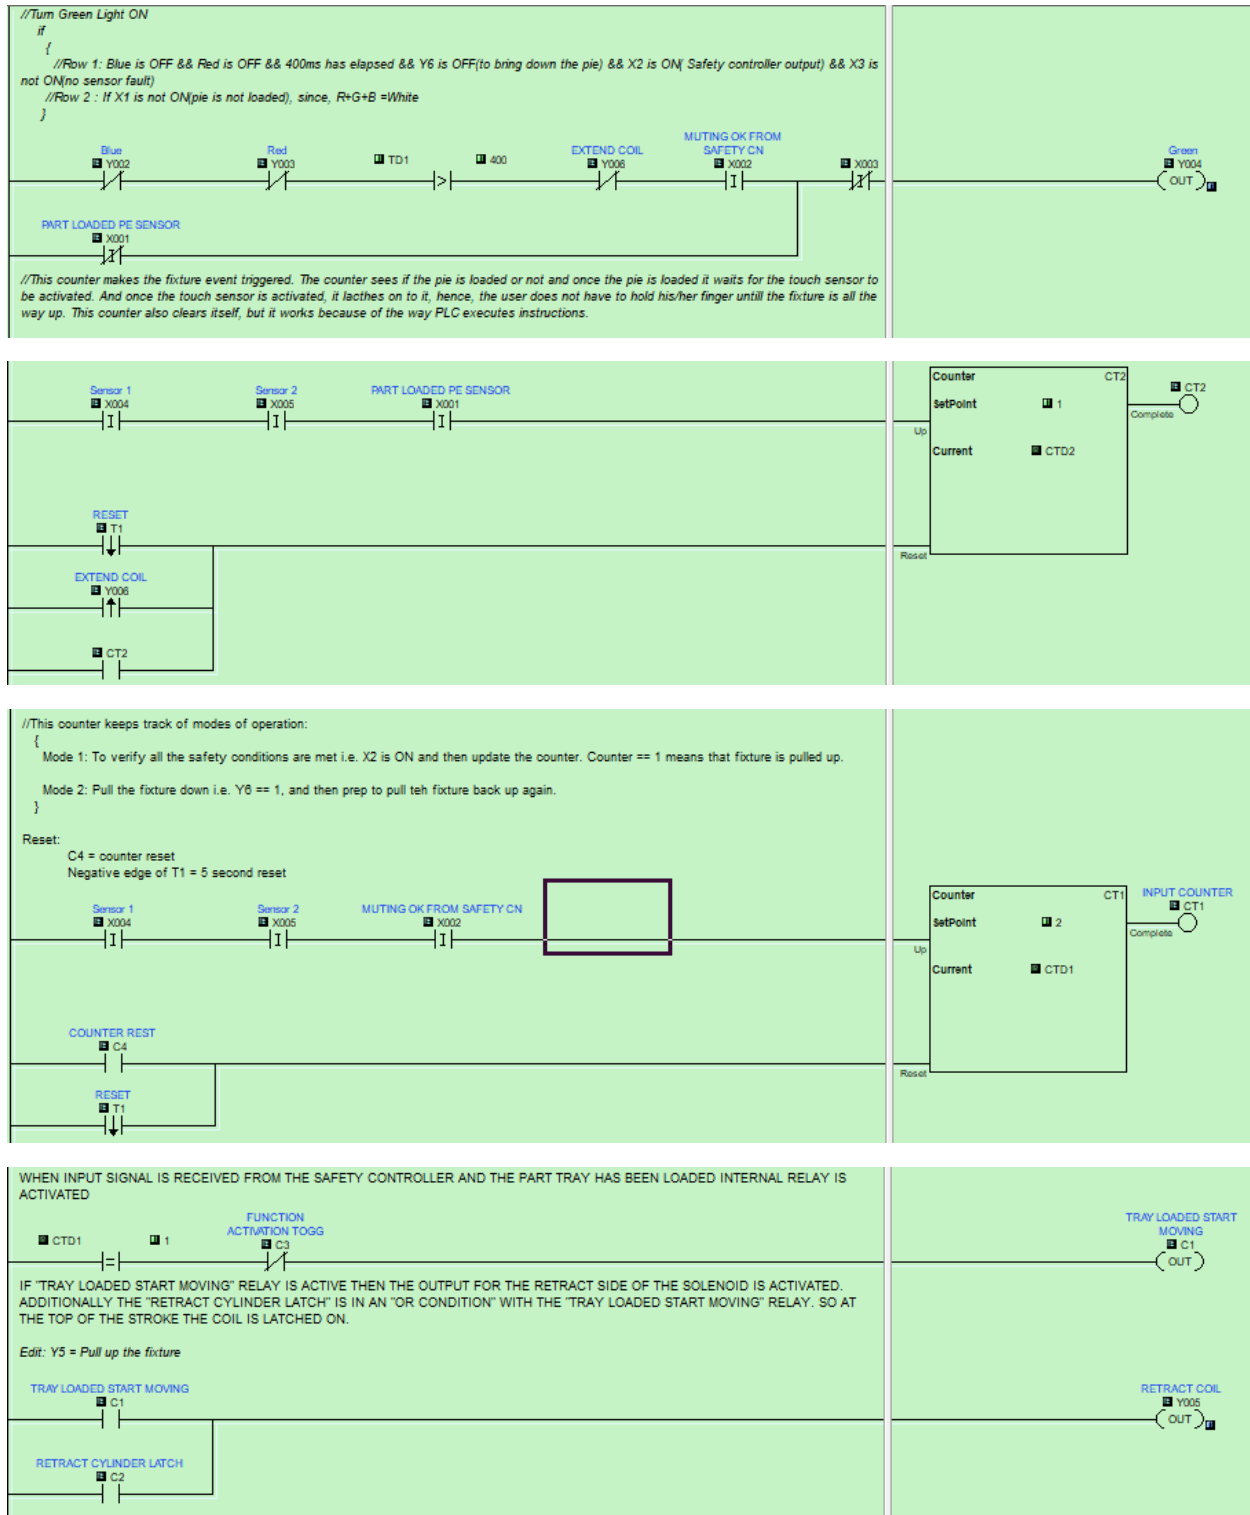
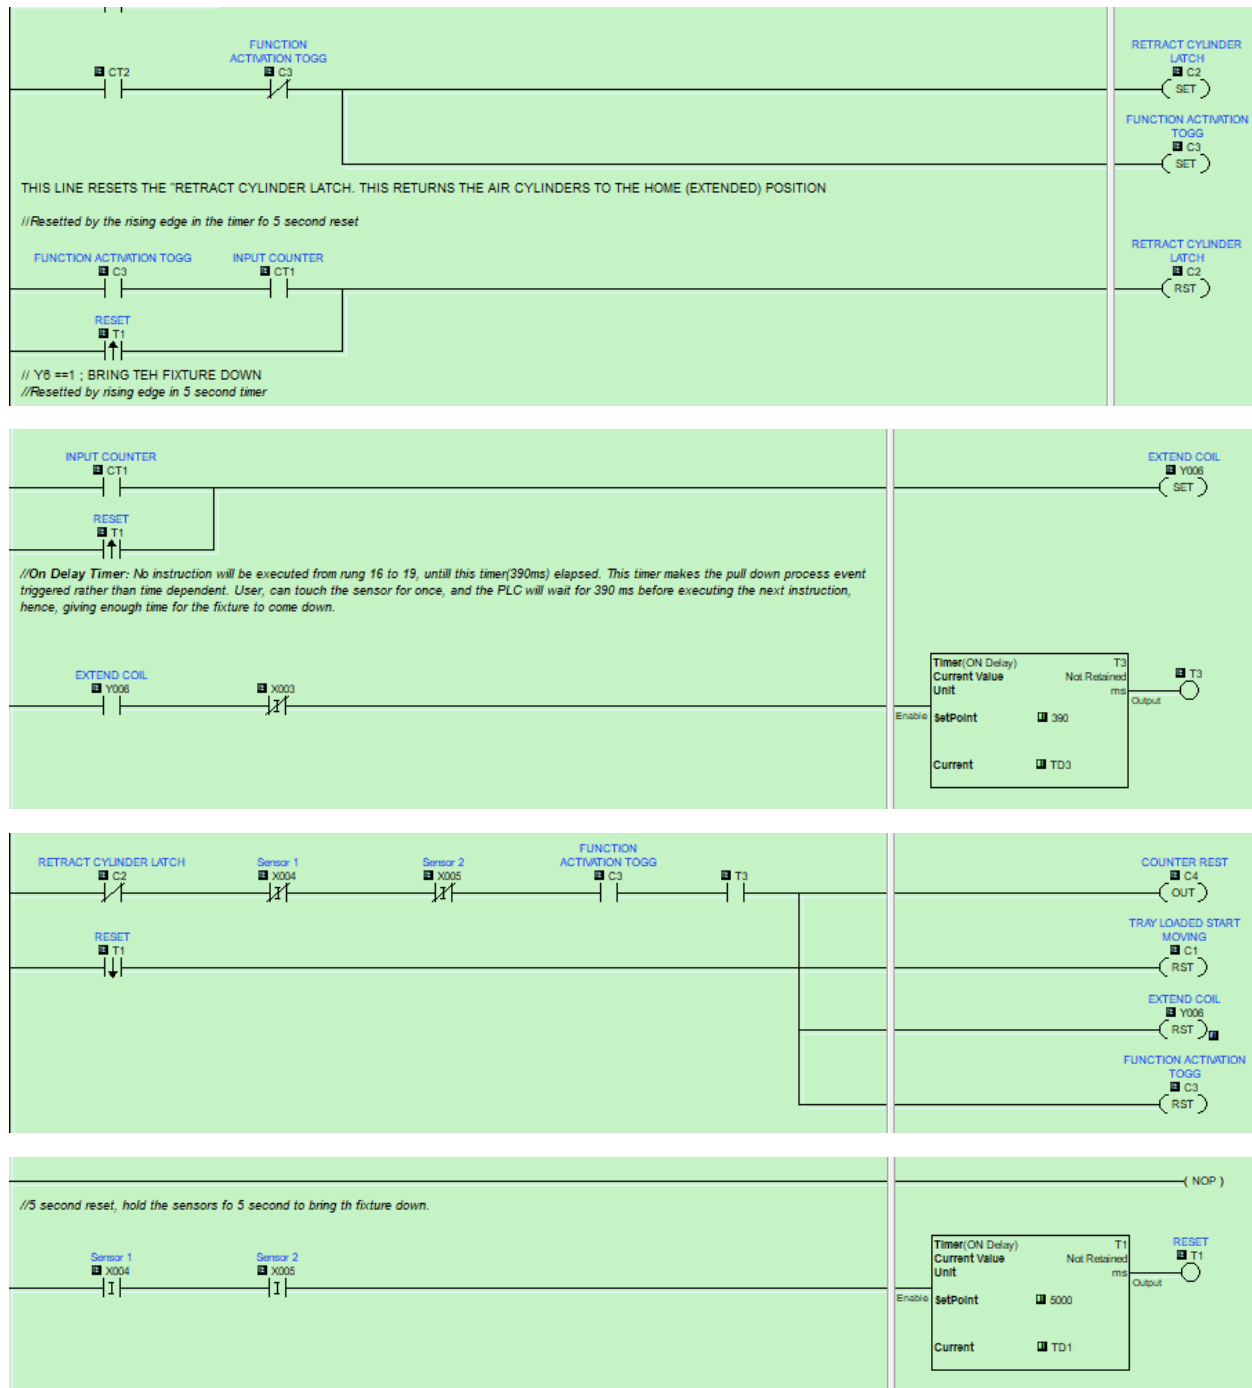
Production line employees said that the combination of red, green and yellow light was confusing. Hence, the PLC was reprogrammed. Now user must only wait for green light to turn on before he/she can remove the finger. Furthermore, red light will only turn on if the fixture is stuck or need a system reset. Red light will also blink if there is top-rear sensor fault. White light would turn on if the fixture is displaced from its position.

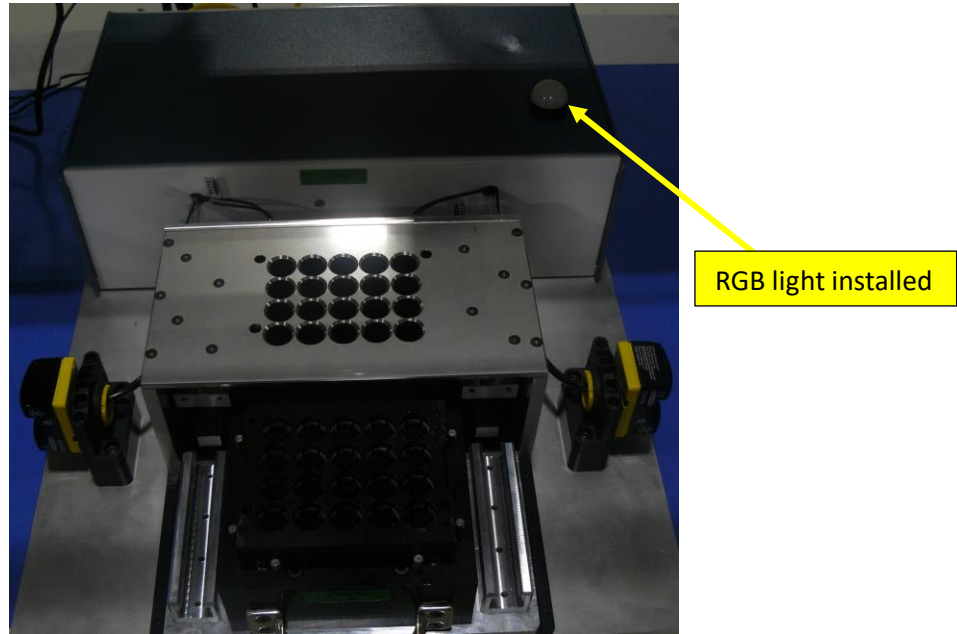
Everything in the new fixture is wired according to the wiring diagram, all connections are probed and are connected correctly. New code is updated in the PLC, safety controller is configured, and relay connection are changed accordingly. However, since the components are arranged differently inside, hence the RGB light was installed in the opposite side, due special constraints while wiring. Tested the 2<sup>nd</sup> PC fixture and it is working as expected. Will work on the ovens tomorrow.
