MARINE STRUCTURES CONDITION ASSESSMENT AND REPAIR RECOMMENDATIONS REPORT, HERRON ISLAND, WA

Prepared for HMC Management

KPFF Project No. 109086
September 24, 2010

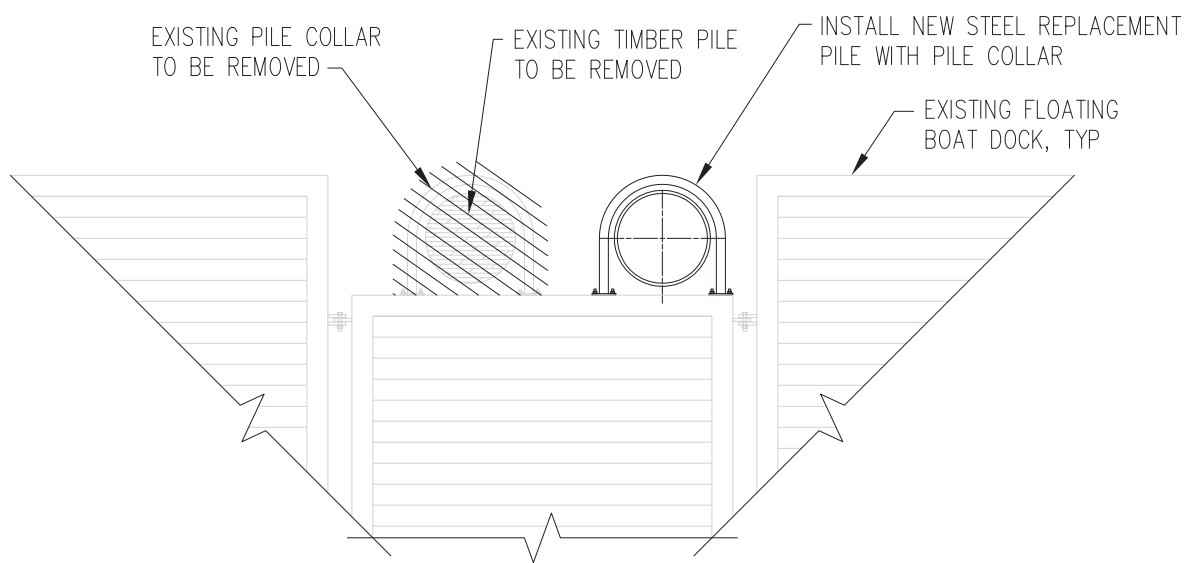
1 ENLARGED PLAN - NORTH BEACH MARINA

Observed Conditions: A summary of observed conditions is provided below by location. Observed areas of distress are also noted on **Figure A**.
