Update "With-Site-Visit" Reserve Study

HMC Management Lakebay, WA

Report #: 24901-6
For Period Beginning: October 1, 2019
Expires: September 30, 2020

Date Prepared: April 18, 2019

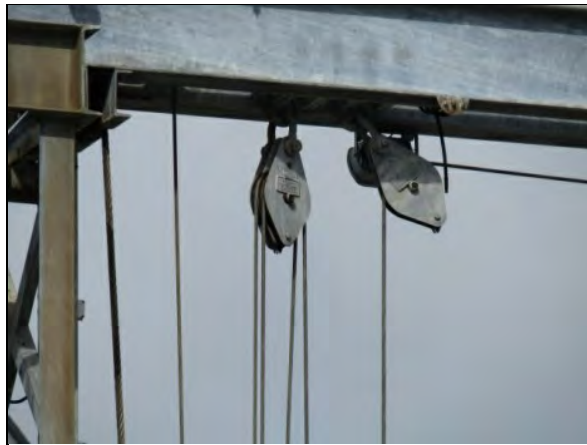
Comp #: 704 Ferry Terminal Cables - Replace**Quantity: Extensive linear feet**

Comments: Previous history includes FY 2014/2015 replacement at \$27,200 expense. Also, all counterweight and lift cables were replaced in 2007 and then lift cables at the Mainland Terminal only in FY 2011/2012. For purposes of long term budgeting, best to plan for proactive and simultaneous replacement of all cables every 5-7 years (utilize galvanized product) to ensure smooth, safe operation and cost efficiency.

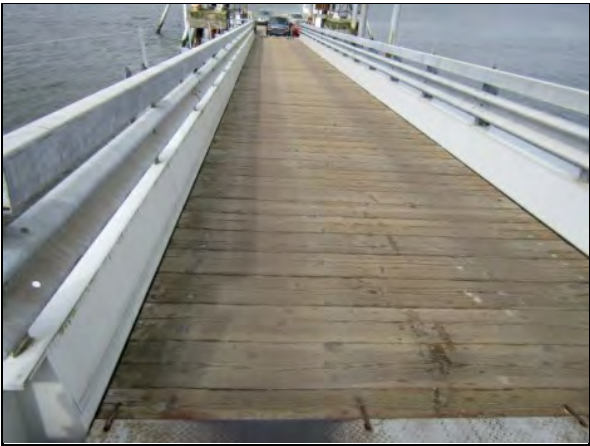
Comp #: 706 Ferry Terminal Wood Decks - Replace

Location: Island and Mainland Terminals
Funded?: Yes. Meets National Reserve Study Standards criteria for Reserve Funding
History: FY 2014/2015 replacement at \$144,000 plus portion of \$46,000 "soft" costs
Comments: Fair condition. FY 2014/2015 replacement at \$144,000 plus portion of \$46,000 "soft" costs. We understand that removal of wood decking is required when each painting project occurs but assume decking will only be recommended for similar large scale replacement as indicated below. Spot replacements to sustain in between are already factored within Component # 700, Ferry Terminals - Inspect/Repair. Previous discussion regarding possible transition to steel planking may be revisited again for distant future replacement; update in reserve study updates as conditions merit.

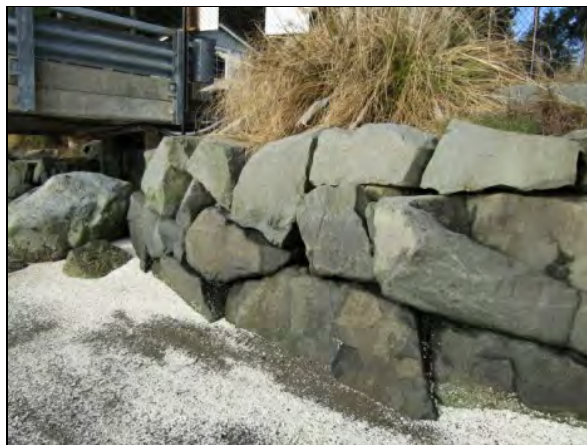
Comp #: 710 Ferry Ramp Bulkhead - Repair**Quantity: Moderate square feet**

Comments: No apparent instability, sloughing, deterioration of rip-rap, etc... Some repair occurred in 2006; no further project history was provided. Geo-technical evaluation is beyond the scope of our service and extent / timing of future event is difficult to predict. Consult with appropriate engineering firm as conditions warrant.

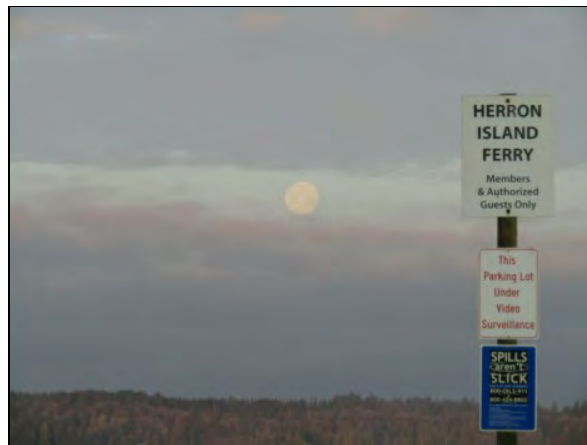
Comp #: 718 Ferry Ramp Surveillance - Replace**Quantity: (2) camera, DVR**

Comments: Modest system installed at Mainland Terminal in 2012 at an expense of \$2,300. No reported change in status since previous research indicated no plans to substantially increase system that would merit reserve designation. Treat minor replacements as an operating expense.

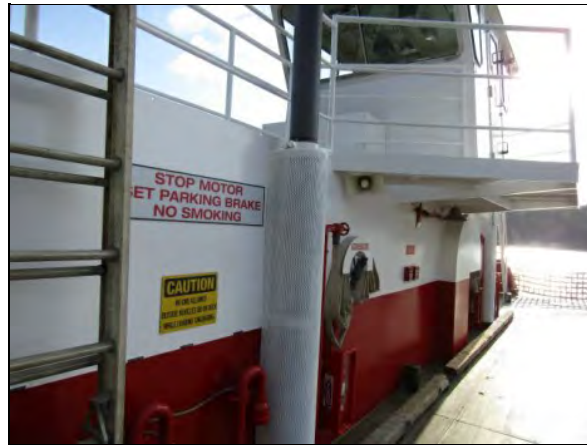
Comments: Welded steel hull and framed vessel was built in 1989. Where observed, paint was in good condition overall. Our previous research informed us that dry dock and significant maintenance occurs every two years on the even year, so next event in FY 2020/2021 is factored below. Comprehensive inspections and projects including such as paint, zincs, seals, prop and shaft repairs, etc....are indicated. FY 2018/2019 expense was \$118,000 and included significant painting among other maintenance. Your 11/12 2018 newsletter indicated "freshly painted inside and out" and "Charlie's electrical, mechanical, and engine systems are refreshed, repaired". Separate \$30,600 expense to overhaul engines in FY 2018/2019 - see Component #744. Prior events include FY 2016/2017 at reported expense of \$90,000, FY 2014/2015 cost indicated was \$84,600. Carefully track needs and expenses for consideration of possible segregation of individual maintenance events in future reserve updates.

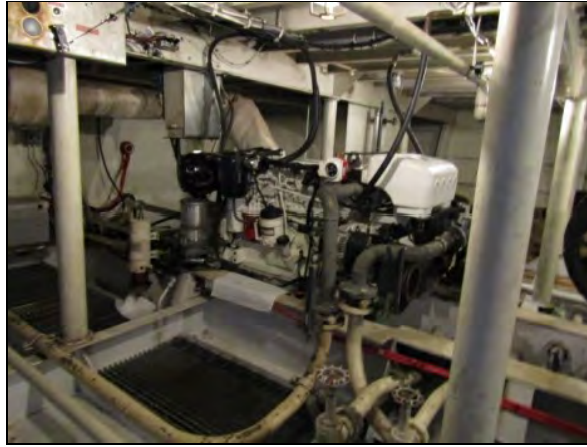
Comments: Replacement of previous two-cycle GM diesel engine with new four-cycle John Deere units in FY 2013/2014. Our previous research informed us that likely overhaul schedule will need to every four year to six year interval (improved from previous historical average of every three years). Overhaul in FY 2018/2019 at reported expense of \$30,600; monitor and update assumption in future reserve updates as conditions warrant.
