Home Inspection Report

4456 Gina Street
Fremont, CA 94538

Date of Inspection: 08/07/2023

Inspection No. 261489-1644

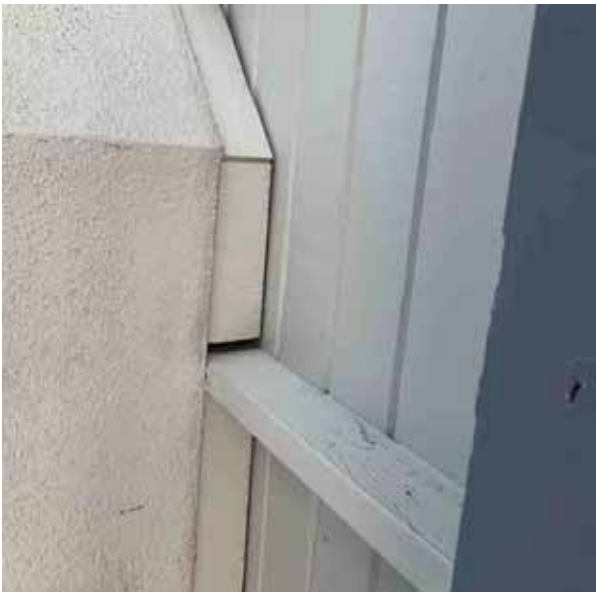
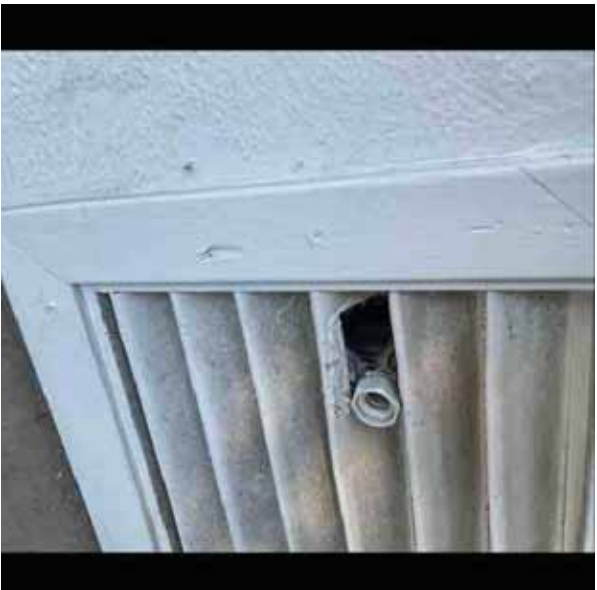
3.3.4 Wall penetrations/voids should be sealed to avoid potential water/pest intrusion. **(Exterior Front)**

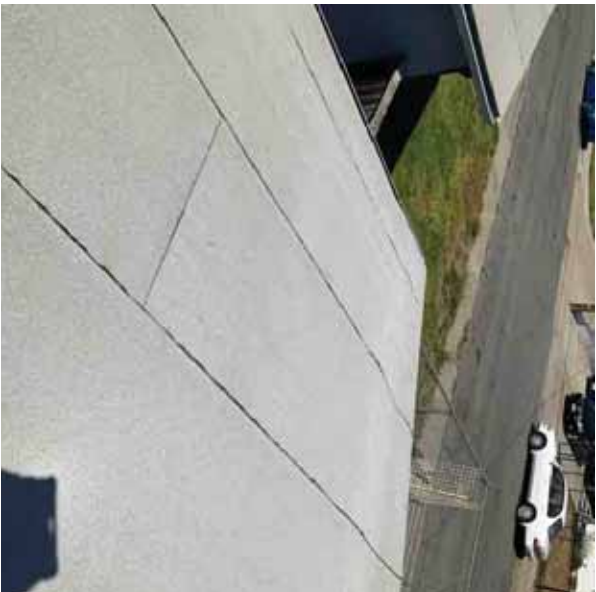
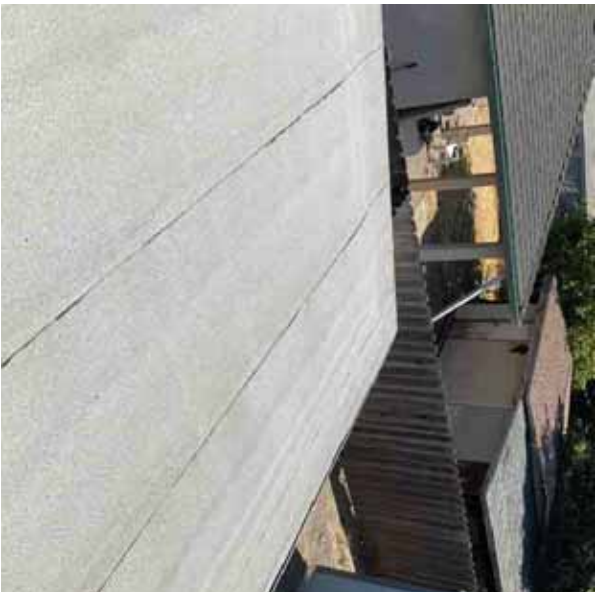
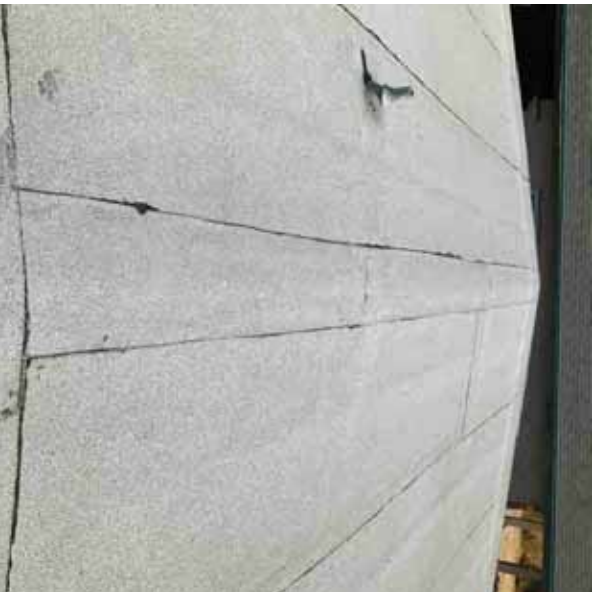
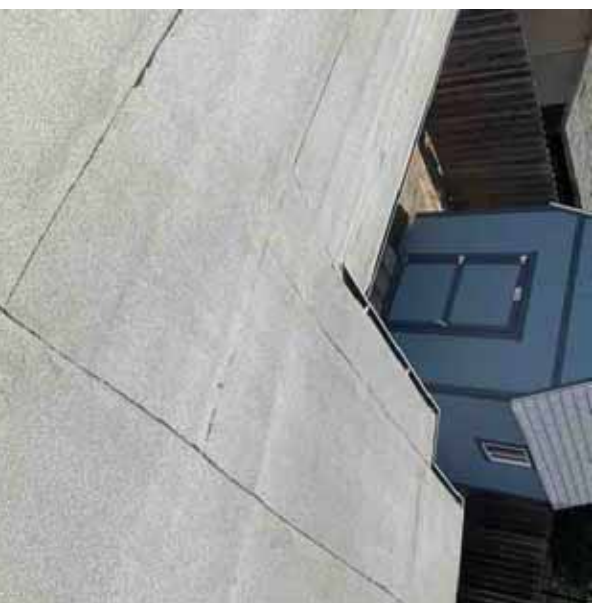
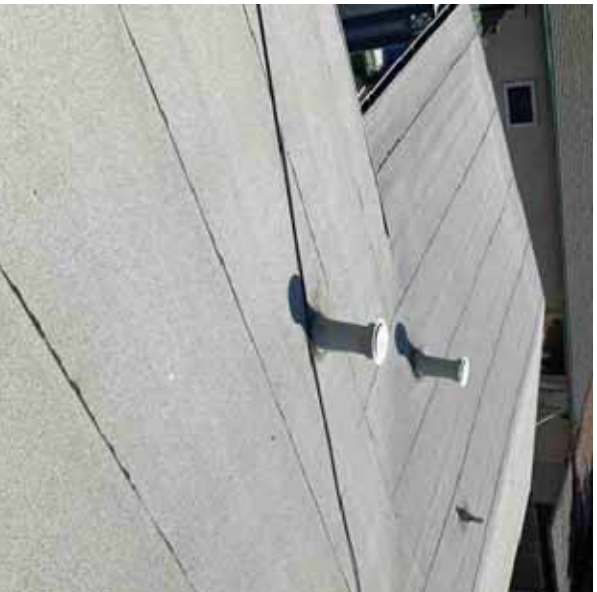
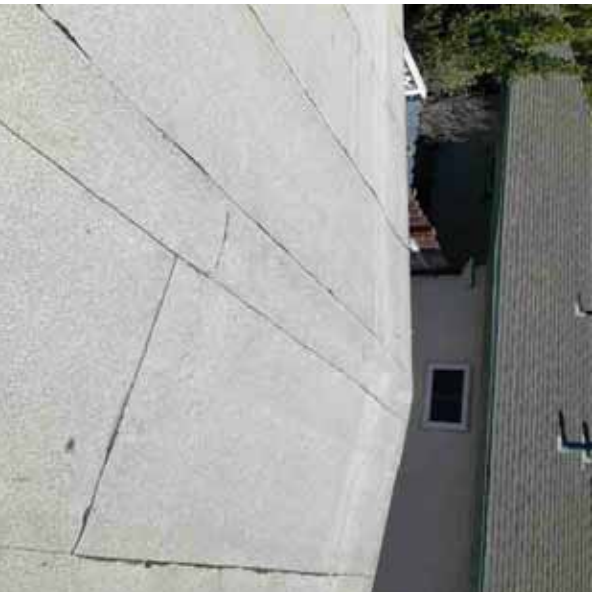
4.3.2 The roofing material has been recently installed, inquire to installation date and any if a transferable builder warranty is available. The company that installed the system has performed a roof inspection prior to listing and has performed recent maintenance. Inquire as to specifics for your information.

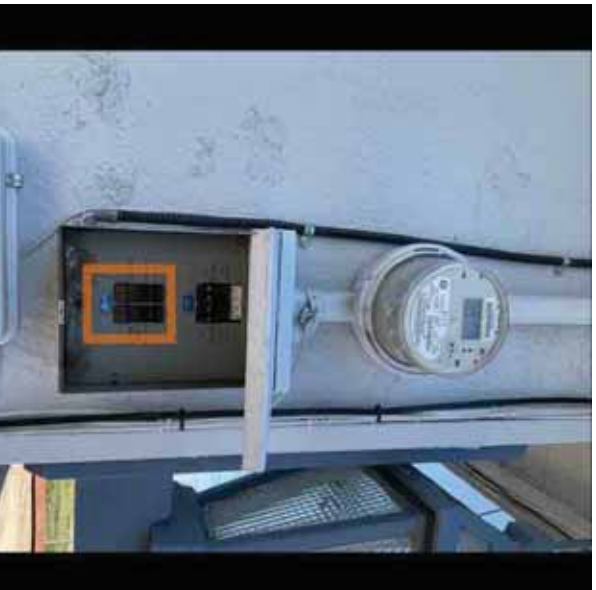
8.5.1 **The electrical meter and emergency disconnect is located on the exterior front side of the building. (Exterior Front)**

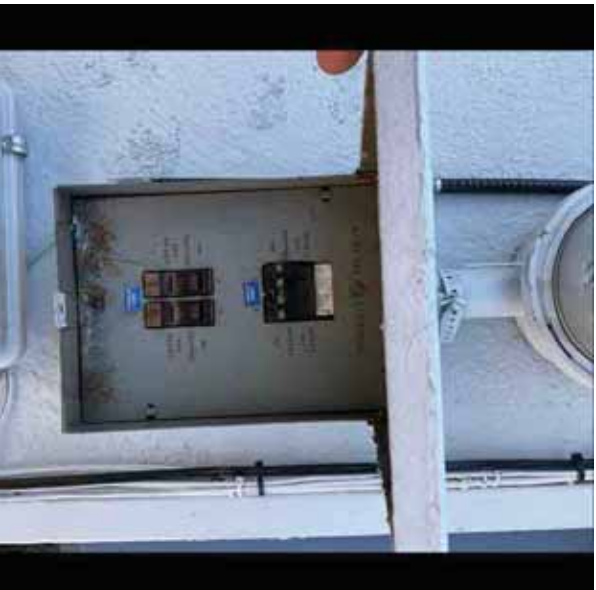
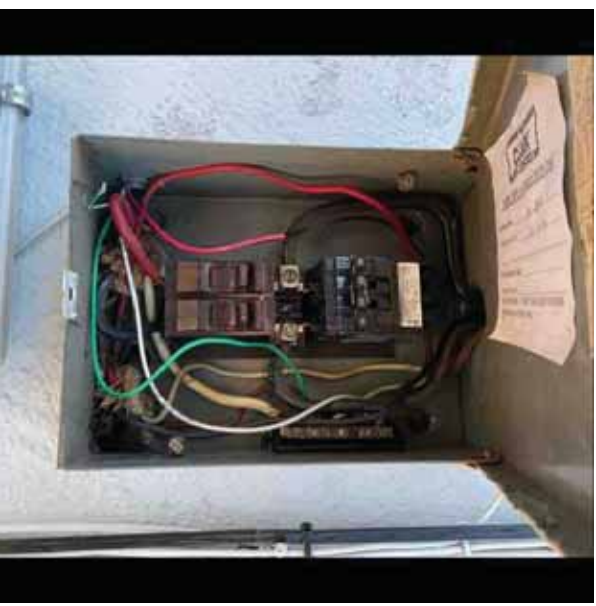
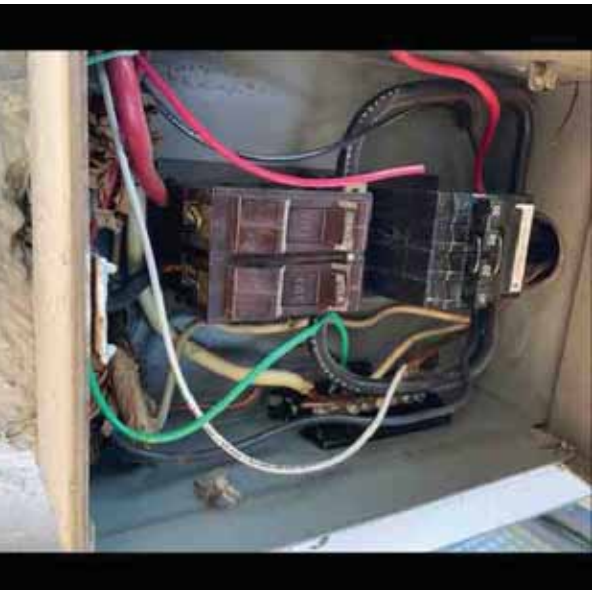
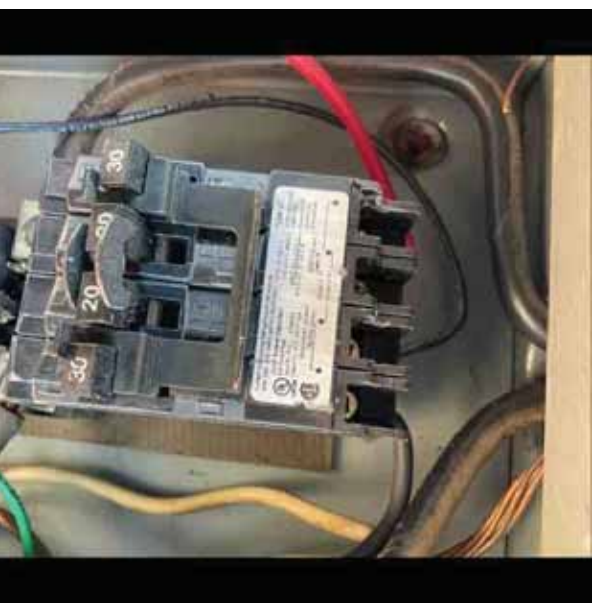
8.6.2 The distribution panel is unlabeled / not fully labeled. The individual circuits should be labeled for convenience. **(Exterior Front)**

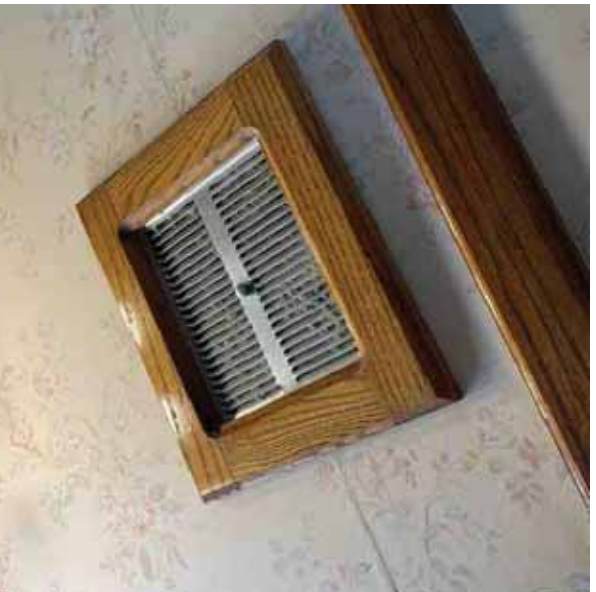
8.12.2 The exhaust fan has dirty grill. Clean as needed for proper ventilation. **(Hallway Bathroom)**

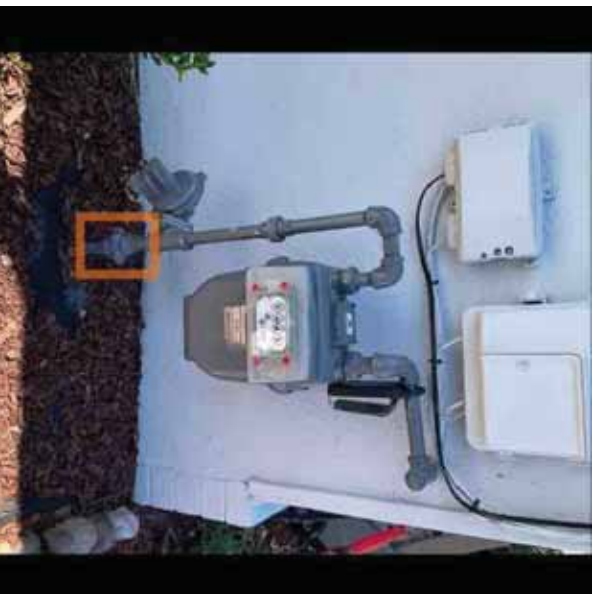
9.5.1 The gas meter and emergency disconnect is located on the exterior front side of the building. **(Exterior Front)**

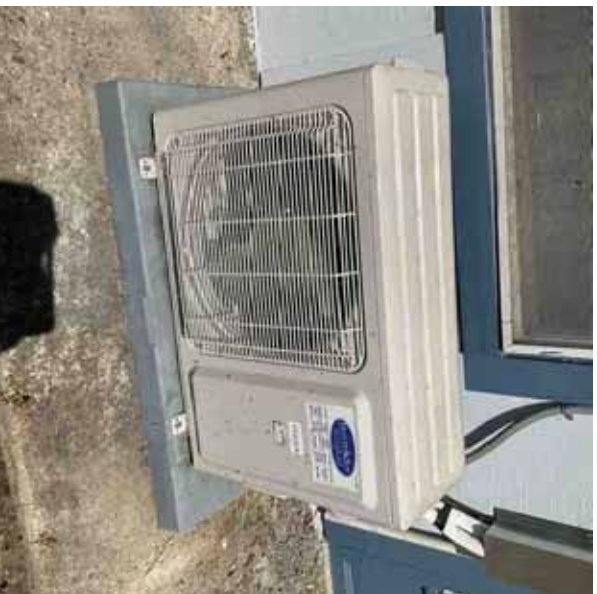
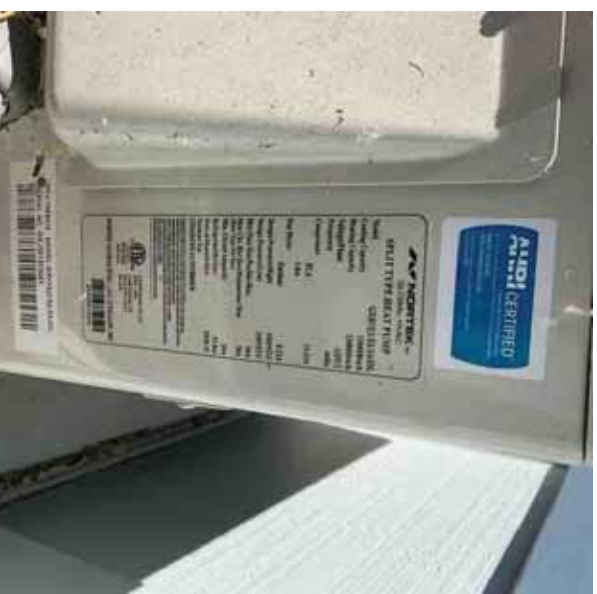
- 9.6.1 According to the average manufacture service life, the typical air conditioner last between 15 - 20 years. The air-conditioner was manufactured in: 2020 **(Exterior Back)**

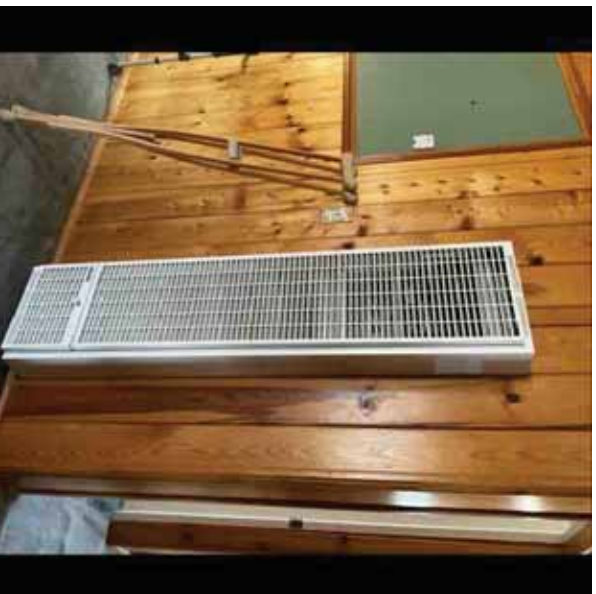
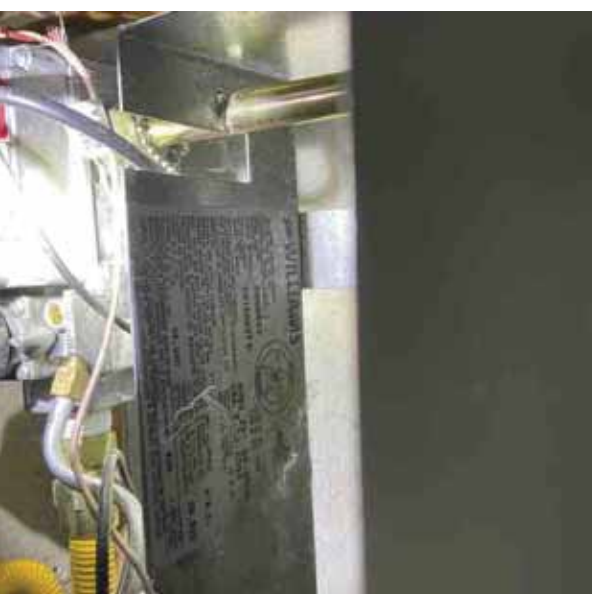
- 9.8.2 The floor / wall furnace did not respond to normal operating controls due the gas line being shutoff. A qualified HVAC contractor should further assess and repair / replace as required to restore proper function. (Hallway)

- 9.8.3 The average life expectancy of a furnace is around 20 years, this unit was manufactured in : 2012

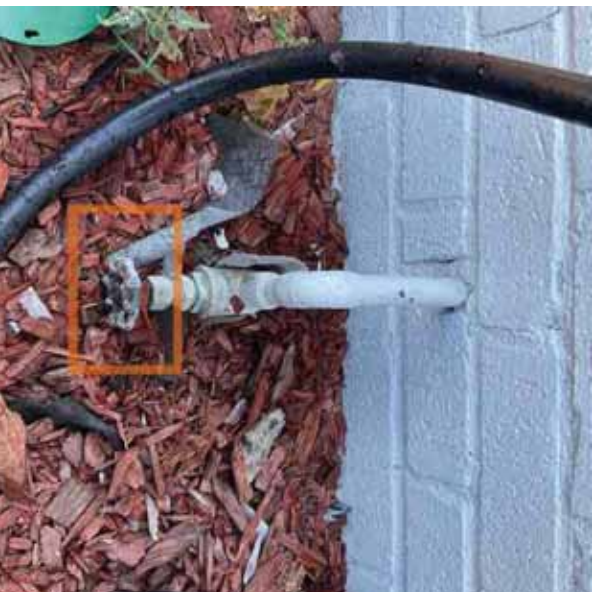
10.3.2 The water main and emergency disconnect is located on the exterior front side of the building however, improvements can be made to the grade for ease of access to the shut off during emergency purposes. **(Exterior Front)**

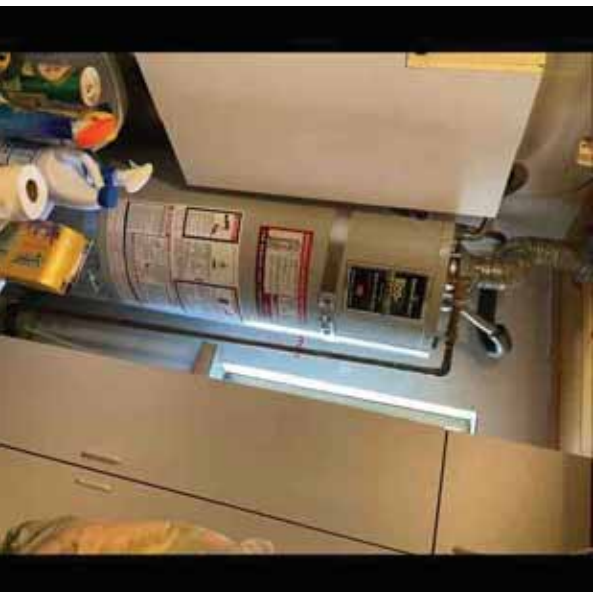
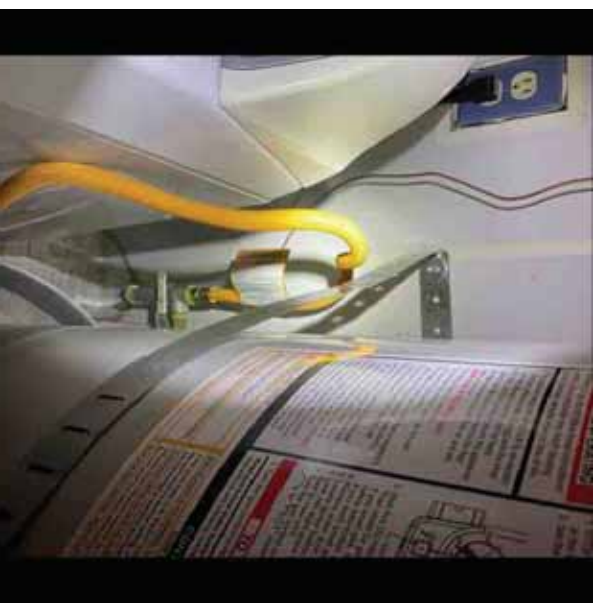
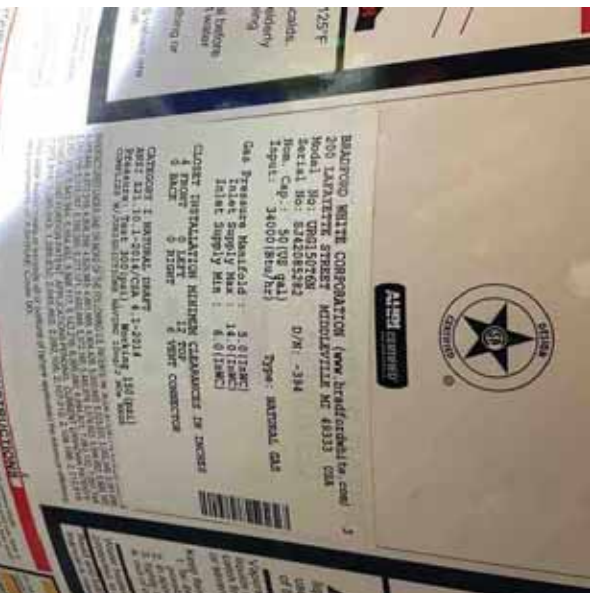
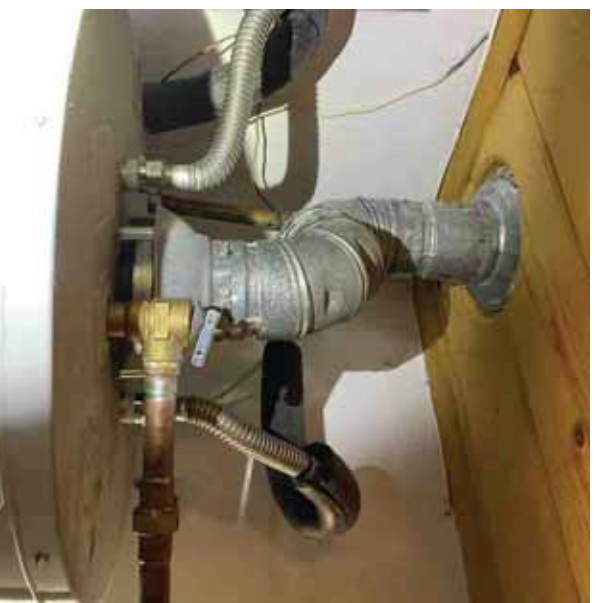
10.6.5 The typical tank type water heater has a life span of 10-15 years. The water heater was manufactured in: 2018 (Garage)

10.6.6 The connection at the pressure relief valve reduces the diameter of the pipe and has the chance to restrict the flow of water in the event it is activated, correct to restore intended function.

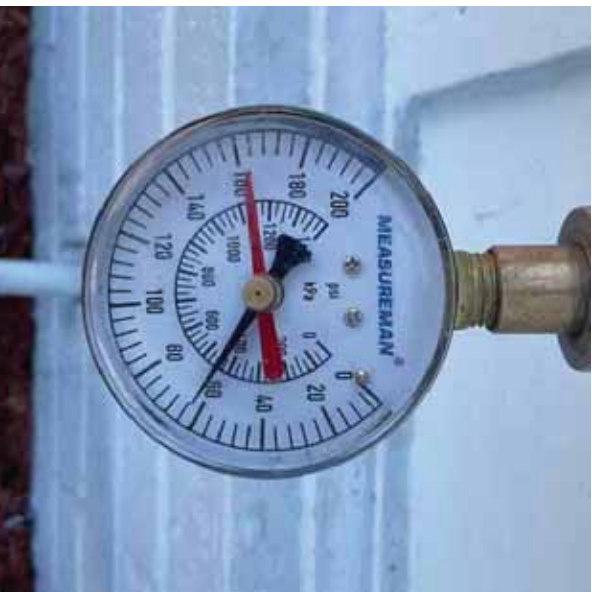
10.8.2 Sample PSI reading was taken from the hose bib and it is within the normal range. (**Exterior Front**)

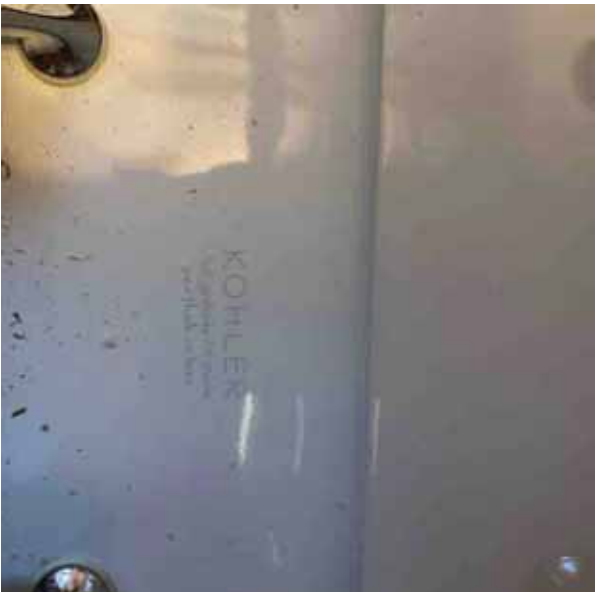
10.11.2 1.6 gpf

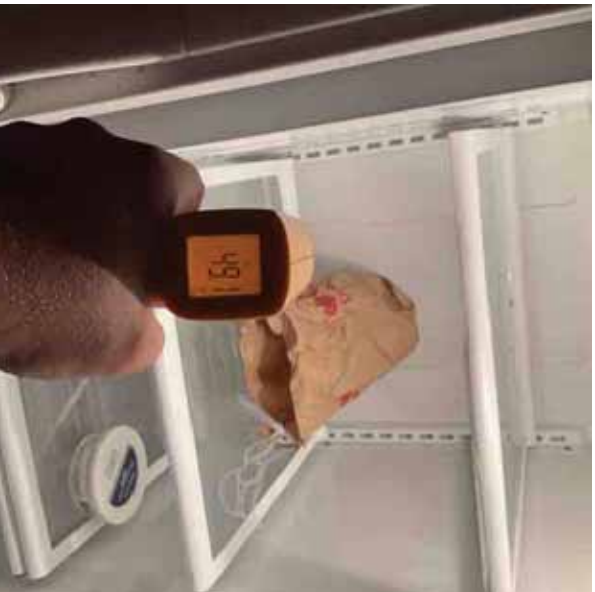
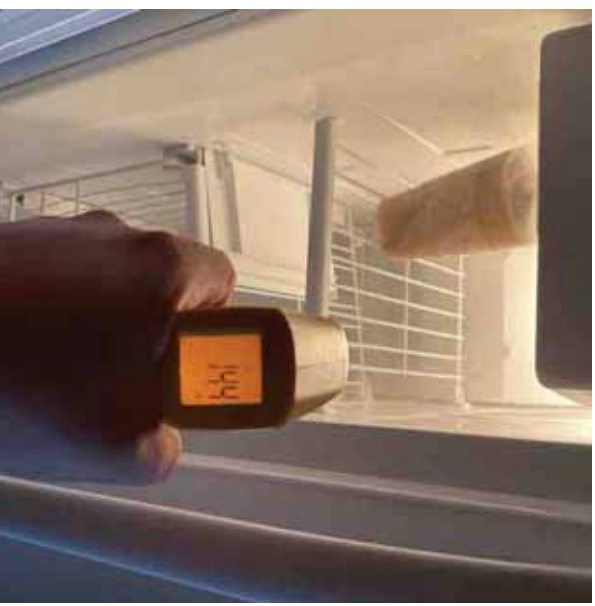
12.1.2 Sample temperature readings from the fridge and freezer. **(Kitchen)**

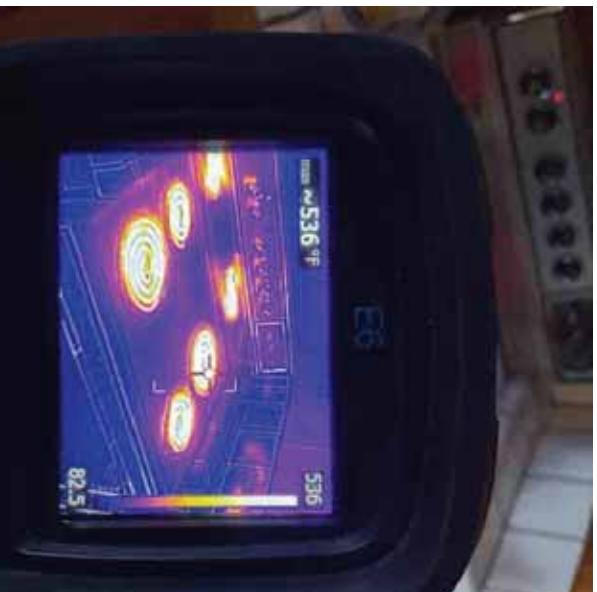
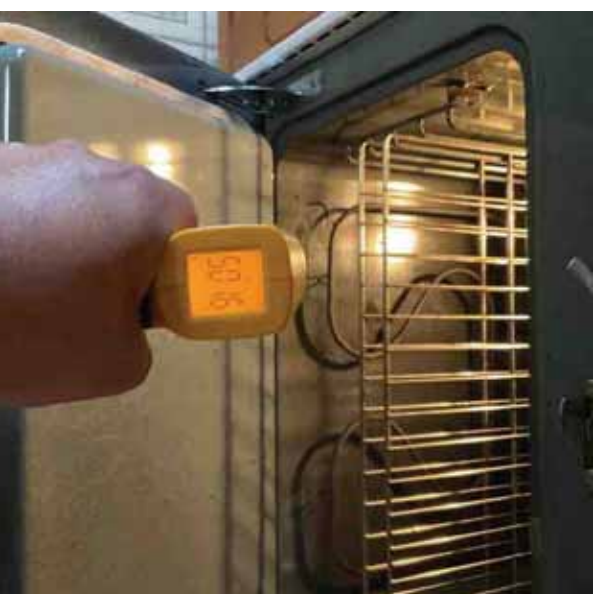
12.2.2 Sample temperature reading from the oven was taken. (Kitchen)
