National Energy
Board

**30 September 2009 release of gas and
subsequent fire at the Enbridge Gas
Distribution Inc. Lisgar Gate Station in
Mississauga, Ontario**

November 2012

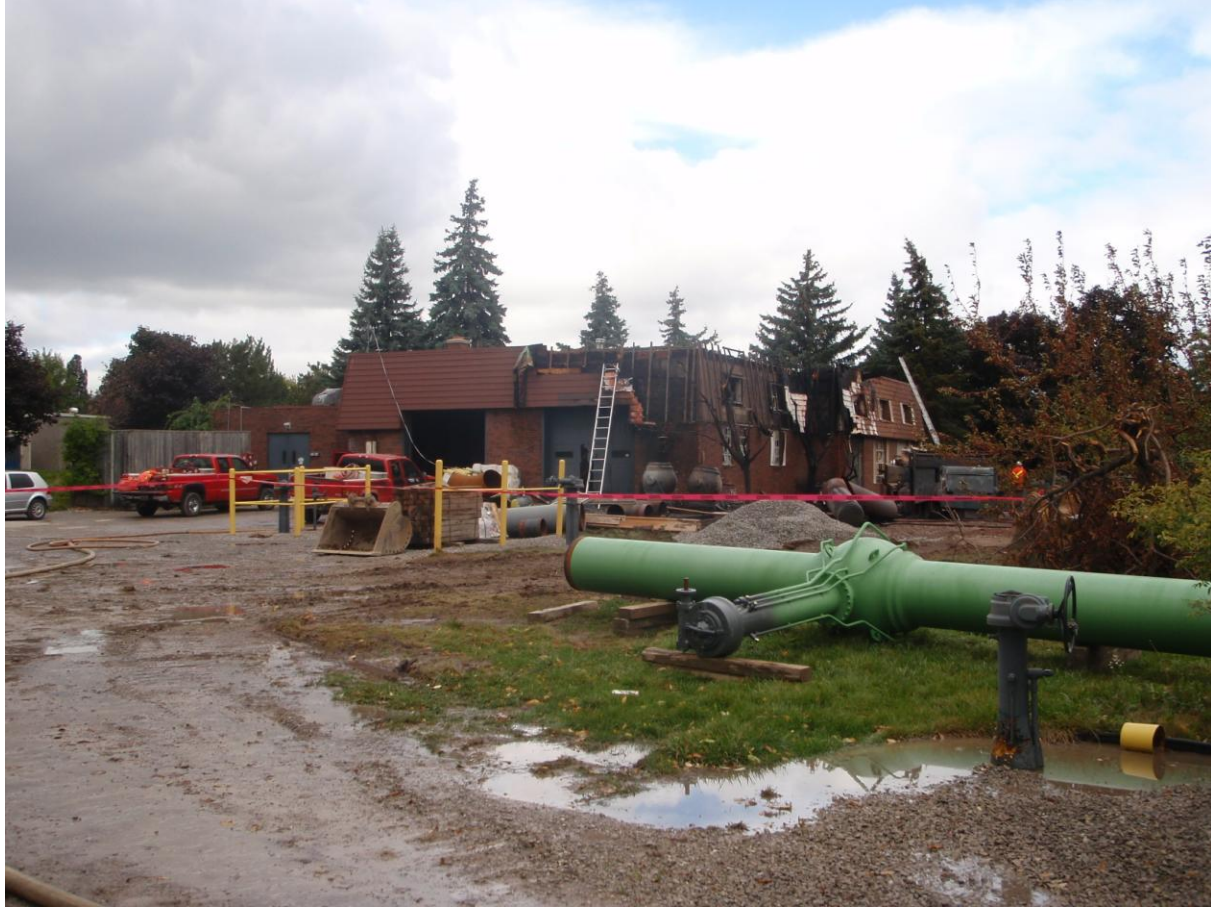
Figure 1. Lisgar Gate Station

The Lisgar Station shown in Figure 1 is located in Mississauga, Ontario, south of Highway 401 on Winston Churchill Boulevard at Aquataine Avenue (Appendix I).
