TECHNICAL MEMORANDUM

Date: 09/29/2021	Study No: 47-1XXIA003, 0000024741
To: Pavement Analysis and Design Branch	Tech Memo No: NTP 22-01-1
From: Research Team	Revision No:
Subject: Pavement Evaluation of Roller Compacted Concrete Pavement in Leahey

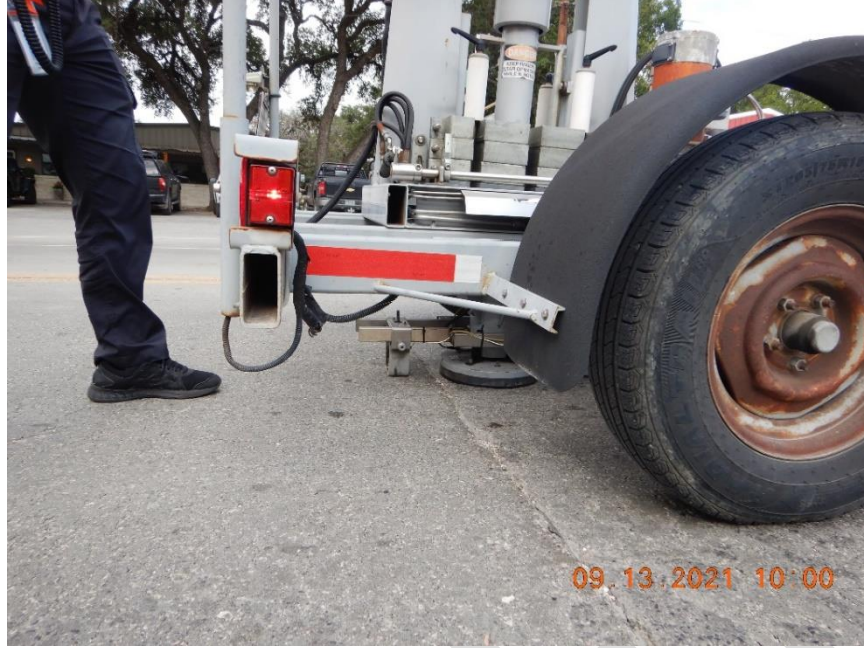
Figure 14 FWD testing at downstream of the joint of RCC pavement

FWD testing was conducted on both north- and south-bound lanes on US 83 for 3500-ft from the south end of the project. For RM 337, FWD testing was conducted eastbound direction only from the west end of the project to US 83, a total of approximately 2500-ft. To evaluate load transfer efficiency (LTE) at transverse contraction joints and cracks, a total of 17, 19 and 5 locations were selected on US 83 northbound, southbound and RM 337, respectively, and FWD testing conducted. Tables 1 through 3 show the locations of the joints and cracks selected for LTE evaluations. Here, the locations with Joint x were are those where FWD testing was conducted previously by MNT, while the locations with Sx are where FWD testing was conducted in this investigation. For LTE evaluation at each joint, FWD drops were made at 4 locations – mid-slab, upstream and downstream of the joint, and mid-slab. Figure 14 shows FWD testing at downstream of the joint.

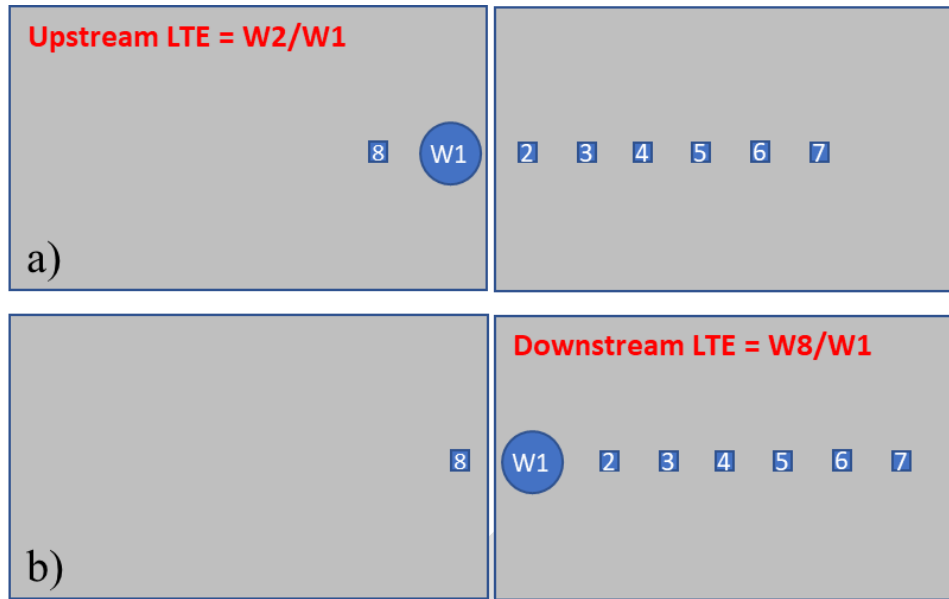
Figure 15 FWD sensor configurations for (a) upstream and (b) downstream LTE determination

Here, δ_U and δ_L are deflections at the unloaded and loaded side, respectively. The configuration of sensors during the LTE testing for upstream and downstream are shown in [Figure 15](#). At a joint or a crack, 2 LTE values are evaluated – one for upstream and the other for downstream. For upstream LTE, W_1 becomes δ_L and W_2 is δ_U , while for downstream LTE, W_1 becomes δ_L and W_8 is δ_U ,
