MDT EE Pit Commissioning Results and Status on MDT Configuration DB Works

Hok-Chuen Cheng
(University of Michigan)
28 May 2013

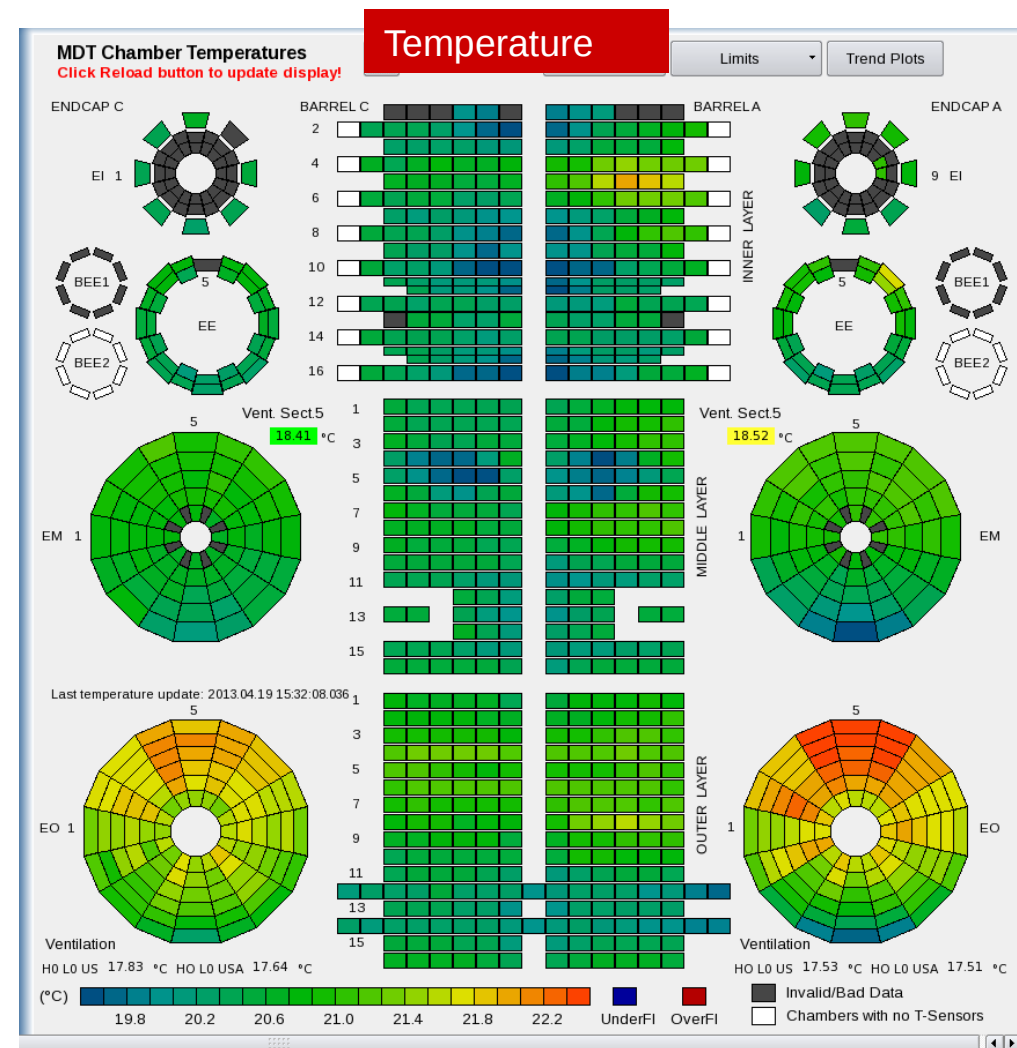
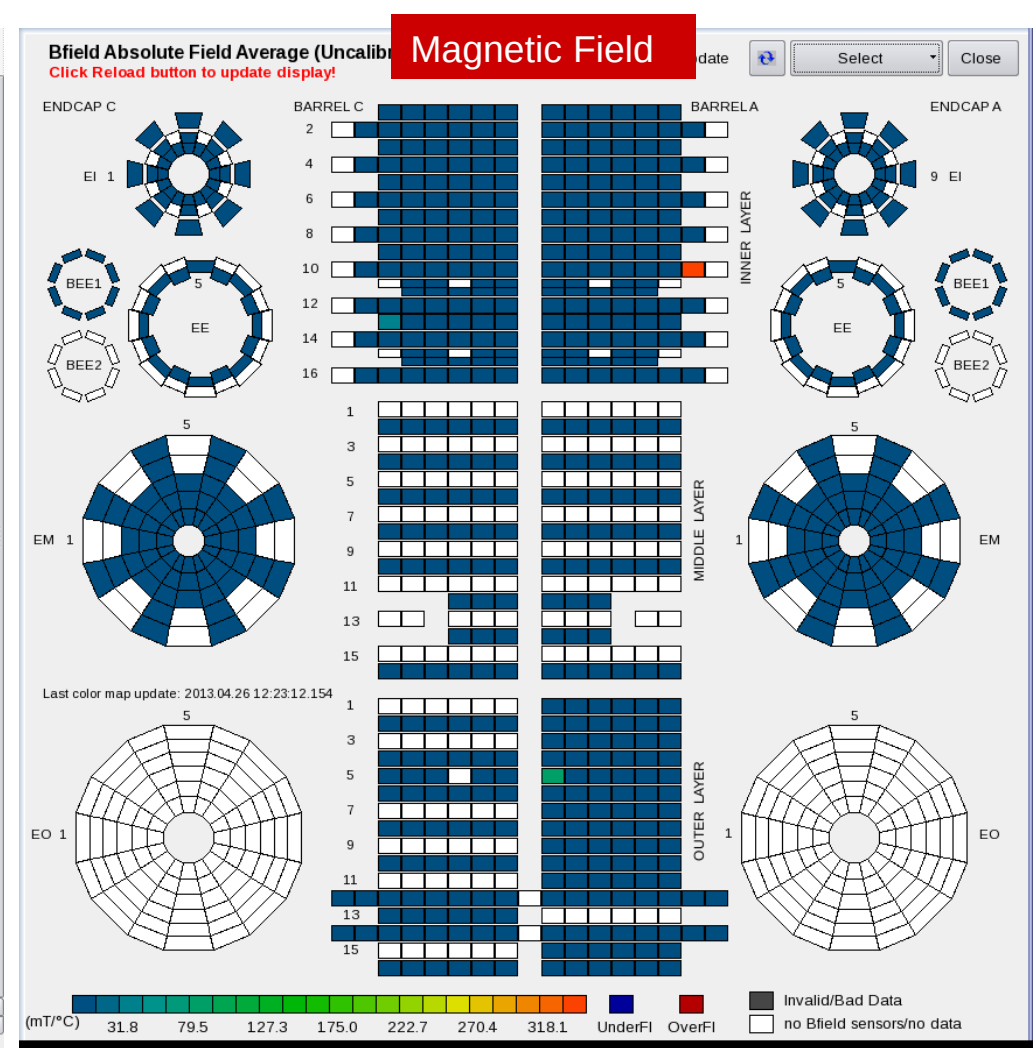
Temperature and Magnetic Sensors

- Checked all sensors in all chambers
 - EE A-side OK in the DCS FSM except for 1 chamber T sensor

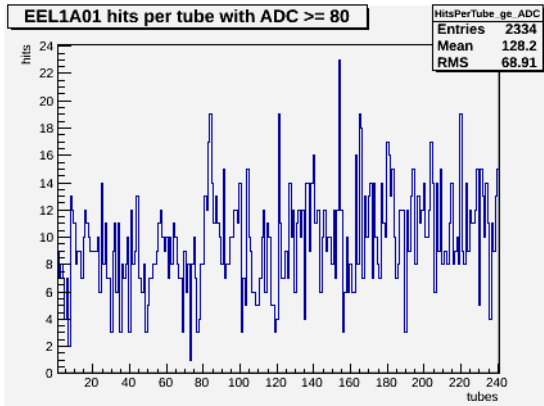
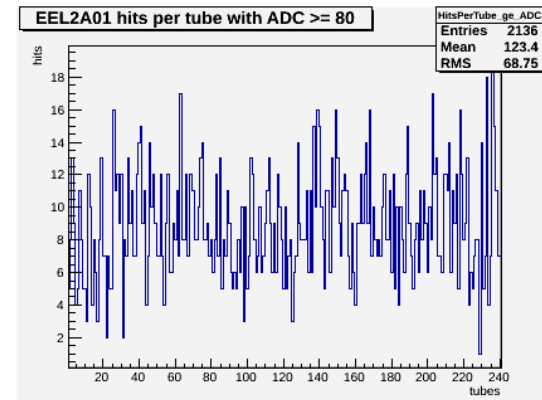
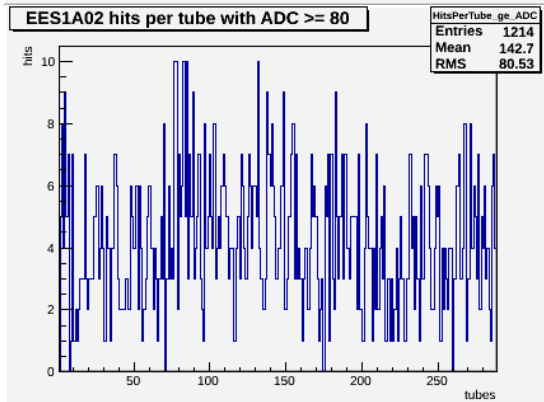
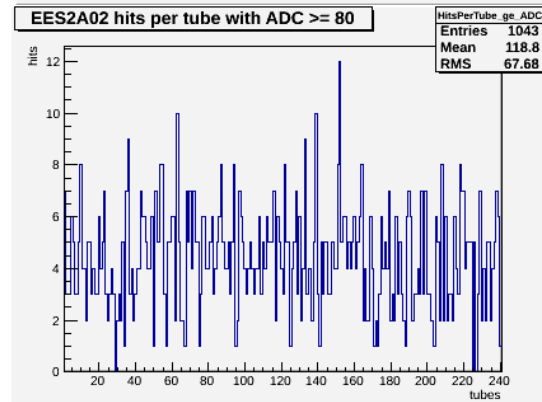
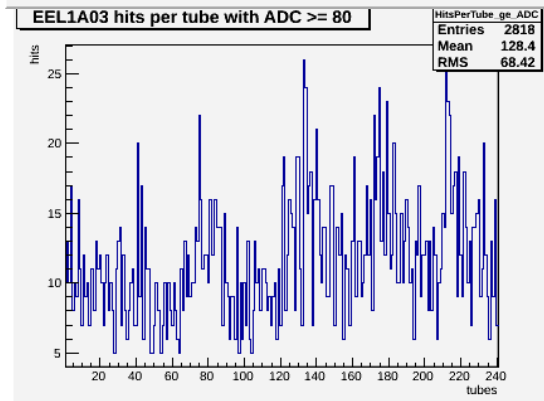
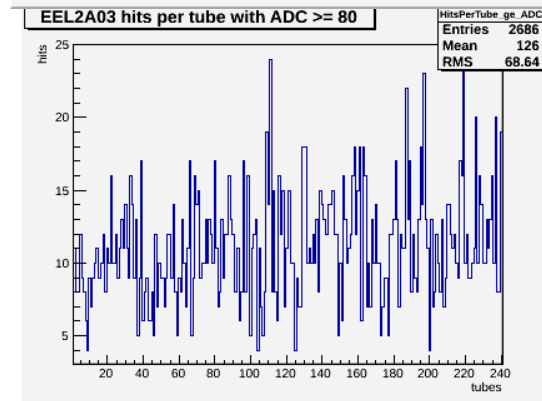
Dead tubes determined by hits per tube with $ADC \geq 80$
