## The Role of Forensic Engineering in the Diagnosis of Electrocution Fatalities: Two Case Reports

#### 3.1. Case report 1

### 3.2. Case report 2

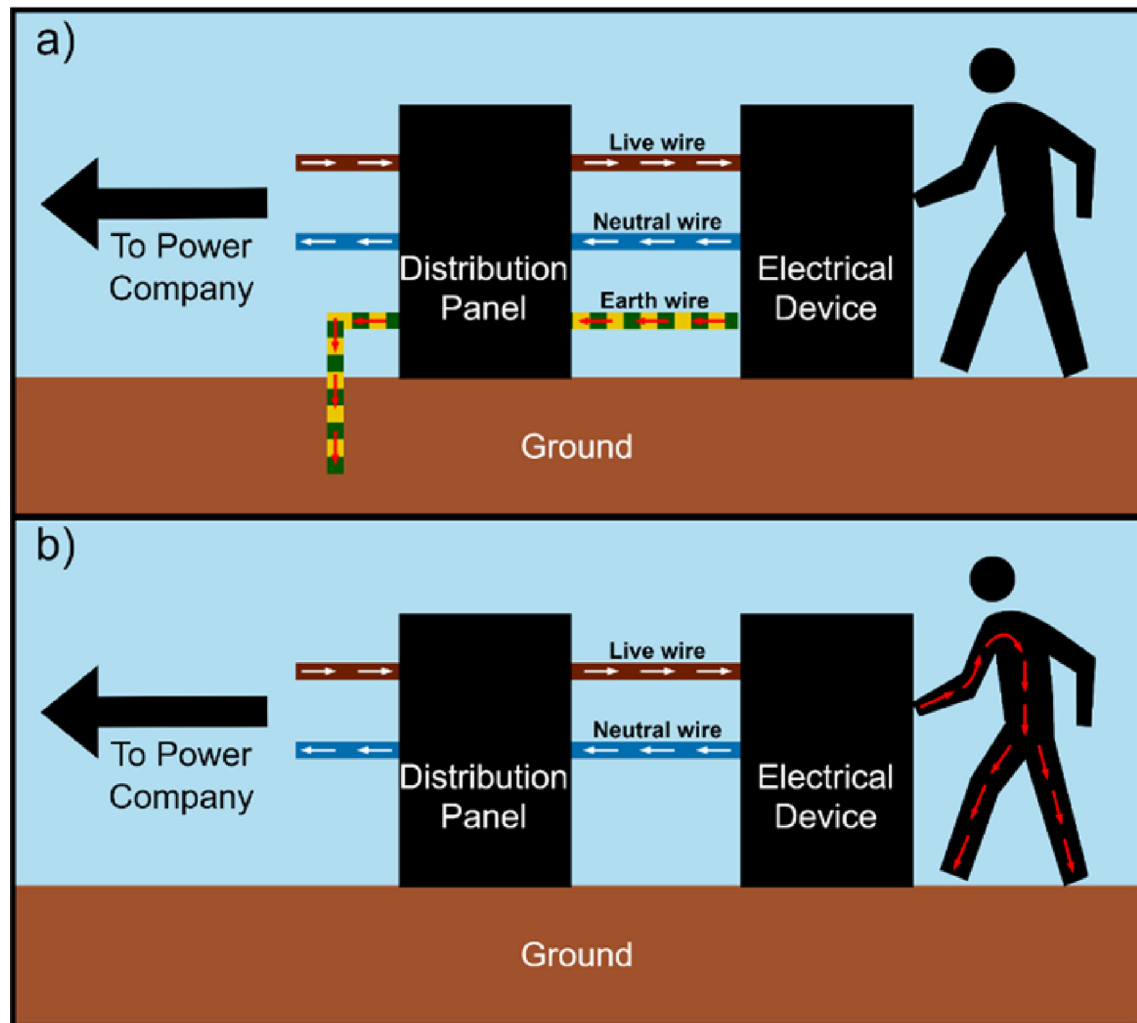
missing in the event of a fault, the current will take an alternate path to the ground. If the body makes contact with the wire, the current can enter and exit the body, leading to electrocution if the current is high enough [4,10]. Hence, this is why the presence of the earth wire is crucial. Fig. 7 demonstrates the path of the current when the earth wire is present or absent. The electrical device indicates the device that contains the fault. In the figure, the white arrows indicate the current path in the absence of a fault, while the red arrows indicate the current path during a fault. The color codes introduced previously for the live, neutral, and earth wires are applied here.

Fig. 7a indicates the flow of the current when all three wires are present in the cable. The current path is from the power company to the distribution panel and then to the electrical device. The current is subsequently returned to the power company through the neutral wire. In the event of a fault, the earth wire will carry the fault current through the electrical device and ground it. If a person is in contact with a faulty electrical device, they will not be affected as the fault current takes the lowest resistance path through the earth wire rather than the high resistance path through the human

Fig. 7. Diagram demonstrating electric current path during a fault when (a) earth wire is present and (b) earth wire is absent.

body. In Fig. 7b, the earth wire is absent, which leads the current to flow through the body of the person making contact with the electrical device to the ground during the fault instead of its usual route through the earth wire. This current path can lead to electrocution if the amount of the current exceeds the maximum amount of current that the human body can tolerate.
