Women in Aerospace

University of Illinois at Urbana-Champaign

1. Rocket Operation Assessment

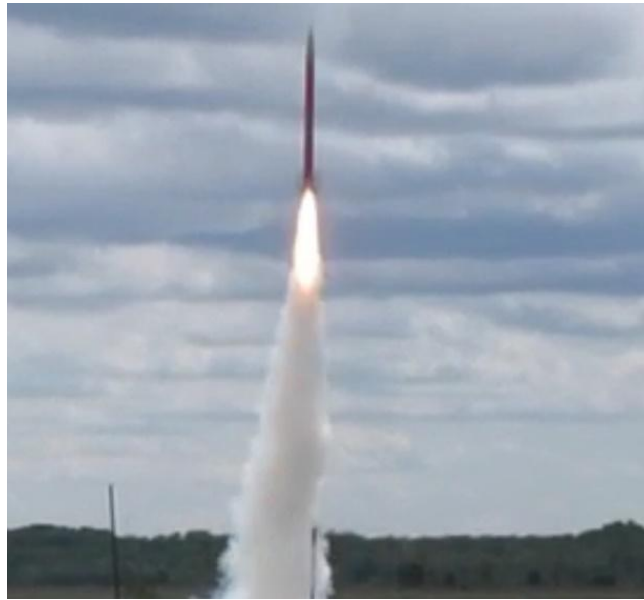
The flight paths for both were as expected, with the rocket going almost straight up with minimal deviation on each launch. A photo of the second launch can be seen in Figure 1.

Figure 1. Still from the second flight of the rocket.

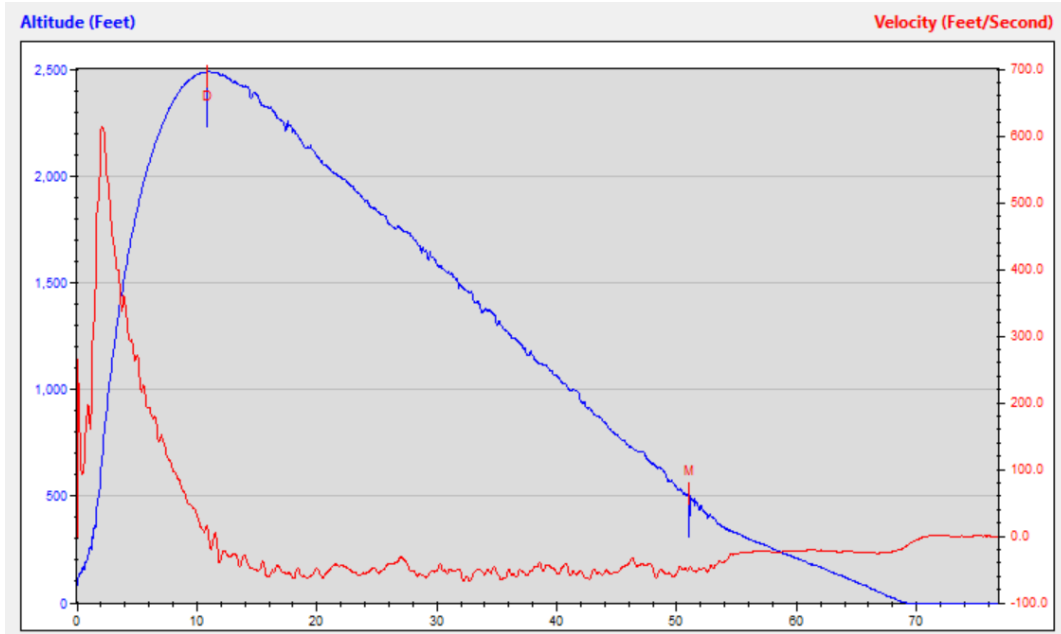
Figure 6. Altitude and velocity data collected from the Stratologger for the first flight.

In both flights, the actual peak velocity was higher than the predicted velocity. The predicted J motor peak velocity was 495 ft/s, while the peak velocity of the first flight was 610 ft/s. This may have been due to assuming a higher coefficient of drag for the rocket during the flights without active drag than the actual value. The predicted K motor peak velocity was 695 ft/s, while the peak velocity of the second flight was about 950 ft/s. As can be seen in figure 7, the Stratologger did not record very good data during motor burn, as evidenced by a reading of 4000 ft/s.
