# Post-Flight Report

University of Wisconsin - Platteville

Pioneer Rocketry

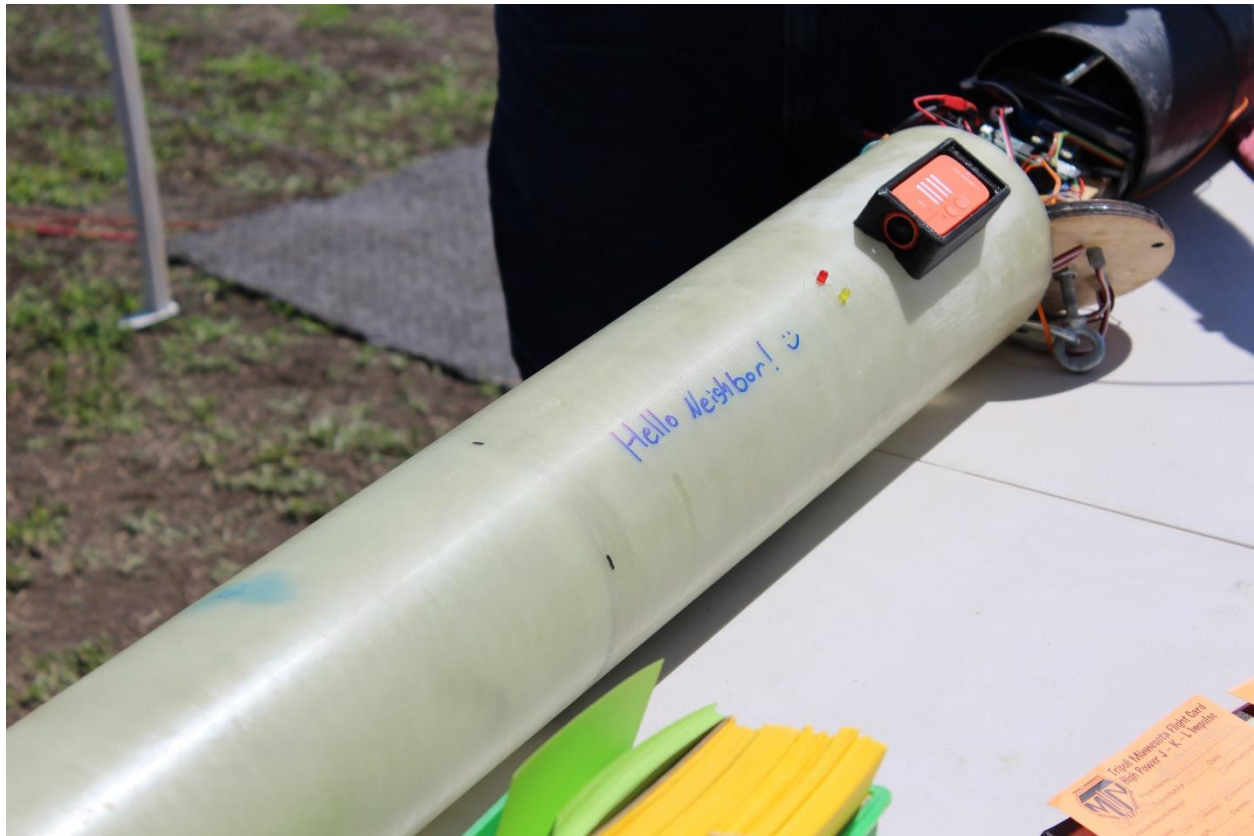
Unfortunately, due to electronics problems, we were not able to get the rocket to a flight ready state within the 1-hour time limit. However, the pre-launch procedure did get us to a state where we could launch the rocket. There were no missing steps in the procedure to prepare for launch, and due to this we had a successful launch. The post-launch procedure guided us through the process of retaining flight data, along with taking pictures of the final landing location before touching the rocket. Figure 6 shows the rocket almost entirely prepped for launch.

*Figure 6 Mr. Rogers being prepared for launch.*
