MEMORANDUM

From: Bulldog Rocketry

Subject: Bulldog Rocketry 5-2-15 Test Launch Summary

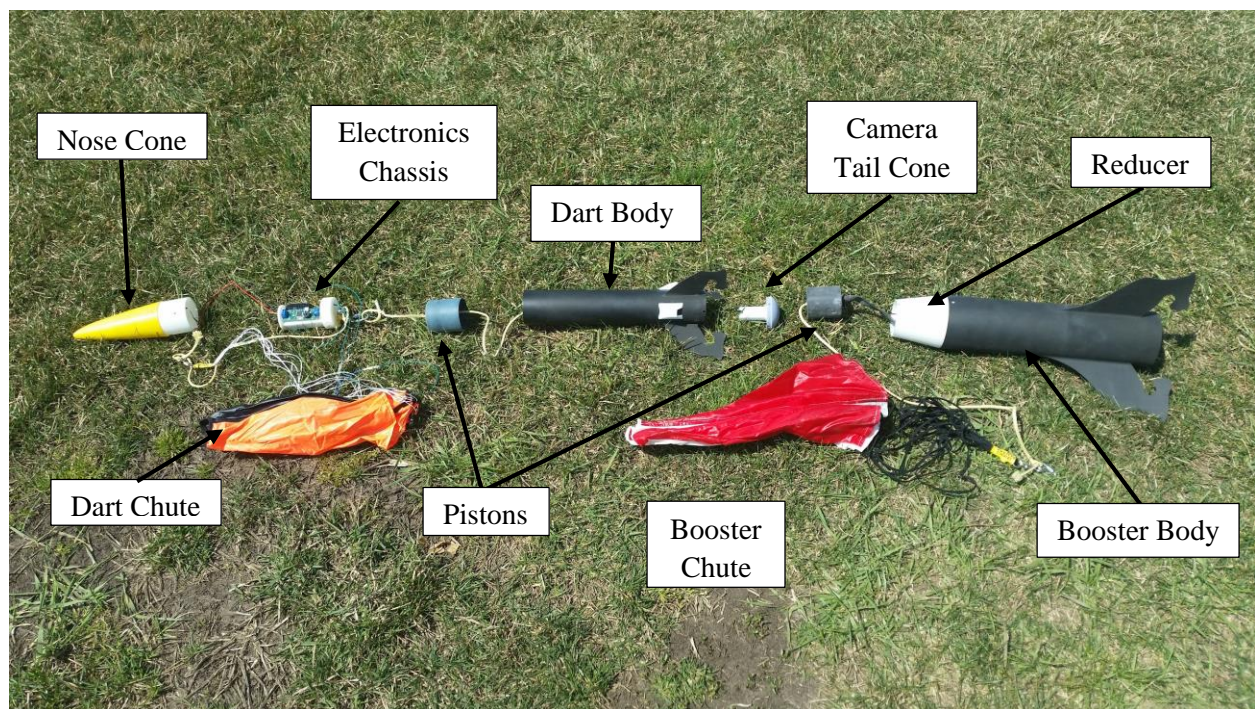
Figure 3: Major component layout of the rocket

After the preliminary design, the rocket needed further design work in order to achieve a stable rocket prior and after burnout. In order to accomplish a stable rocket, the booster fins became extremely large to assist in relocation of the center of pressure (CP). However, having the fins extremely large made them less rigid and became a concern. Bulldog Rocketry decided to move towards alternative materials in the booster, so the mass could be reduced, which resulted in making the fins smaller. The material of choice was PA 802-CF, which is a carbon fiber nylon 11 used in a laser sintered 3D printer. Using this material allowed for the booster's mass to be just one third that of the original booster design. This increased the stability of the overall rocket, along with allowing for the ability to give the dart more of the momentum.
