Post-Flight Performance Report

Wichita State University

Team RISE

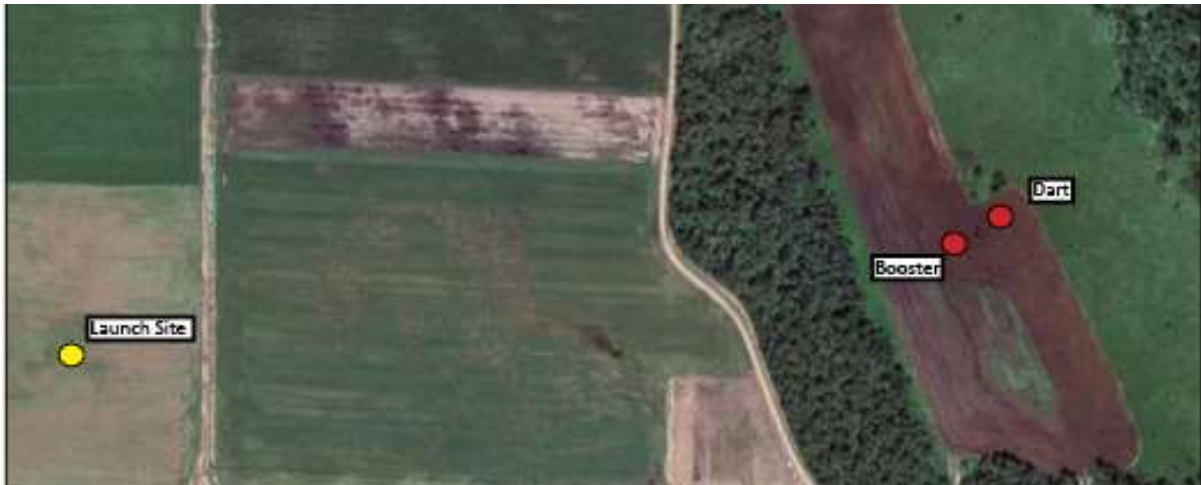
Location for the booster and dart after the second launch can be seen in Figure 5. Since both parachutes were easily spotted immediately after they were safely deployed, landing site was estimated to be somewhere after the tree line located East of launch pad. There was no need to use the radio tracker since both parachutes were also spotted on the ground. The booster and dart were recovered in perfect conditions

Figure 5. Location of recovered parts after second launch.

with no damage to the structure or the electronics.

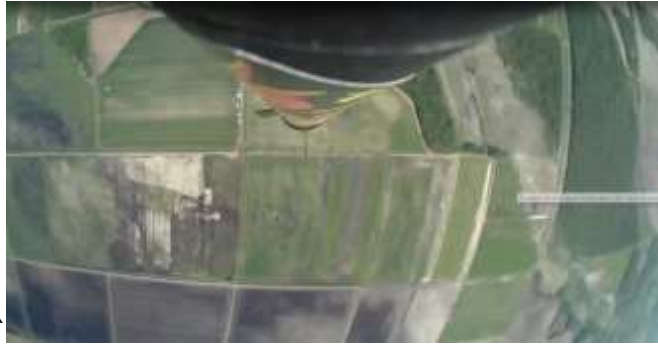
On-board video was successfully recorded during both launches with a direct downward view using the 808 Keychain Camera with a lens mounted externally to the dart using an extender cable. This camera records HD footage at 30 frames per second. The launch pad is visible during the entire ascent. Separation and dart parachute ejection could also be easily viewed in the footage. Figure 7 is an example screenshot from the on-board footage. For part of the flight where rotation was significantly higher (approx. >5rps) the video became warped and curved as seen in Figure 8.

Figure 7. *View from onboard camera.*

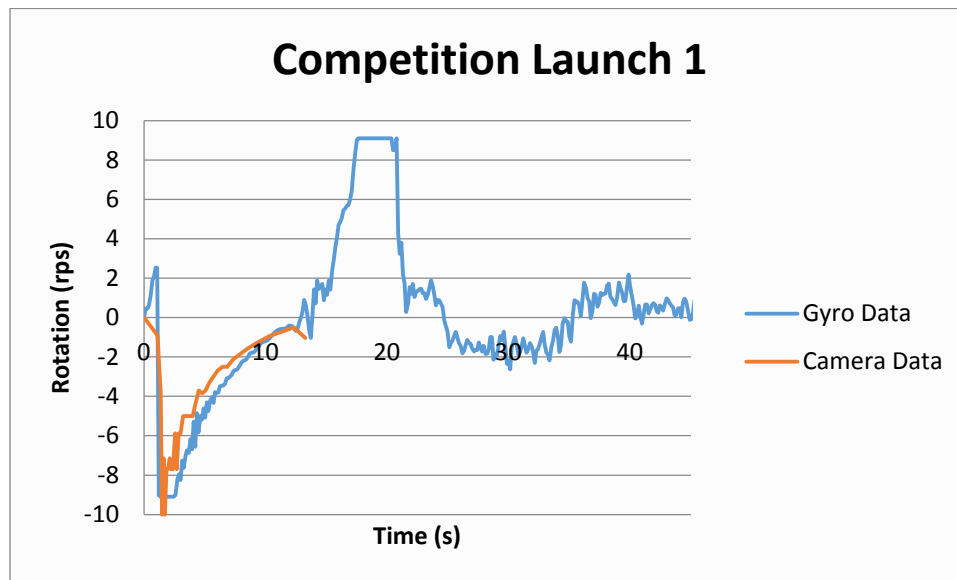
To compare the collected data to the on-board video, the video was observed and time stamps were hand recorded using a reference point on the ground. Due to the high spin rate, the footage became warped during sections and therefore no rotation data could be collected from it. The two rotation rates during flight can be compared in the two graphs in Figures 9 and 10 for both flights. There was some error in rotation found for the rotation logger, but there could also be large error in recording rotation by eye from the on-board footage.

Figure 9. *Launch 1 Gyro Data Comparison*

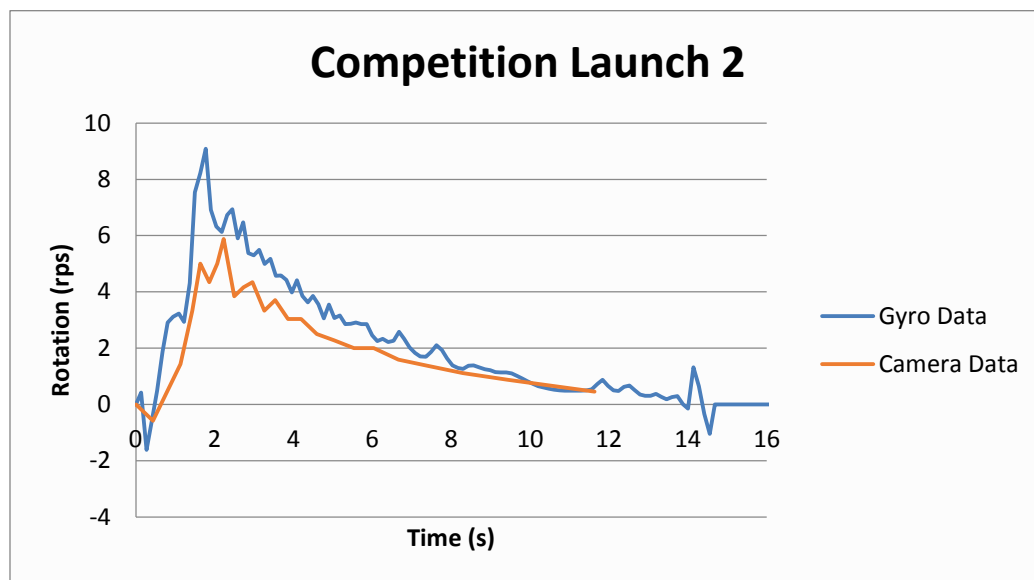
Figure 10. *Launch 2 Gyro Data Comparison*
