Inspection Report

Property Address:
98 Woodmere Road
West Hartford Ct 06119

Date of Inspection 6-20-2013

Premier Home Inspection, LLC

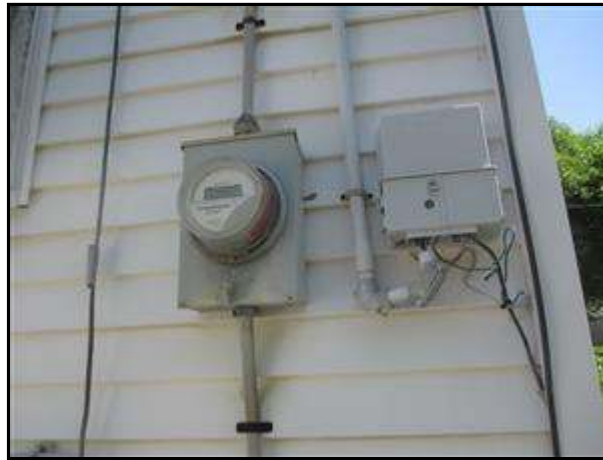
1.16 Picture 1 Roof

Observation: The electrical service entry at the time of the inspection shows no major issues, such as water intrusion, frayed wiring, etc. The box seemed secure and tight to the home.

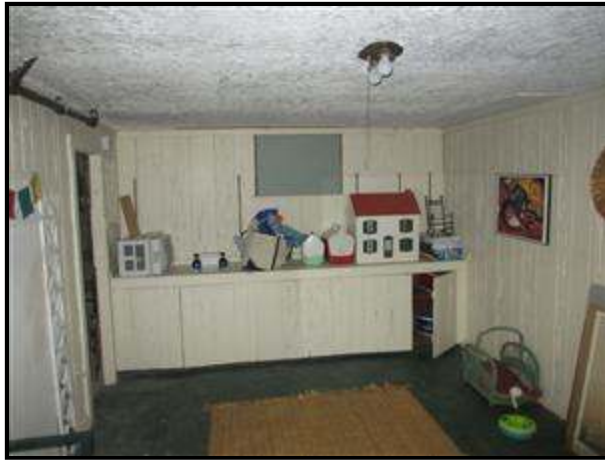
Basement

> I was unable to view the foundation, sill, load bearing girder and the sub flooring.

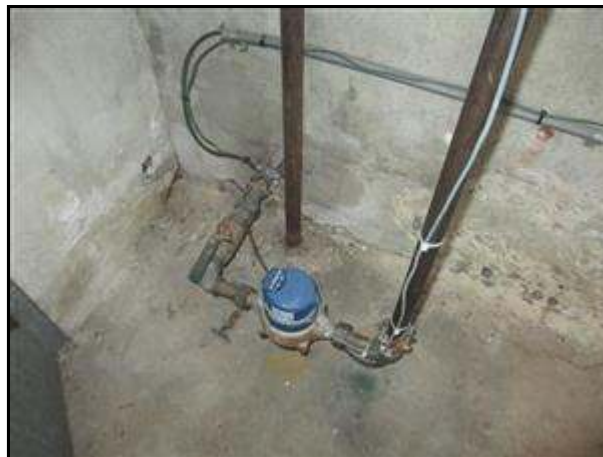
7.9 Picture 1 Water Shut off

Observation: The main water shut off is located in the basement at the back of the wall when you enter the

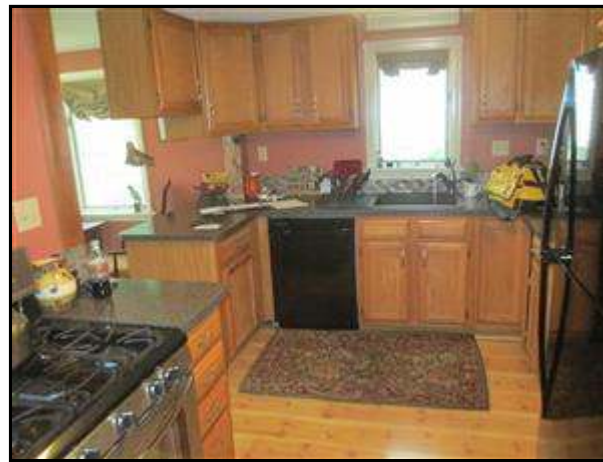
8.0 Picture 1 Kitchen

Observation: I ran the faucet water and the water volume appears adequate, I ran the hot and cold water and found no major defects. I did note shut offs under the sink. No leaking was noted from them at the time of the inspection.

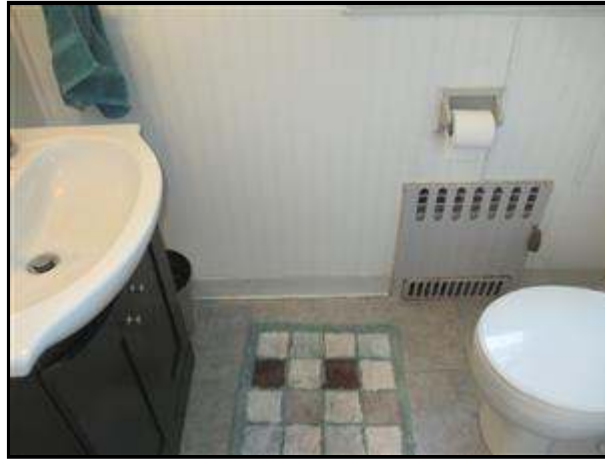
10.0 Picture 1 Bathroom

Observation: No leaks were noted at the time of the inspection.

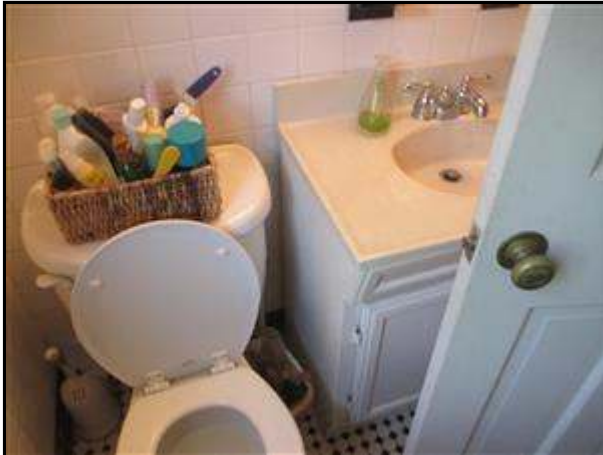
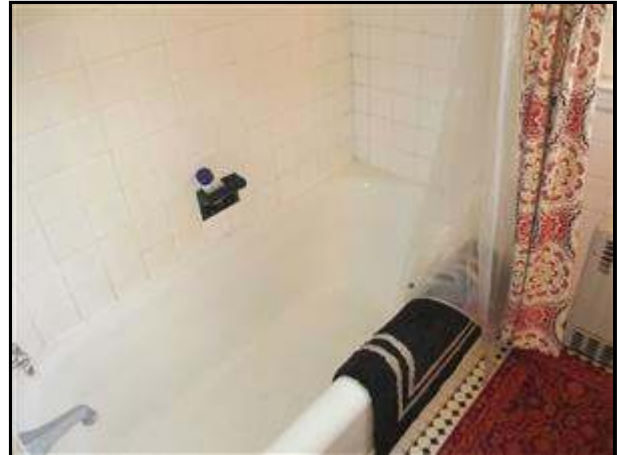
Observation: No leaks were noted at the time of the inspection.**11.1 Sink and Hot water Temp.****Comments:** Inspected**Observation:** Water Volume appears adequate; I ran the hot and cold water and found no major defects.**11.2 Tub/Shower****Comments:** Inspected**Observation:** I ran water into the tub and it held water, the water temperature was acceptable both hot and cold. The tub also drained at a normal rate.**11.3 Tile/Fiberglass Wall****Comments:** Inspected**Observation:** The bathroom walls around the tub are tile, no major defects were found and the caulking appears to be in good condition.**11.4 Toilet****Comments:** Inspected**Observation:** I flushed the toilet and it did function properly, it is tight to the floor. I did not note any leaking at the time of the inspection.**11.5 GFCI/Electrical/Fan****Comments:** Inspected
