# N238PS — G1000 LOW VOLTS Troubleshooting Guide

**Aircraft:** N238PS (Diamond DA40NG, MAM40-858) **Problem:** G1000 NXi displays lower voltage than actual bus voltage, causing intermittent LOW VOLTS annunciations **Date:** February 2026 **Prepared by:** Aircraft Owner (Ingram Leedy)

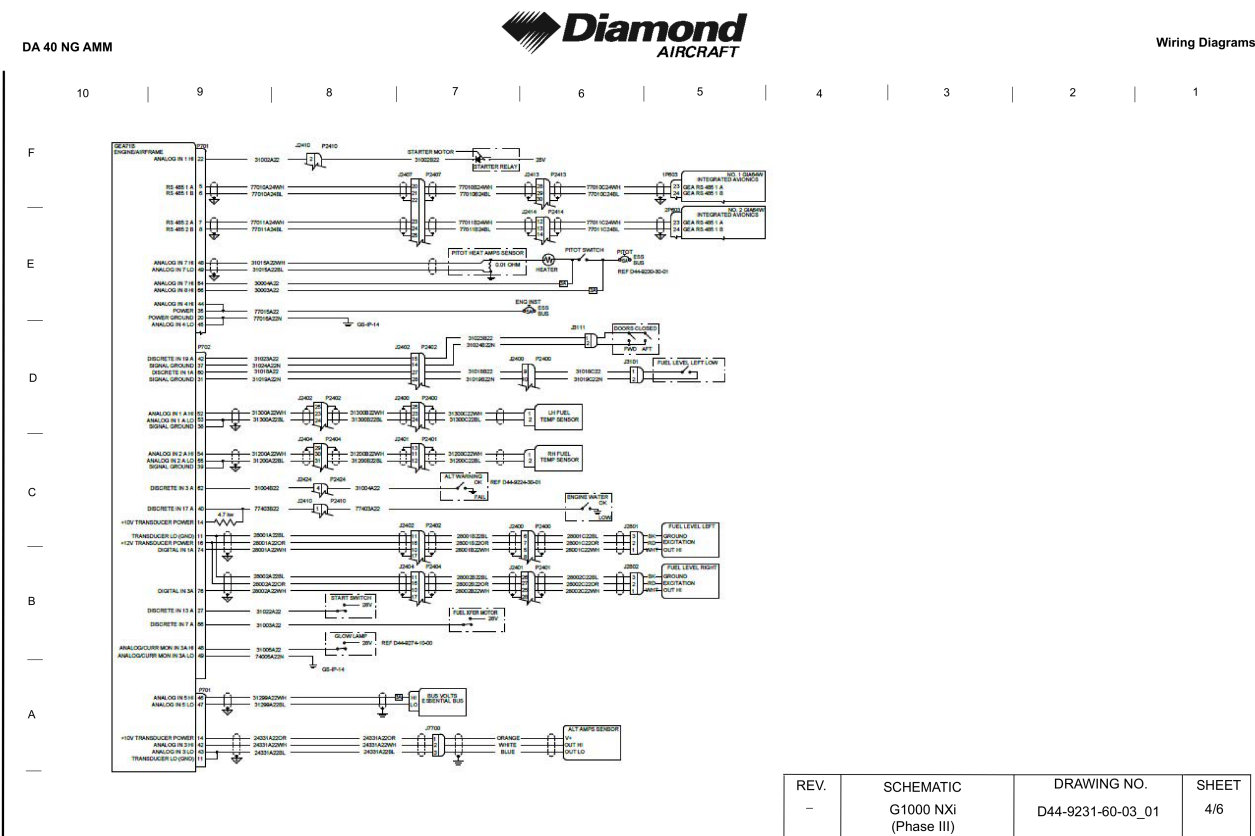
**AMM Schematic — G1000 NXi GEA 71S Wiring (D44-9231-60-03, G1000 NXi Phase I & II, Sheet 4/6):**

The G1000 bus voltage ("volt1") is measured by the **GEA 71S** (Engine/Airframe unit), mounted on the **instrument panel shelf** behind the MFD (AMM 31-40-00, p.985, Figure 6). It is the bottom-left unit on the shelf, accessible by removing the lower instrument panel cover.

- Per the AFM (Doc 6.01.15-E, Section 7.10.1, p.7-43): "The voltmeter shows the voltage of the essential bus. Under normal operating conditions the alternator voltage is shown, otherwise it is the voltage of the main battery."
- The GEA 71S **senses bus voltage via a dedicated analog input** — Pin 46 (ANALOG IN 5 HI) and Pin 47 (ANALOG IN 5 LO), connected to the **Essential Bus** via shielded wires 31299A22WH/BL. A **3A fuse** protects the HI wire (31299A22WH); its physical location is not identified on the available AMM schematics. This fuse carries

essentially no current (high-impedance analog input), so degraded fuse contacts would not cause the observed offset. An open fuse would produce a **0V reading**, not a low reading.

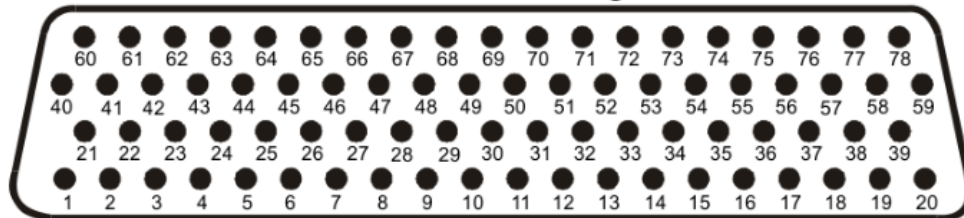
### P701 Connector

View of P701 connector looking at rear of unit.

When you have the GEA 71S connector P701 in hand, these are the pins relevant to the voltage problem:

Pin	Function	Wire (from AMM CH.92)	Where It Goes	Why It Matters
46	ANALOG IN 5 HI	31299A22WH (shielded)	Essential Bus via 3A fuse (HI)	<b>Voltage sense high — what's being measured.</b> A 3A fuse protects this wire. If the fuse were open, the reading would be <b>0 volts</b> (no signal), not a low reading — so the fuse is not the cause of our ~1.4V offset. The fuse location is not shown on the AMM schematic.
47	ANALOG IN 5 LO	31299A22BL (shielded)	BUS VOLTS ESSENTIAL BUS (LO)	<b>Voltage sense low — reference for the measurement</b>
44	ANALOG IN 4 HI	77015A22 (tied to Pin 35 (AIRCRAFT POWER))	GEA power supply (same wire as AIRCRAFT POWER)	<b>Measures GEA's own supply voltage (Essential Bus)</b>

**Inspect:** - **GEA 71S harness plug P701** — is it fully seated with lock engaged on the J701 receptacle? This connector carries all voltage measurement pins. Check Pin 20 (POWER GROUND), Pin 45 (ANALOG IN 4 LO), and Pin 35 (AIRCRAFT POWER) specifically. - **Ground stud GS-IP-14** — this is where the GEA 71S power ground wires (Pin 20 (POWER GROUND) and Pin 45 (ANALOG IN 4 LO), wire 77016A22N) terminate. Check for loose nut, corrosion, or paint under the ring terminals. - All GS-IP ground studs on the IP bus bar (see table below) - Look for anything that appears disturbed, loose, or not fully reconnected

**At each connector, check for:** - Backed-out pins (look from the rear of the connector) - Corrosion on pin or socket contacts - Connector not fully seated or lock not engaged - Damaged strain relief (wires pulling on connector)
