N238PS — G1000 LOW VOLTS Troubleshooting Guide

Aircraft: N238PS (Diamond DA40NG, MAM40-858) **Problem:** G1000 NXi displays lower voltage than actual bus voltage, causing intermittent LOW VOLTS annunciations **Date:** February 2026 **Prepared by:** Aircraft Owner (Ingram Leedy)

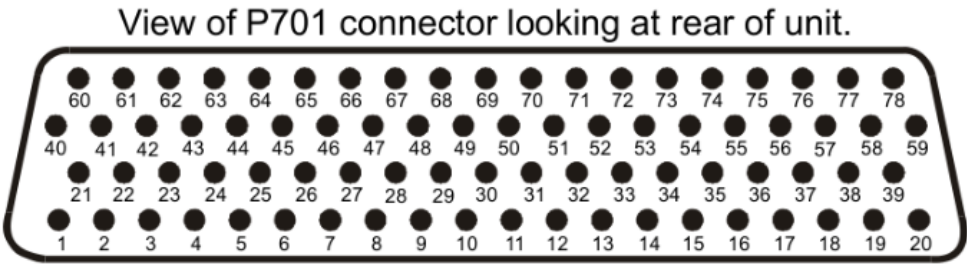
P701 Connector

P701 harness plug — view looking at rear of connector:

When you have the GEA 71S connector P701 in hand, these are the pins relevant to the voltage problem:

46	ANALOG IN 5 HI	31299A22WH (shielded)	Essential Bus via 3A fuse (HI)	Voltage sense high — what's being measured . A 3A fuse protects this wire. If the fuse were open, the reading would be 0 volts (no signal), not a low reading — so the fuse is not the cause of our ~1.4V offset. The fuse location is not shown on the AMM schematic.
47	ANALOG IN 5 LO	31299A22BL (shielded)	BUS VOLTS ESSENTIAL BUS (LO)	Voltage sense low — reference for the measurement
44	ANALOG IN 4 HI	77015A22 (tied to Pin 35 (AIRCRAFT POWER))	GEA power supply (same wire as AIRCRAFT POWER)	Measures GEA's own supply voltage (Essential Bus)
45	ANALOG IN 4 LO	77016A22N (tied to Pin 20 (POWER GROUND))	GS-IP-14 (ground)	GEA ground pin — same wire as Pin 20 (POWER GROUND), shares ground path
35	AIRCRAFT POWER 1	77015A22	Essential Bus via ENG INST 5A	GEA power supply — affects internal voltage reference
20	POWER GROUND	77016A22N	GS-IP-14	GEA ground reference — if high-R, ALL readings shift

At each connector, check for: - Backed-out pins (look from the rear of the connector) - Corrosion on pin or socket contacts - Connector not fully seated or lock not engaged - Damaged strain relief (wires pulling on connector)
