# N238PS — G1000 LOW VOLTS Troubleshooting Guide

**Aircraft:** N238PS (Diamond DA40NG, MAM40-858) **Problem:** G1000 NXi displays lower voltage than actual bus voltage, causing intermittent LOW VOLTS annunciations **Date:** February 2026 **Prepared by:** Aircraft Owner (Ingram Leedy)

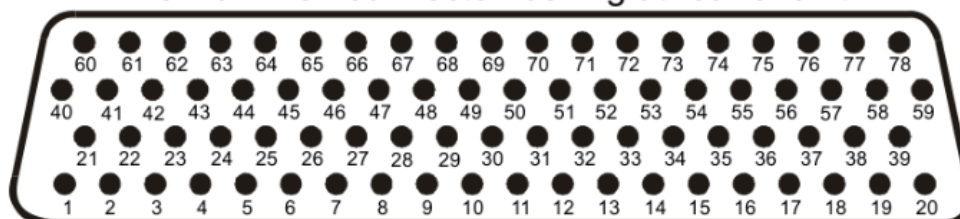
### P701 Connector

View of P701 connector looking at rear of unit.

46	ANALOG IN 5 HI	31299A22WH (shielded)	Essential Bus via 3A fuse (HI)	Voltage sense high — what's being measured. A 3A fuse protects this wire. If the fuse were open, the reading would be <b>0 volts</b> (no signal), not a low reading — so the fuse is not the cause of our ~1.4V offset. The fuse location is not shown on the AMM schematic.
47	ANALOG IN 5 LO	31299A22BL (shielded)	BUS VOLTS ESSENTIAL BUS (LO)	Voltage sense low — reference for the measurement
44	ANALOG IN 4 HI	77015A22 (tied to Pin 35 (AIRCRAFT POWER))	GEA power supply (same wire as AIRCRAFT POWER)	Measures GEA's own supply voltage (Essential Bus)
45	ANALOG IN 4 LO	77016A22N (tied to Pin 20 (POWER GROUND))	GS-IP-14 (ground)	GEA ground pin — same wire as Pin 20 (POWER GROUND), shares ground path
35	AIRCRAFT POWER 1	77015A22	Essential Bus via ENG INST 5A	GEA power supply — affects internal voltage reference
20	POWER GROUND	77016A22N	GS-IP-14	GEA ground reference — if high-R, ALL readings shift

**At each connector, check for:** - Backed-out pins (look from the rear of the connector) - Corrosion on pin or socket contacts - Connector not fully seated or lock not engaged - Damaged strain relief (wires pulling on connector)
