## INSPECTION CONDITIONS

**FILE #:** 21-10-7-01.

**INSPECTION SITE:** 309 E 7th St.

**INSPECTION SITE  
CITY/STATE/ZIP:** West Point, Georgia.

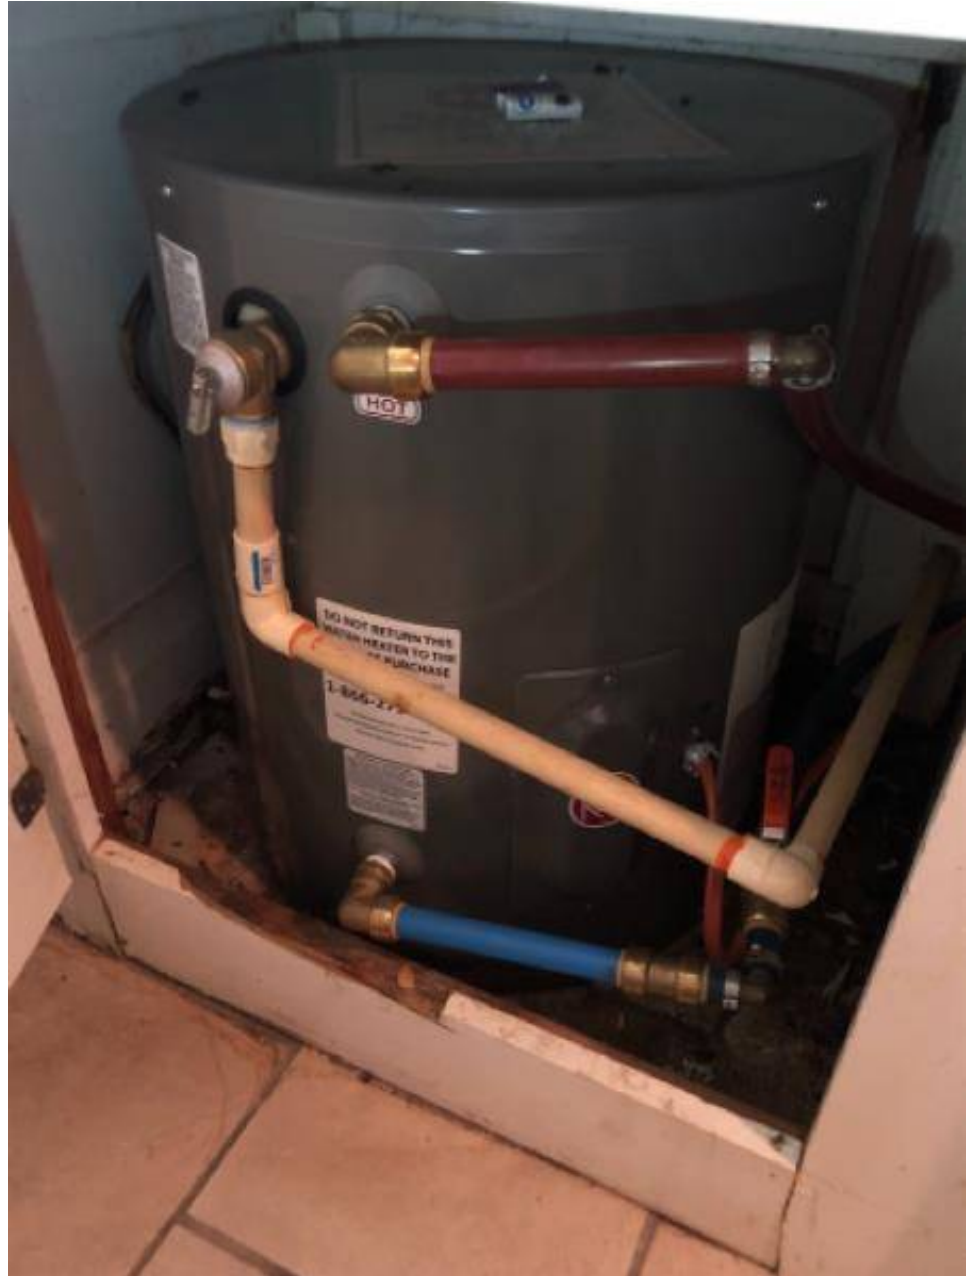
**LOCATION:** Kitchen.

**CONDITION:** The water heater responded properly during the inspection. Pressure relief valve noted, not tested, A water shutoff valve is installed.

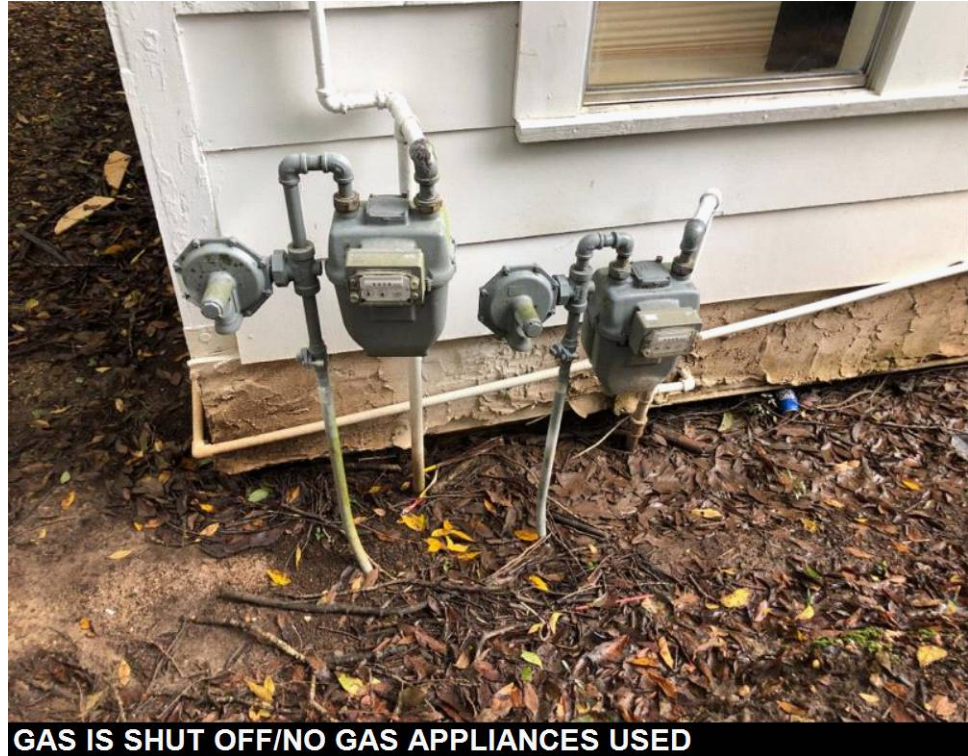
System appears to be in satisfactory condition. Meter located at, right side of home. Gas is currently turned OFF. Gas appliances were replaced with electric.

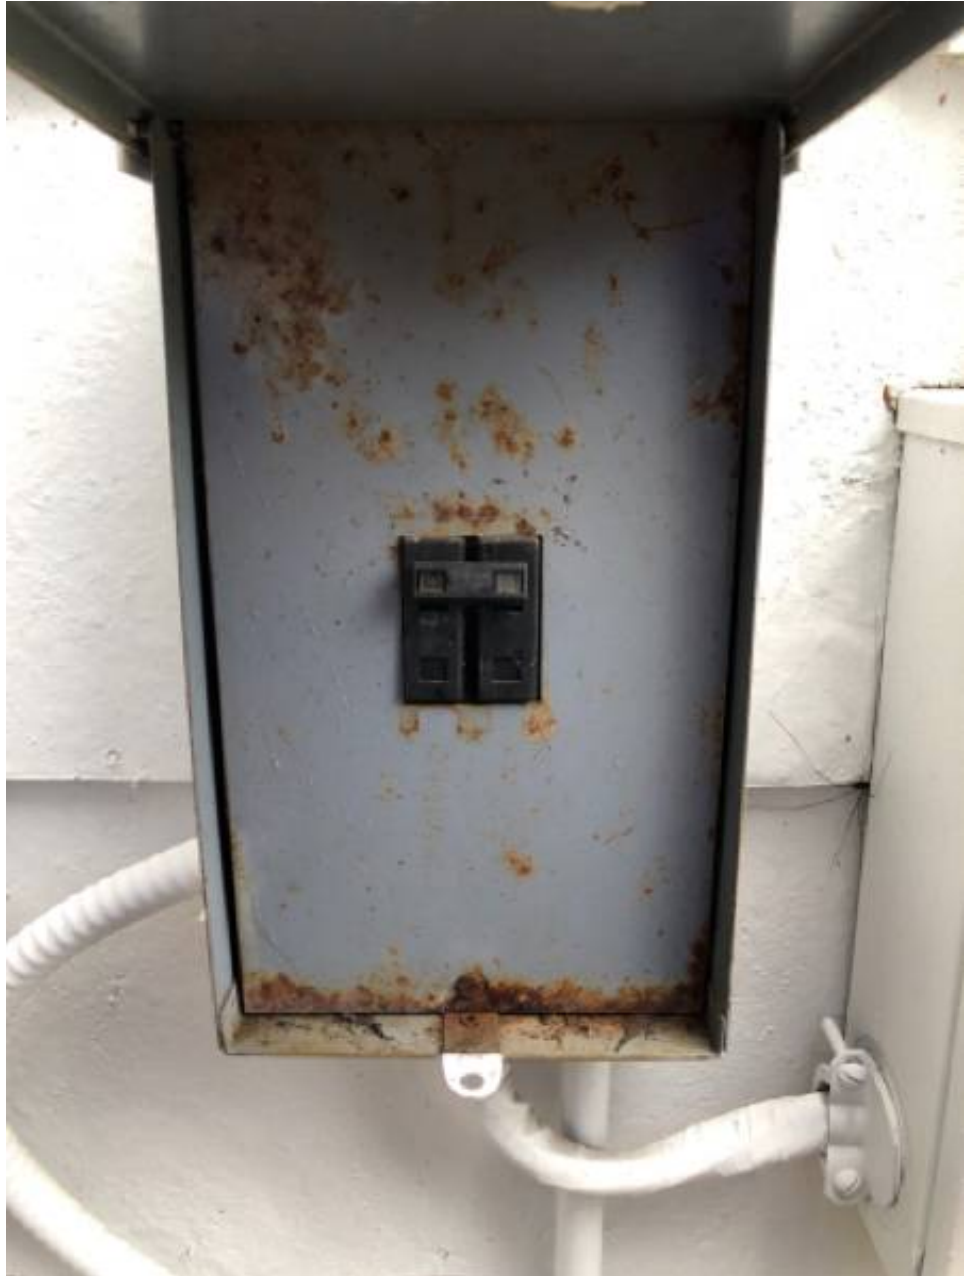
**MAIN PANEL LOCATION AND NOTES:** Exterior of house.

**AMP RATING:** 100 AMPS.

**Inspector Notes:** Circuit and wire sizing correct so far as visible, Grounding system is present.

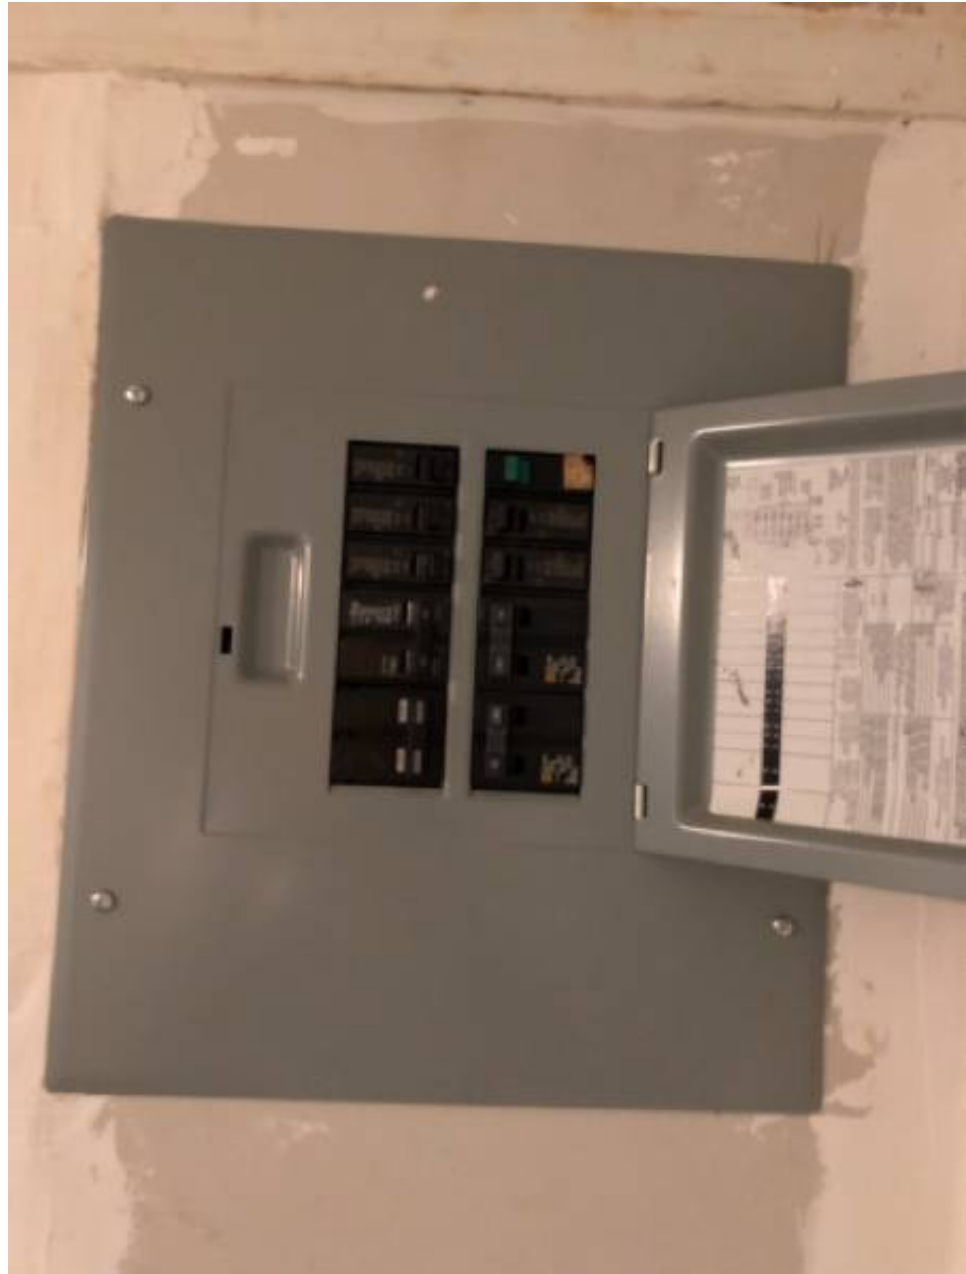
**SUBPANEL #1 LOCATION:** Kitchen.

Circuit and wire sizing correct so far as visible, Grounding system is present, **Multiple wires are connected to a single lug on a circuit breaker where only one wire should be connected. The electrical panel does not have detailed labeling for the breakers required by current industry standards. Breakers should be labeled in detail as to the room, ie. Master Bedroom, Front Bedroom, Bonus Room, etc.**
