AYALA ALABANG R1P

1.1 Fire protection and safety audit

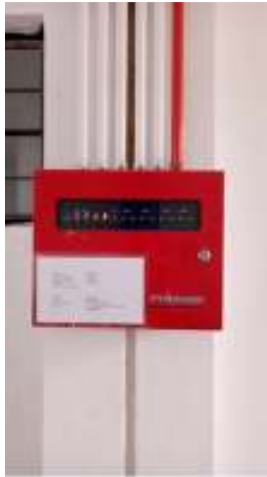
(a) FDAS panel

On the inspection date, it was established that there is Fire Alarm Control , **PYGARD brand** and the devices are SMOKE DETECTOR “**PYGARD**” brand.

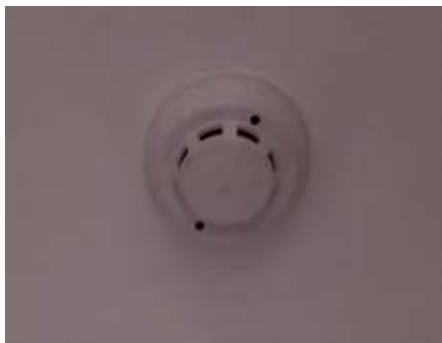
(e) Smoke Detector

- 16 out of 20 smoke detector devices were tested, activated after spraying of smoke tester. Location of functioning SD are
 - the lobby
 - hallway
 - conference room
 - file room
 - back room
 - pantry
 - customer care
 - utility room
 - Motor control center room
