102-06904-DCM/DFH
June 24, 2014

Subject: **Palo Verde Nuclear Generating Station (PVNGS)**
Unit 3
Docket No. STN 50-530
License No. NPF 74
Licensee Event Report 2013-001-01

Leakage on Reactor Vessel Bottom-Mounted Instrumentation Nozzle 3

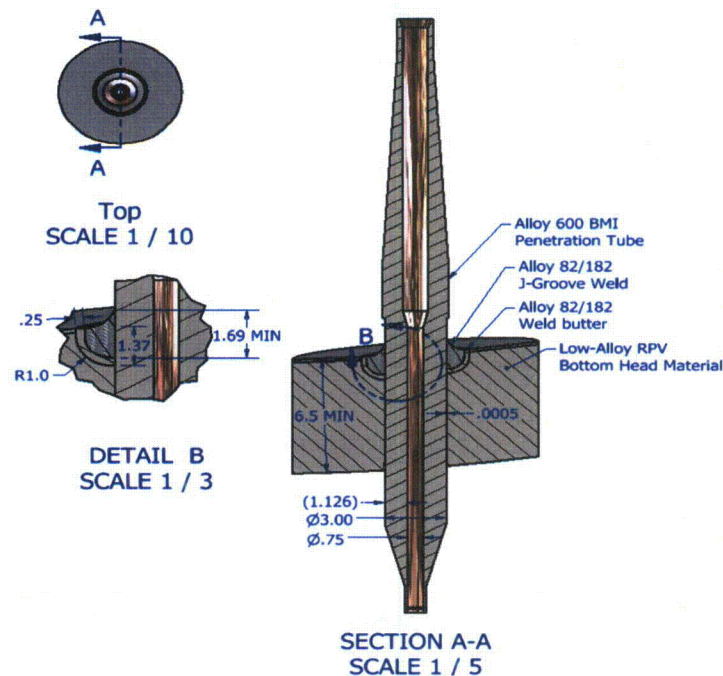
Figure 1- Illustration of a BMI Nozzle Assembly Including Location of Welds

The BMI nozzle assemblies in the reactor vessel lower head are fabricated from Alloy 600 and are internally connected to the vessel lower head with J-groove welds made from Alloy 82/182 (see Figure 1). These materials have known susceptibility to primary water stress corrosion cracking (PWSCC). Stresses that make Alloy 600 nozzle tubes and their Alloy 82/182 J-groove attachment welds susceptible to cracking are inherently induced by the welding of the nozzle tube to the inside surface of the reactor vessel lower head during
