Draft Technical Summary Report

Results from I76 Viaduct Vibration Survey

PennDOT District No. 6

August 2016

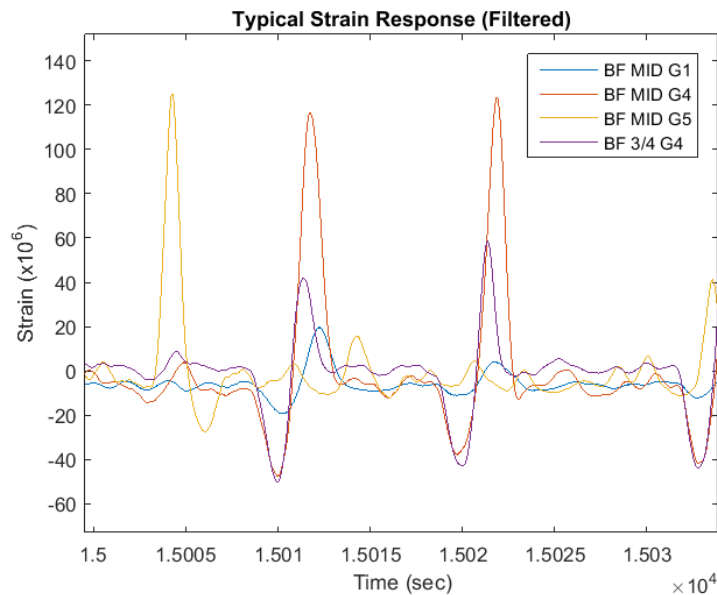
Typical Static Strain Response Under Operational Traffic Loading

Strain levels in excess of 100 microstrain (3 ksi) were not uncommon, and occasional responses as high as 6 ksi were recorded in the bottom flange of longitudinal girders at mid-span. The interior girders (supported at the center of the box girder) experienced the highest responses. A low pass filter was applied to the data to remove the data associated with frequencies above 1.5

The strain data plotted above has been filtered to show only the static response. The additional strain due to the vibration of the bridge is neglected. However, the portion of strain due to the dynamic response (vibration) of this structure is significant. The plot below is during a large event. The static response accounts for over 100 microstrain, but the vibration of the structure causes the total response to exceed 200 microstrain. For this event, an amplification of the static response by approximately 75% is observed. In comparison, the amplification applied for bridge design is only 33% or less.
